NATIONAL ORGANIZATION  
SONS OF UNION VETERANS OF THE CIVIL WAR  
CIVIL WAR MEMORIAL ASSESSMENT FORM

**BATTLE OF ATLANTA MONUMENTS**

Pimsler Hoss Architects, Inc. with the support of consulting professionals has reviewed existing conditions at two historic battlefield monument sites in Atlanta, Georgia. The McPherson Monument is located at the intersection of McPherson Avenue, SE and Monument Avenue, SE. The Walker Monument is located at the intersection of Wilkinson Drive, SE and Glenwood Avenue, SE.

3. Preliminary Preservation Assessment and Restoration Report  
02.01.2012

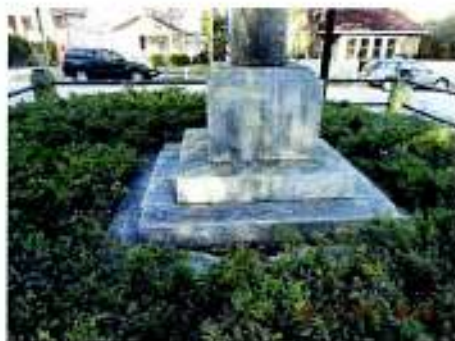
**pedestal base and steps**

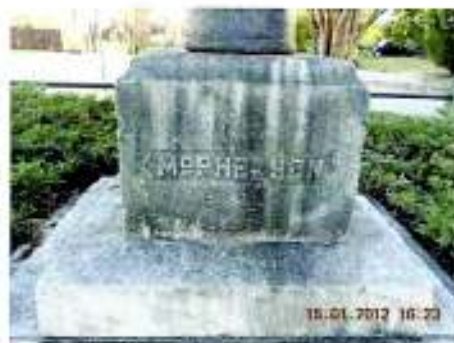
**pedestal inscription**

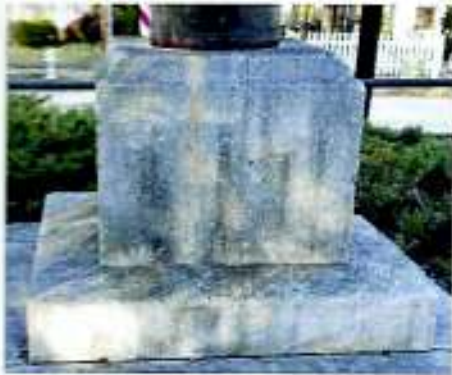
The stone base of the monument has some staining from the rust of the steel cannon above. The pedestal and the steps also have mildew evident on all surfaces.

**pedestal rust stains and mildew**

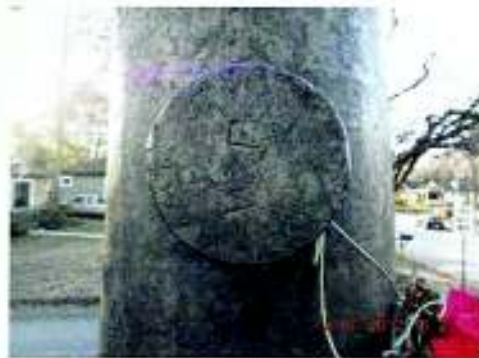
The cannon has identifying marks on each face of the trunnions. 'WF' is inscribed on one face and the other face has a date of 1837.

**trunnion inscription (east)**

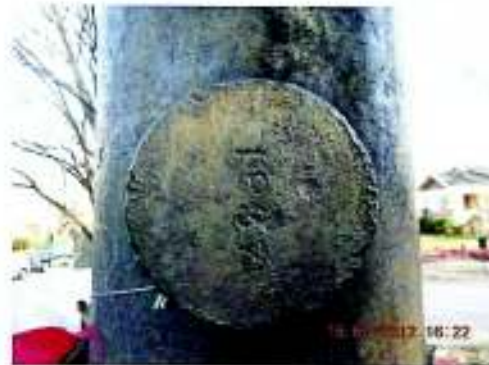
**trunnion inscription (west)**

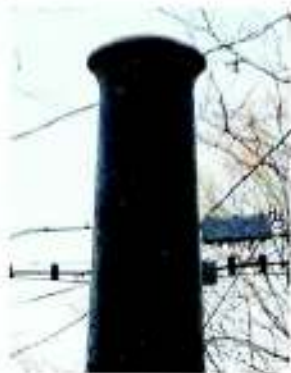
The upper most edge of the cannon has a contoured muzzle, rather than maintaining the shape of the barrel of the cannon. The body of the cannon itself appears to have been coated at some time. This is apparent as one studies the texture of the cannon, where the corrosion is readily evident beneath.

**flared cannon muzzle**

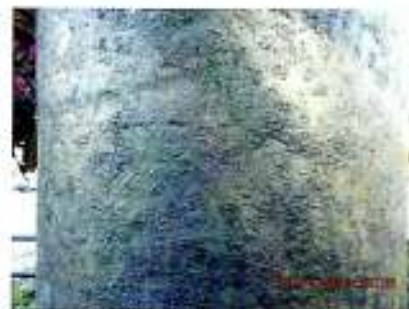
**cannon shaft corrosion**

The existing paint layer should be removed using blasting and an appropriate medium at low pressure. Media to be considered include ground walnut shell, sponge blasting, and dry ice mist. Loose scale, paint residues, and media need to be thoroughly collected.

An industrial/marine coating system should be selected, based not only on cost but the skill and experience of a contractor with these systems. The primer and topcoat must come from the same vendor. Technical advice should be sought from the manufacturer, and instructions followed exactly. Industrial coating systems used in conservation of historic artillery include those from Rustoleum, Sherwin Williams, and PPG.

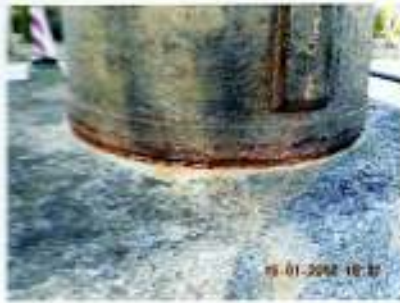
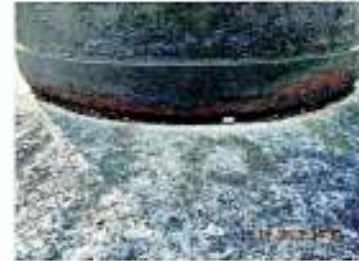
The base of the cannon, as it meets the stone pedestal shows signs of heavy pitting and corrosion with rust particles noted to be flaking off of the cannon at this time.

**cannon base corrosion**

The cannon barrel is approximately 9'-6" tall and 16" diameter at the base. It is not clear how the barrel is attached to the stone pedestal. There is a lot of visual rust and corrosion at the base of the barrel where it rests against the stone pedestal. This area easily traps moisture which is accelerating the corrosion. It was also mentioned on site that the top of the cannon is not capped and allows water/debris to collect in the barrel.

The Metals and Materials engineers on our project team will be conducting tests to identify the condition of the cannon and extent of corrosion. We will review their findings and assess if structural repairs are required on the cannon. Additionally, we may need to coordinate during phase II on recommendations for capping the cannon and affixing it to the pedestal. Measures should also be taken to eliminate areas which trap moisture against the steel and cause corrosion. Using grout filler around the base of the cannon could provide positive drainage of water away from the base.
