CIVIL WAR MEMORIAL ASSESSMENT FORM

Condition Report of granite/marble Civil War monument at Mary Sheridan Park

Year: Erected 1870 Materials: Granite, marble

Dimensions: 7' x 7' x approx. 22' high (7'x7' are dimensions of lowest granite element)

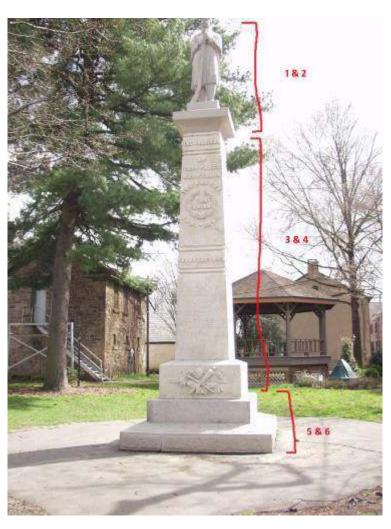
Description: The monument is composed of six stone elements. From the top: (1) granite figure

of a Civil War soldier, (2) granite cornice, (3 & 4) two marble pieces comprising the Shaft, one with most of the text and one we will call the "Bachman" element and

(5 & 6) two granite elements comprising of the Plinth.

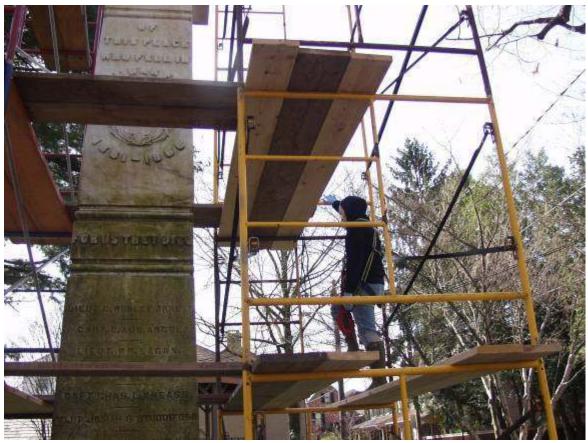
March, 2012

History of past work done on monument that we know of: Harry H. Gordon Studios, LLC worked on the monument in March of 2012, primarily to clean the monument. We set up scaffolding high enough to reach the top of the **upper marble element (#3).**

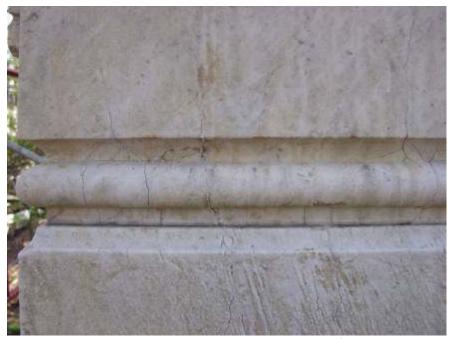
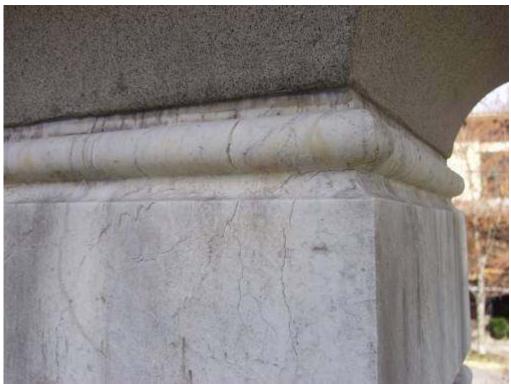
At this time, March 2012, we noticed some cracking in the marble at the **top of element #3**, but nothing of great concern. There is evidence of effort to fill some of these cracks in the past, by others. We are including these images as areas to keep an eye on.

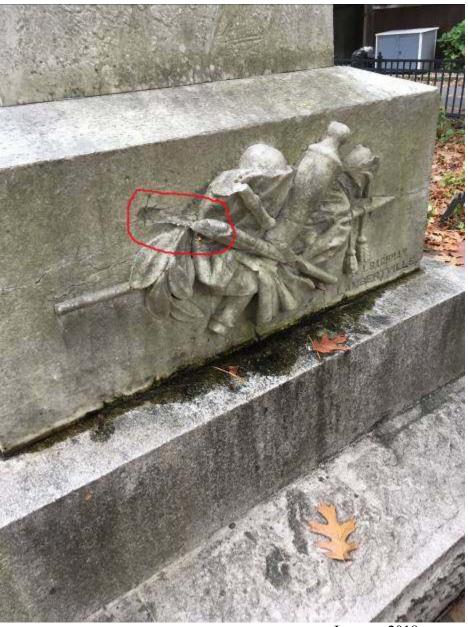
January, 2018

One of our greater concerns is the water seepage from the bottom of the **marble Bachman element onto the top of granite element #5.** We do not have any images of this water seepage from our work in March, 2012, but do remember it happening back then as well. The concern is of course that in cold temperatures this moisture is freezing within the marble and expanding and contributing to further, deeper cracking.

Ideally, the monument would be dismantled and the concerning piece marble element #4 could be assessed and replaced if necessary. We would highly recommend doing this if at all possible, as the question of PUBLIC SAFETY is a great concern. If there is not funding to support dismantling and potential replacement, we recommend action to tighten up the monument from water, reducing the damage from freeze, thaw and drying cycles. This would include gentle cleaning, consolidation to improve grain to grain cohesion and injecting grouting of cracks and filling any open joints. We also highly recommend an annual maintenance program to monitor for open cracks and further deterioration, regardless of whether monument dismantled or restoration action taken. Please see attached proposals/estimates for recommendations.

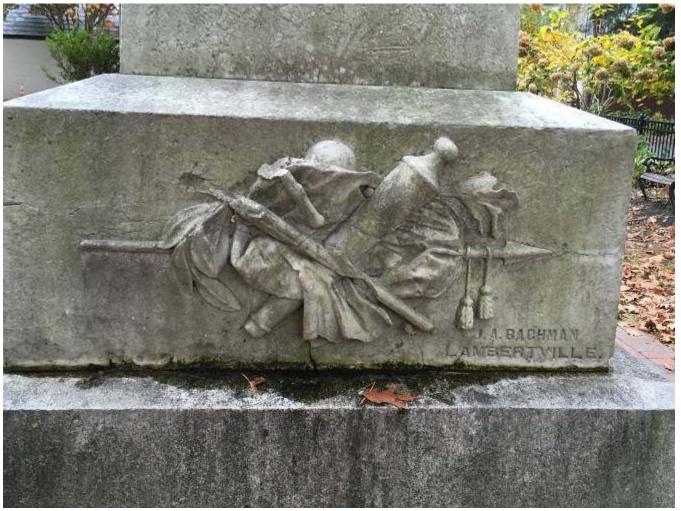
January, 2018

Another image of the front of marble element 4. Note the crack going horizontally through the stone and relief and vertical crack below relief.

The water seepage does not seem to have affected the top of granite element #5, but the marble elements #3 and #4 are showing signs of biological soiling, cracks (ranging from network cracking to 3mm cracks), open cracks, previous repairs, and materials loss (on element #4, the Bachman marble, see red circled area in image above).

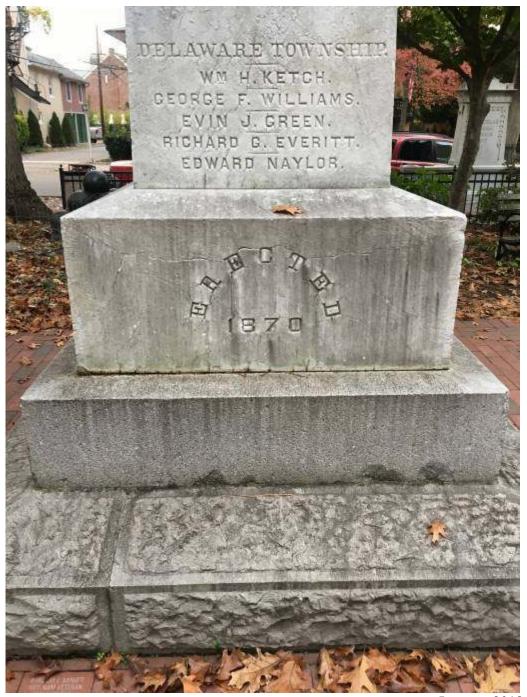
January, 2018

In image below, note the crack from corner to corner of the "Erected 1879" portion of marble piece #4, and the water seepage at the bottom.

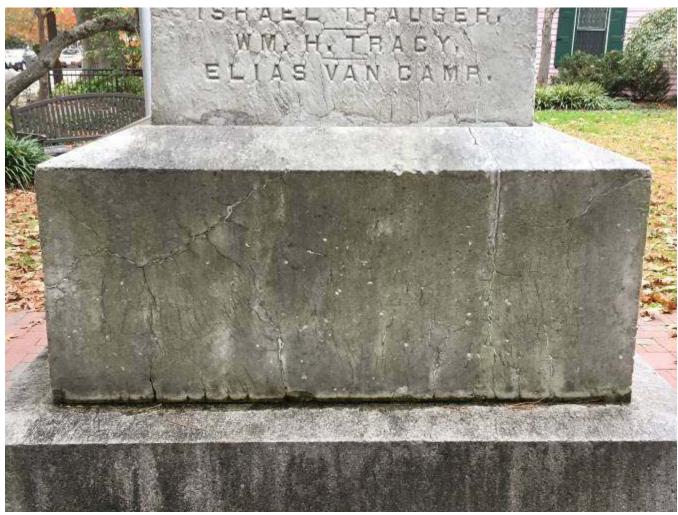
January, 2018

This is a third side of marble element #4, the Bachman marble of concern:

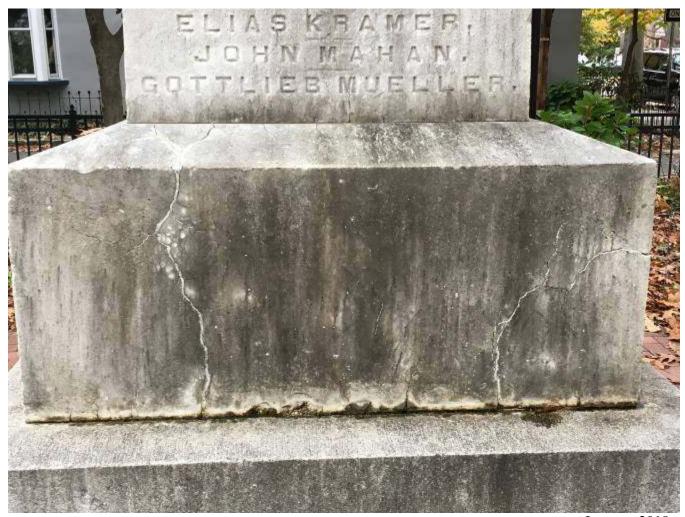
January, 2018

This is the fourth side of marble piece #4. Again, large cracks, these filled by others awhile ago. Our concern here is that these major cracks are in a marble stone lower on the monument, and thus supporting a lot of weight.

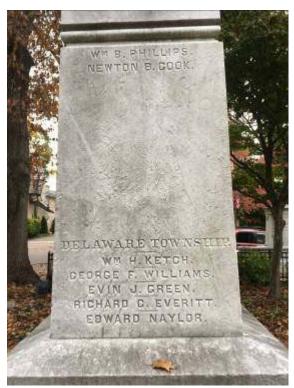
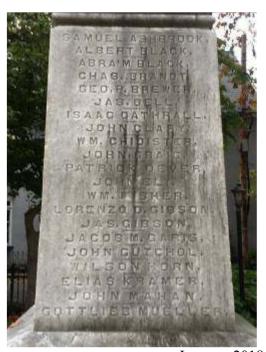
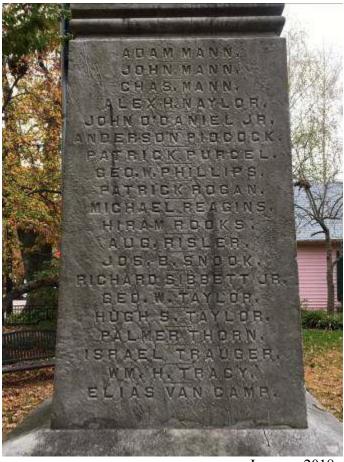
There is some cracking in the upper marble element #3, but we attribute most of these to natural inclusion. This large element also does not have the same heavy weight on it that element #4 does.
