NATIONAL ORGANIZATION  
**SONS OF UNION VETERANS OF THE CIVIL WAR**  
**CIVIL WAR MEMORIAL ASSESSMENT FORM**

The Memorial is *currently* located at:  
 Street/Road address or site location Garden of Memories Cemetery  
 City/Village Salinas Township \_\_\_\_\_ County Monterey

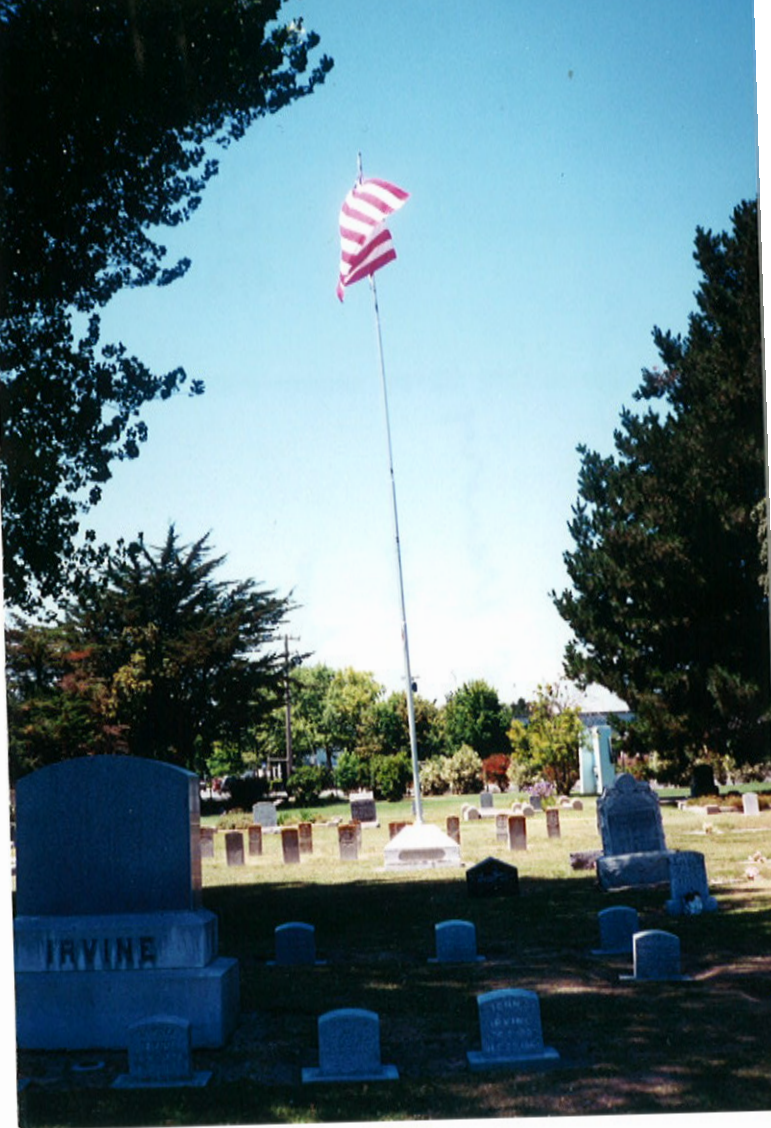
The base looks like its been pulled from ground and re-rested. The  
uneven concrete mounted support makes the Flag pole tilted toward the  
West, the tilted flag pole is quite visually and can be seen as  
abnormally tilted.. The Tombstones in the immediate area has algae.Mos.

Badly tilted, structure pulled from original space that appears unknown and rerested, and re-centered in front of the GAR resting Places. Tombstone's in need of a scrub, but very readable. Three tombstones are missing, only indication of the three missing is concrete stubs indicating the numbers of three graves numbered 1, 2, & 3. Quest for records are still under Camp Lincoln 10 investigation. (CA. & Pacific Dept.)  
There are other random GAR grave sites through out the Cemetery.

By Cleaning Standard, Algae is Butt minimum, structure needs re-mounting.

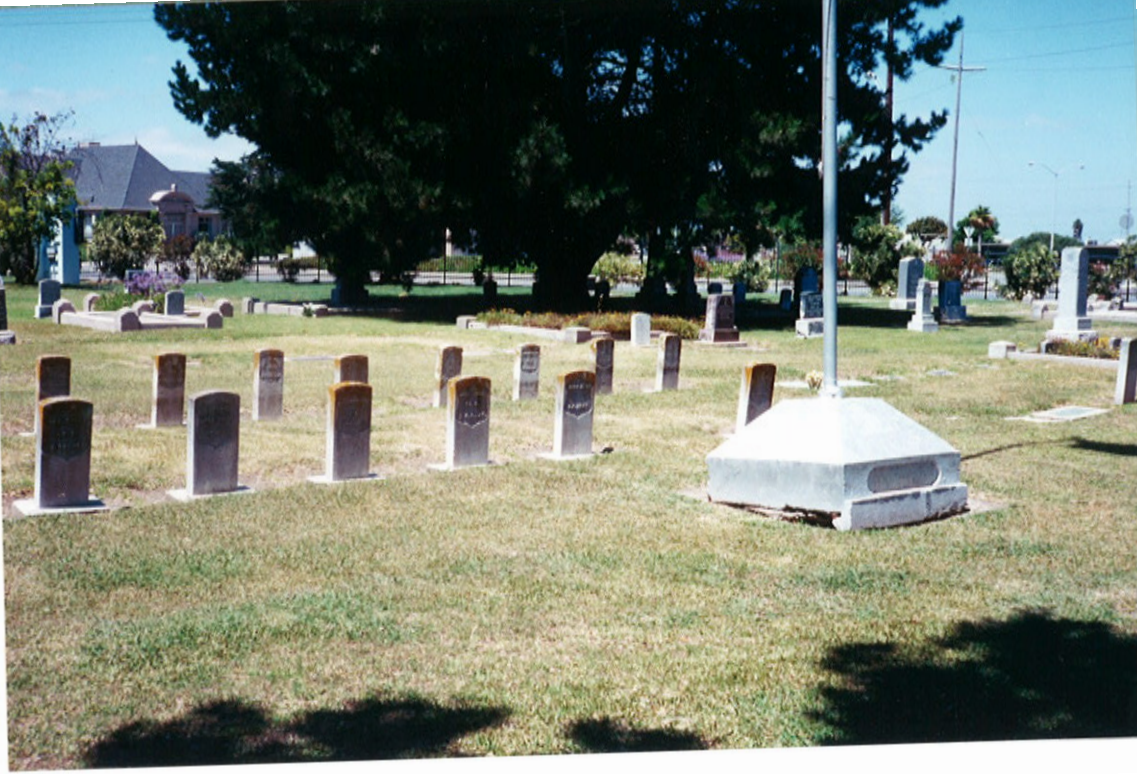
ERECTED BY  
GASTON BERGES UNIT No 109  
U. V. A. — 1926
