NATIONAL ORGANIZATION
SONS OF UNION VETERANS OF THE CIVIL WAR
CIVIL WAR MEMORIAL ASSESSMENT FORM

George Cheyenne WISE – CONSERVATION TREATMENT PROPOSAL

SCULPTURE CONSERVATION TREATMENT PROPOSAL

PROJECT: George Cheyenne Wise Memorial
Zinc

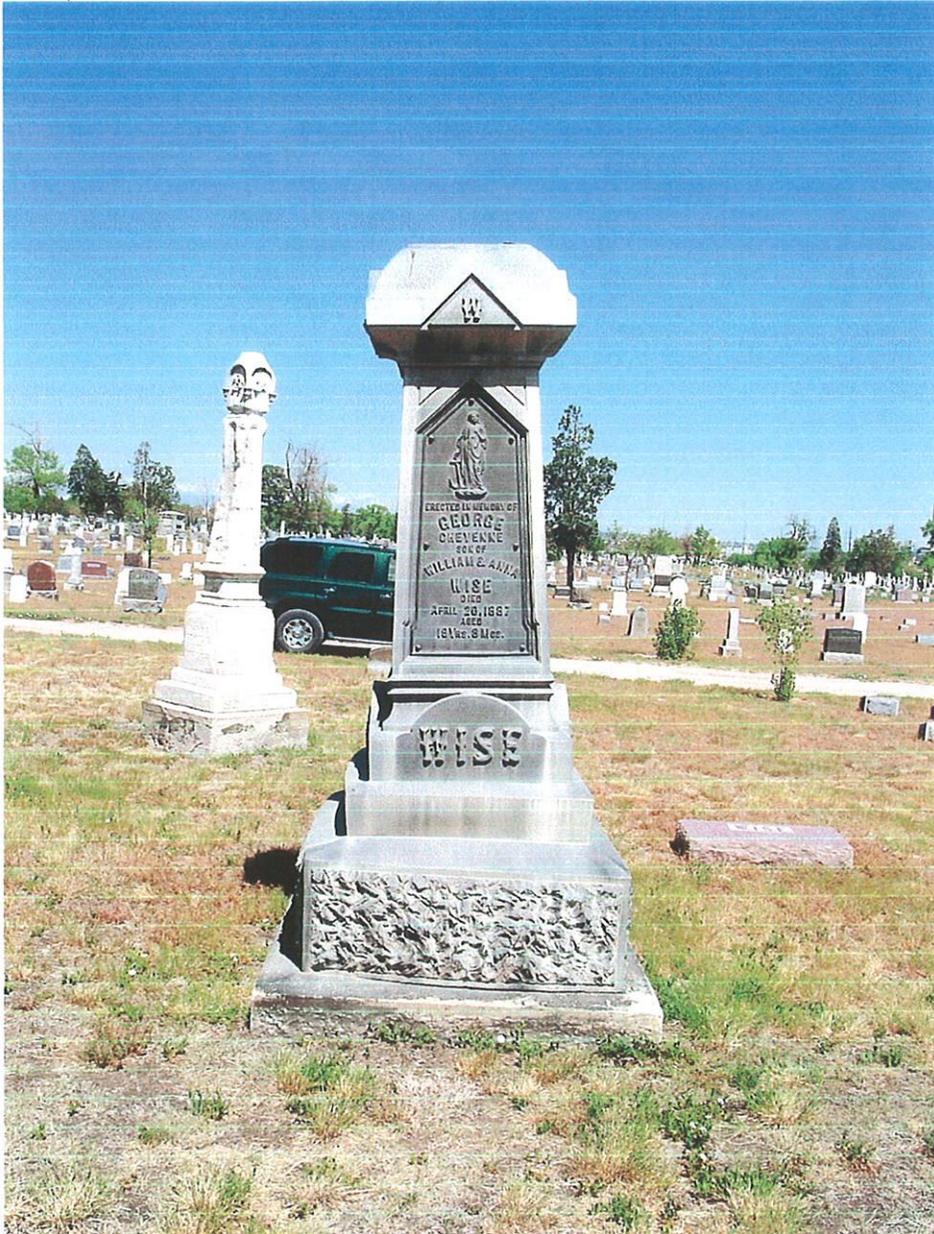
At some prior date, the Civil War Union Soldier was cut from the supporting column of the Wise memorial. The statue is located in storage and has a break through the barrel of the rifle. The column, therefore, is open at the top. The lowest of the three sections of the support column is visibly distorted, bulging from collapse of the zinc after years of supporting the weight of the memorial. Some distortions were also noted in the middle and uppermost sections of the memorial, though they were less severe.

Repairs would be made to the statue and plinth sections while the Memorial in sections. The rifle barrel would be soldered and the repair dressed down. The top section and soldier would be re-joined by soldering where they have been cut apart. Distortions in the zinc metal would be reshaped and eliminated as much as possible. The aged metal has some memory of the new, distorted form, so a full re-alignment is not anticipated.

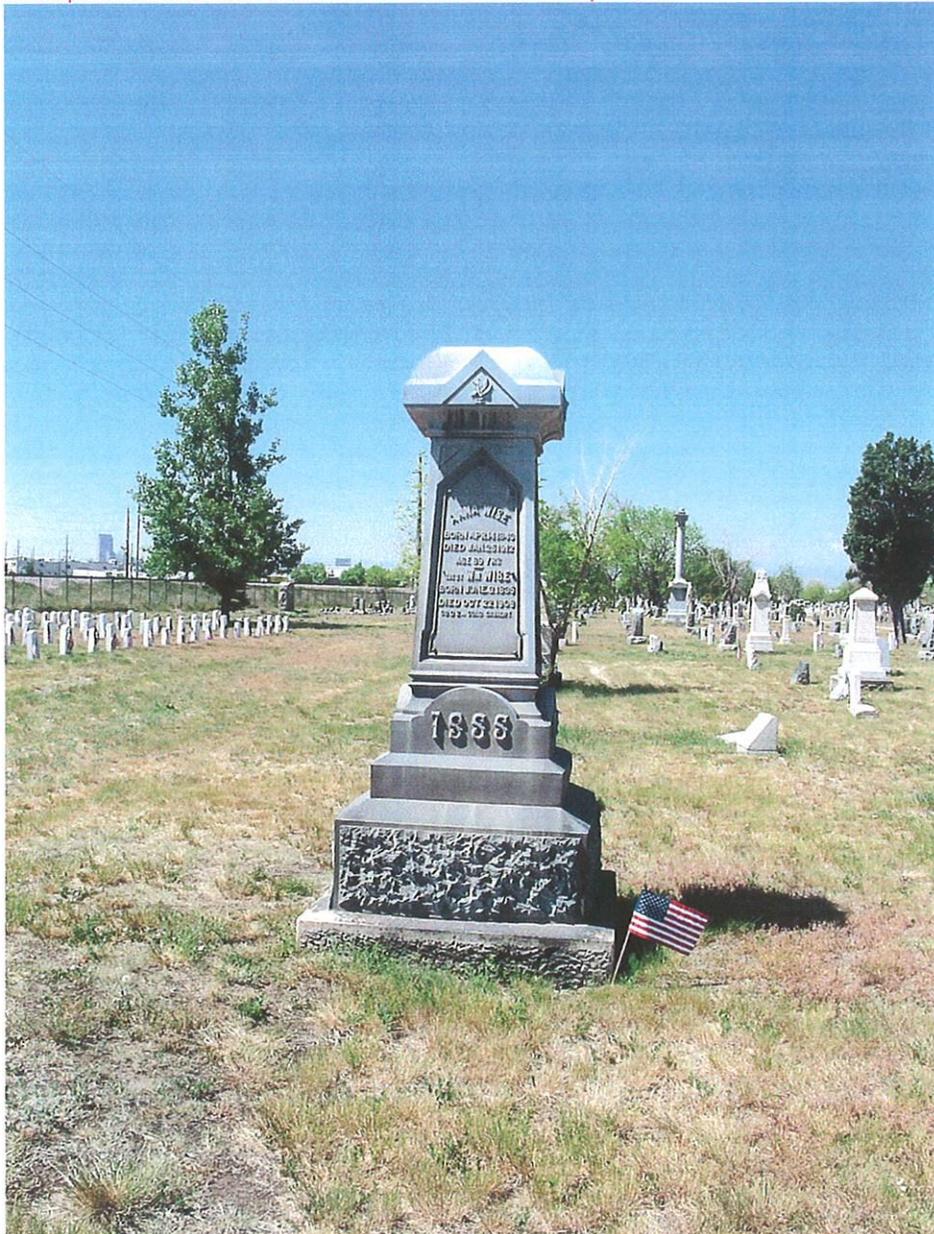
Because it is zinc, the metal of the memorial appears chemically sound; it has not corroded. Lettering remains clearly legible. The sculpture has produced a self-protective patina.

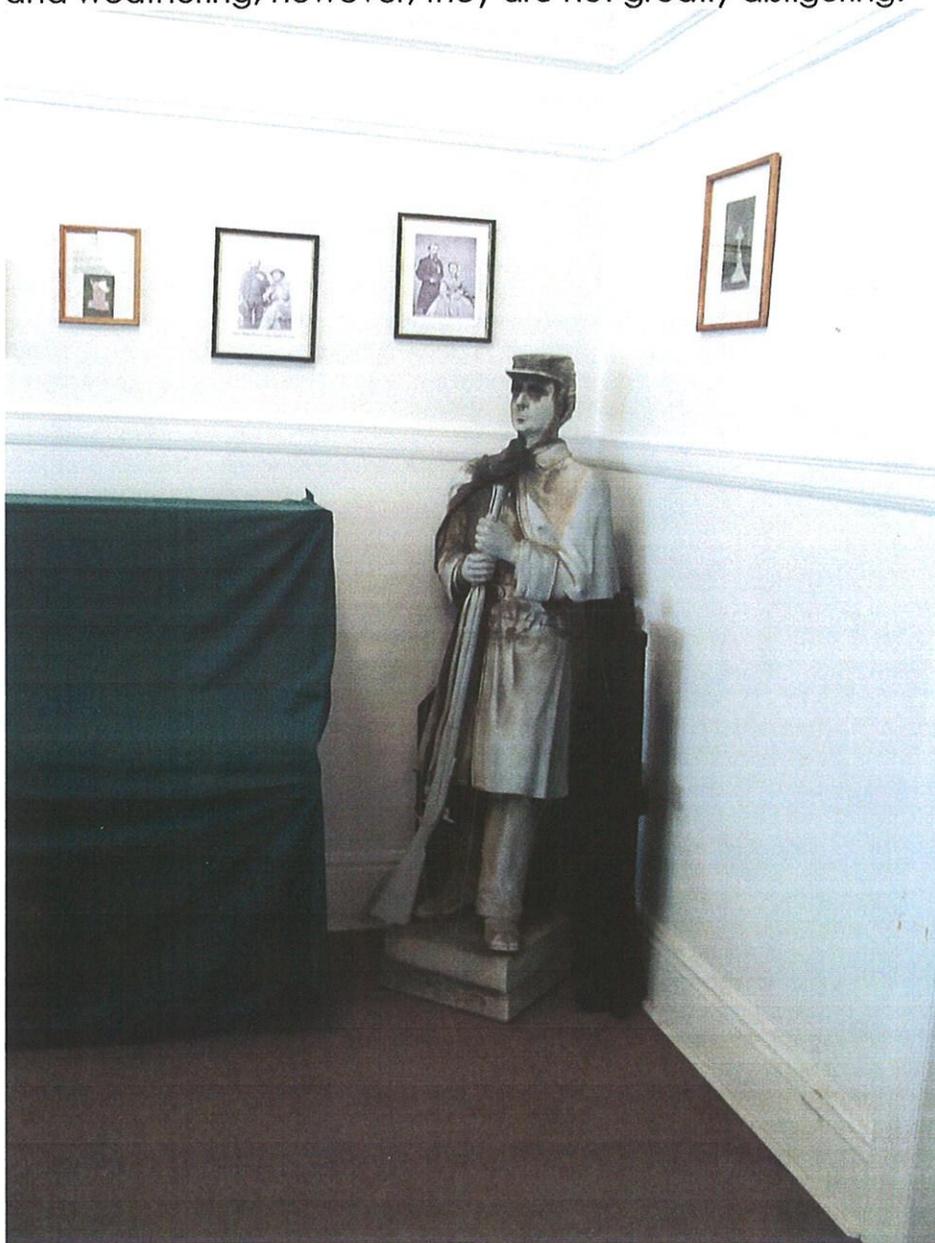
Color variations on the face of the Soldier are notable and indicate age and weathering, however, they are not greatly disfiguring.

Indoors, the statue has been separated from the columnar portion of the Wise Memorial. There is a break in the rifle barrel, located an inch below the right hand.

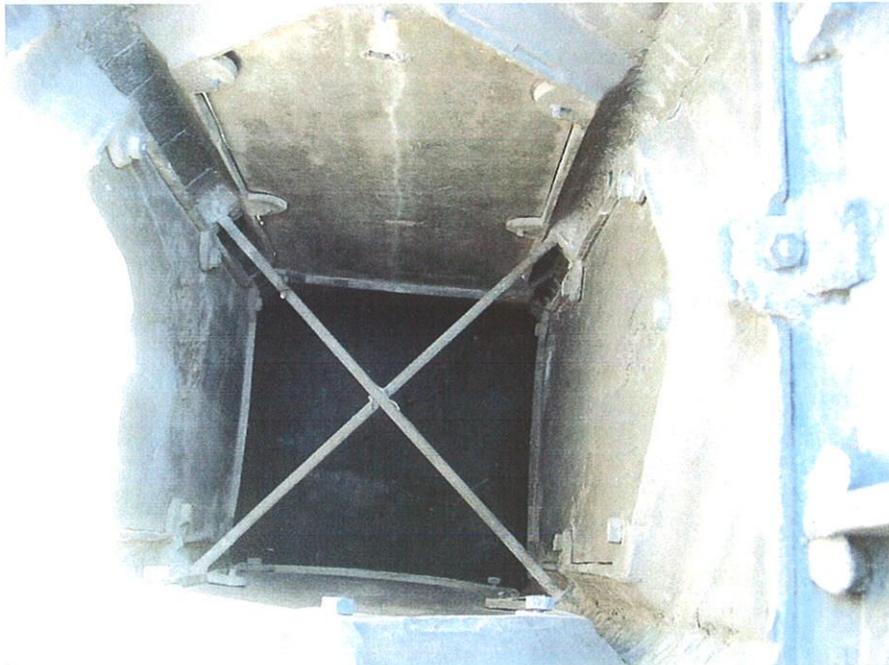
The interior view illustrates bolts securing sections across cast joints. The "X" is a pair of tie rods placed inside the tall center section to aid in keeping the Memorial square.

The armature would be engineered to support weight from each of the three sections and the statue independently from one another. In order to support each section independently, the memorial sections would be separated at the horizontal joints by removing the bolts. The stainless steel armature would be erected, and leveled on site and each historic zinc section would be attached, level and directly to the armature, not to each other. This plan provides each aging zinc section with internal support and eliminates the need for the zinc to support itself. Metal shims may need to be inserted to level the sections of the Memorial as it is reassembled.

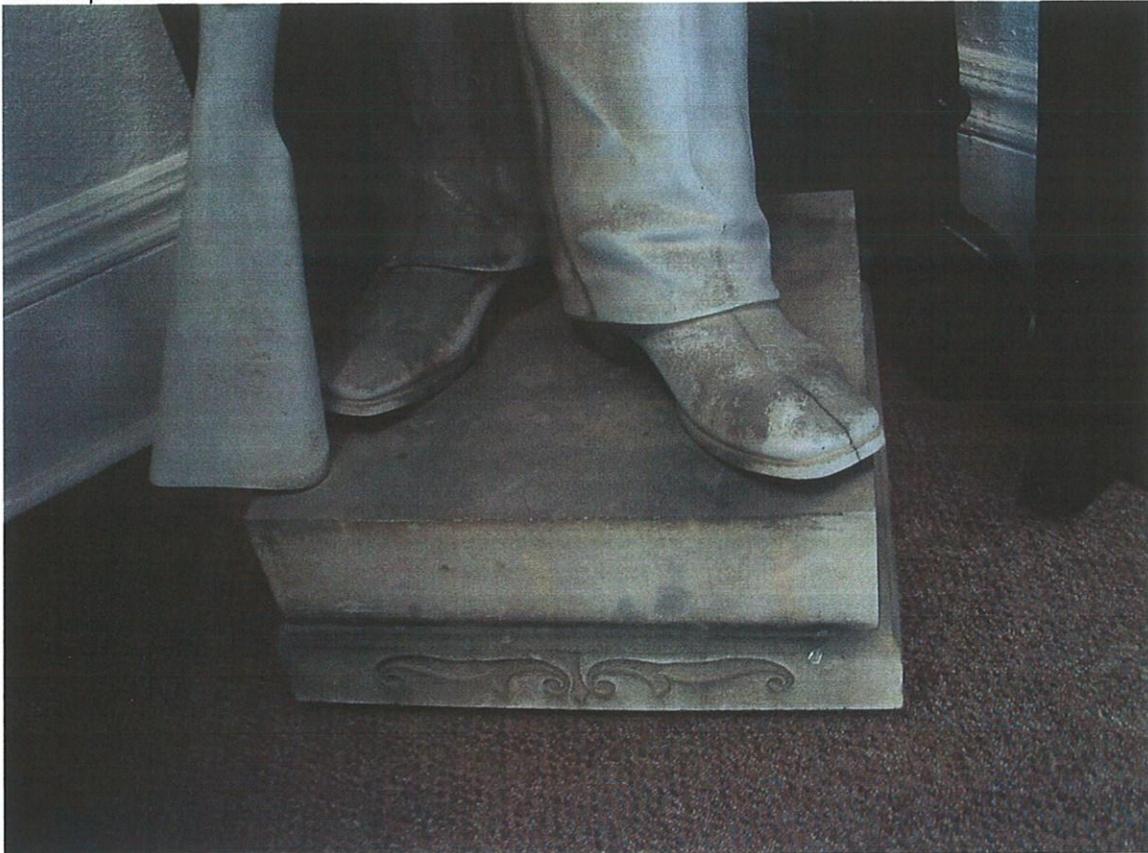
The statue of the Civil War Union Soldier has been cut away from the lower elevation of the Wise Memorial. In this detail photograph some staining and accretions are visible.

Although there is no significant corrosion of the zinc metal exterior, some cleaning will be affected while the sections are separated. Cleaning tests will be conducted prior to full scale cleaning operations being undertaken. Among the arsenal of available cleaning means we recommend testing the use of a pressure washer at limited settings, metal stain removers, ammoniated cleaners, mechanical cleaning methods, and organic solvents (aliphatic as well as aromatic). The purpose of the

cleaning is to remove accretions and accumulated soil and unify the color of the weathered exterior. Cleaning would stop well short of stripping the metal to a bright "like new" appearance. The indicators of age would be preserved through cleaning, but the process would mitigate the irregularities of finish. Gaps between sections of the straightened cleaned and reassembled zinc would be filled with two-part architectural epoxy, toned gray in color to readily disappear from view in the final assembly.

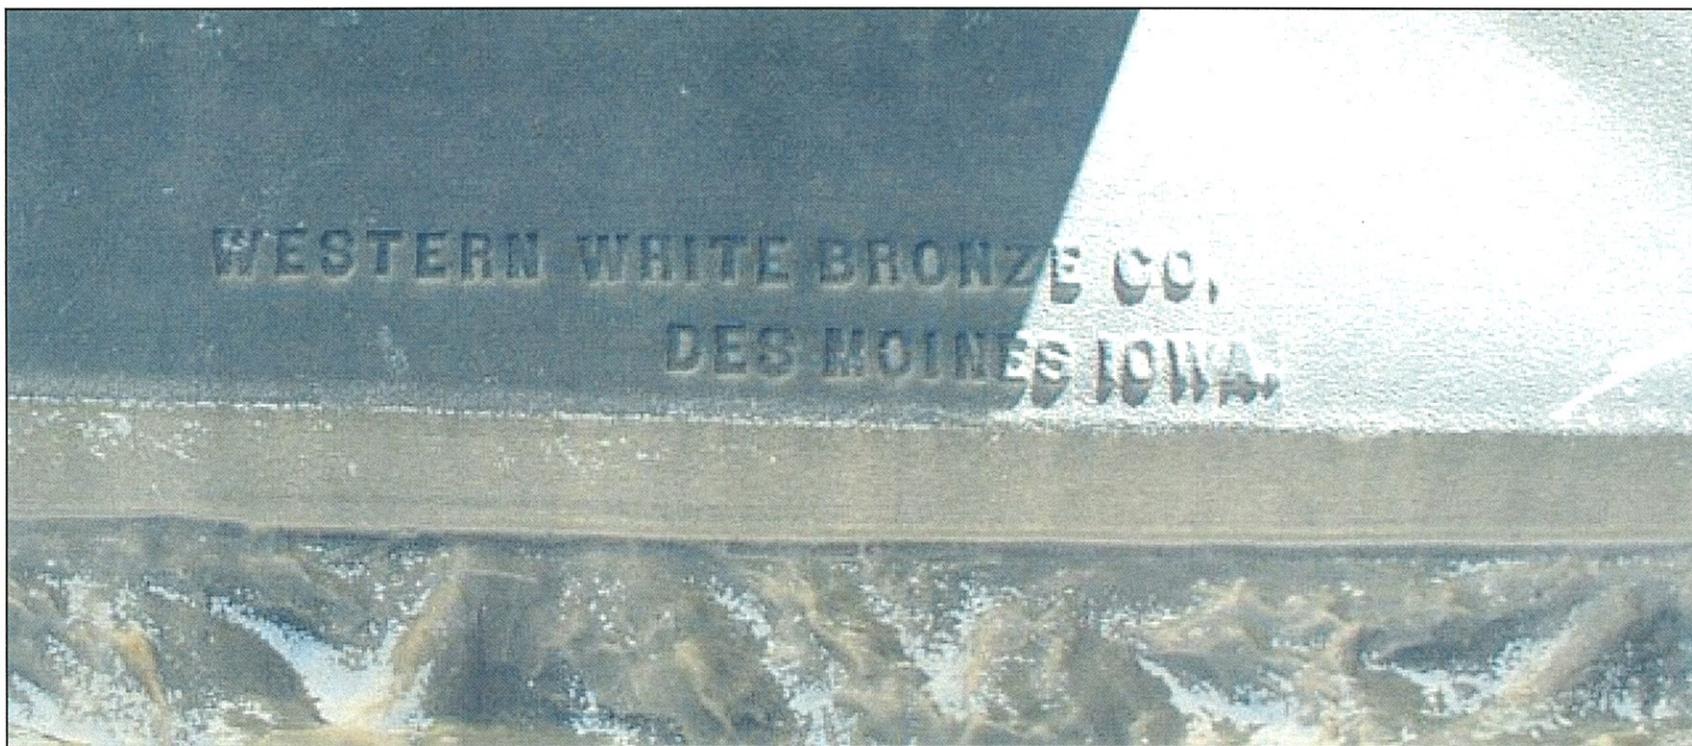
Maker or Fabricator mark / name? If so, give name & location found: _____
Western White Bronze Co Des Moines Iowa(see photo) Upper tier of the lower base

WESTERN WHITE BRONZE CO.
DES MOINES IOWA.
