NATIONAL ORGANIZATION  
 SONS OF UNION VETERANS OF THE CIVIL WAR  
 CIVIL WAR MEMORIAL ASSESSMENT FORM

**S.U.V.C.W. Civil War Memorial Assessment Form  
Orono, Maine Monument**

# **CIVIL WAR MONUMENT ORONO, MAINE**

## **CONSERVATION ASSESSMENT AND CONSERVATION TREATMENT PROPOSAL**

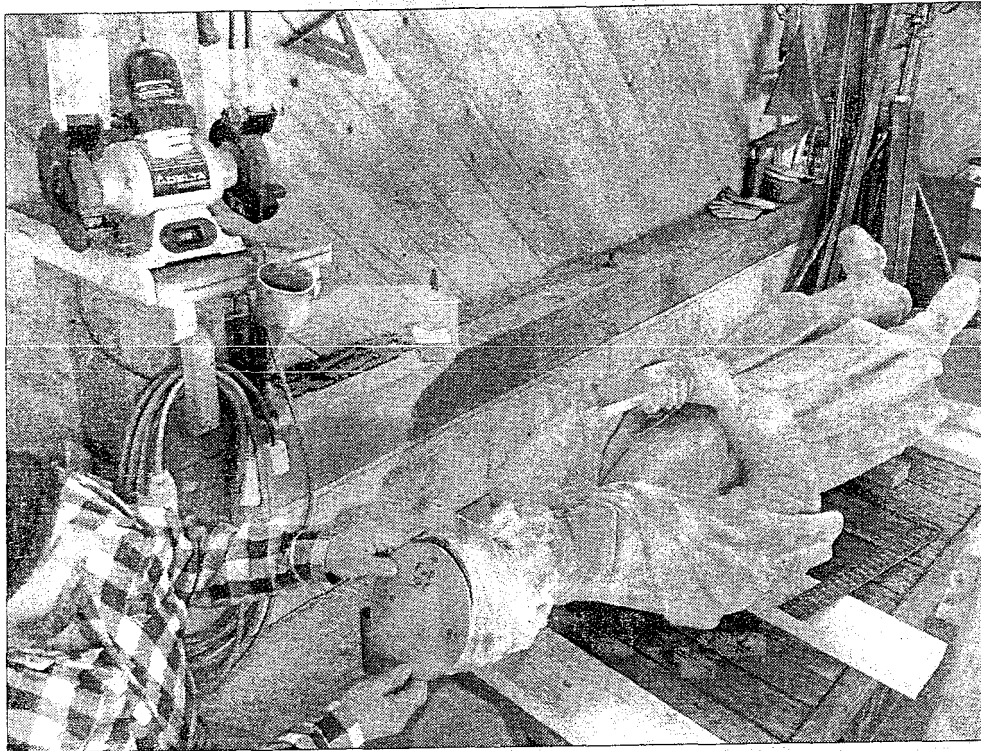
Artist and pipe welder Peter Crockett, owner of Argyle Iron Works, has been hired by the Orono Historical Society to refurbish the town's Civil War Monument. Water leaked into the statue of the historic soldier and caused head to toe damage, the artist said. He is designing a top of the militia cap that will be water-resistant.

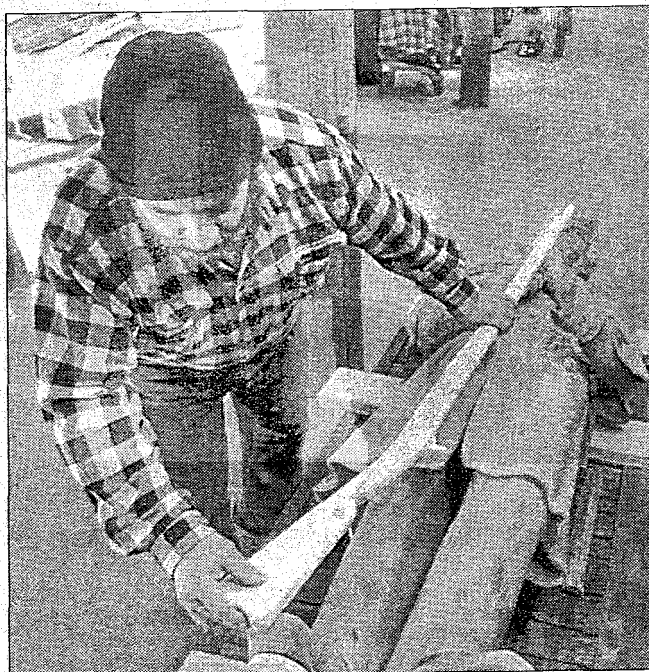
Peter Crockett of Argyle, an artist and pipe welder hired by the Orono Historical Society to refurbish the town's Civil War monument, demonstrates where the soldier's new gun will be placed.

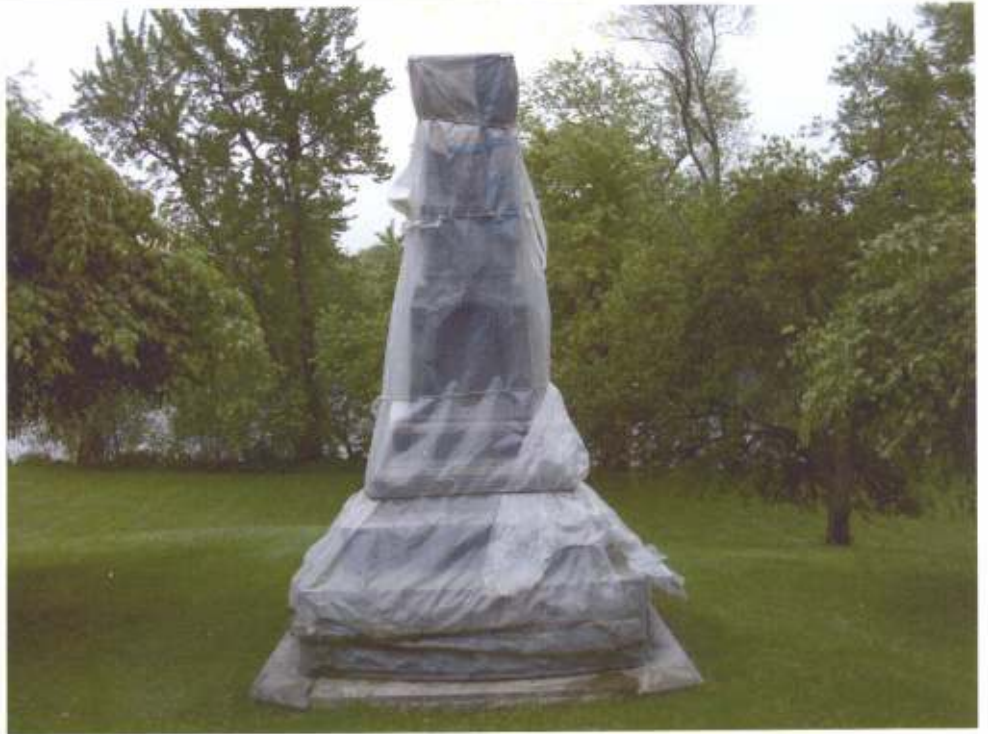
1 ORONO, ME CIVIL WAR MONUMENT  
WEBSTER PARK

FRONT FACE OF PEDESTAL, LOOKING SOUTHWEST  
TOWARDS STILLWATER RIVER. MONUMENT IS UNDER  
RESTORATION. STATUE IS REMOVED FOR RESTORATION.

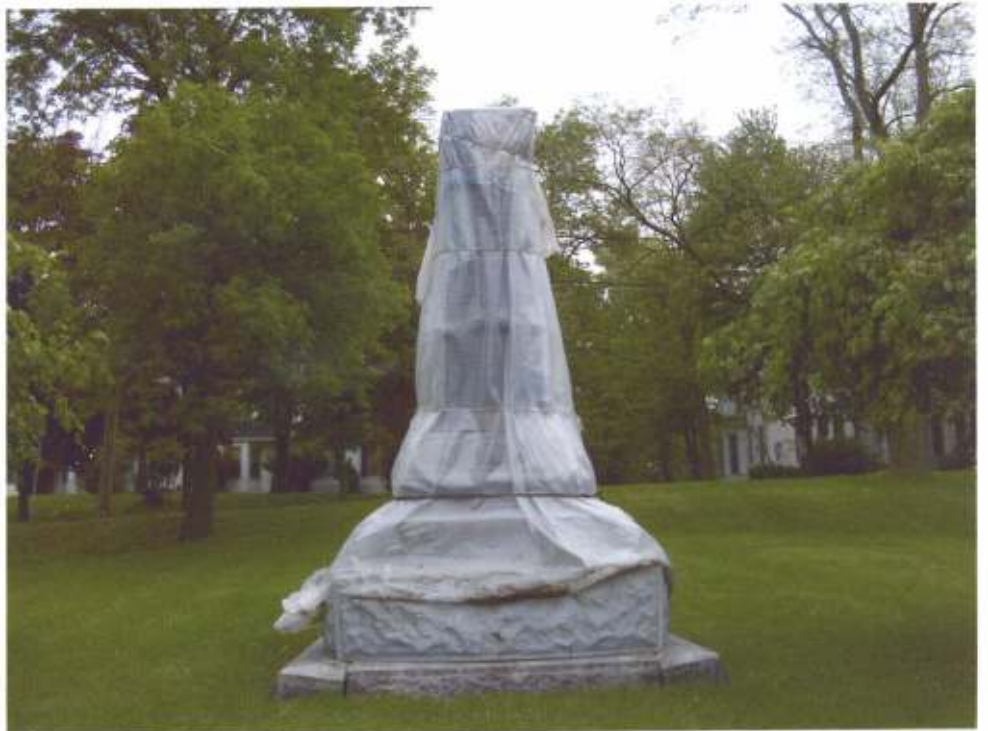
2 ORONO, MAINE CIVIL WAR MONUMENT  
WEBSTER PARK

REAR FACE OF PEDESTAL, LOOKING NORTHEAST  
TOWARDS NORTH MAIN ST. MONUMENT IS UNDER  
RESTORATION. STATUE IS REMOVED FOR RESTORATION.

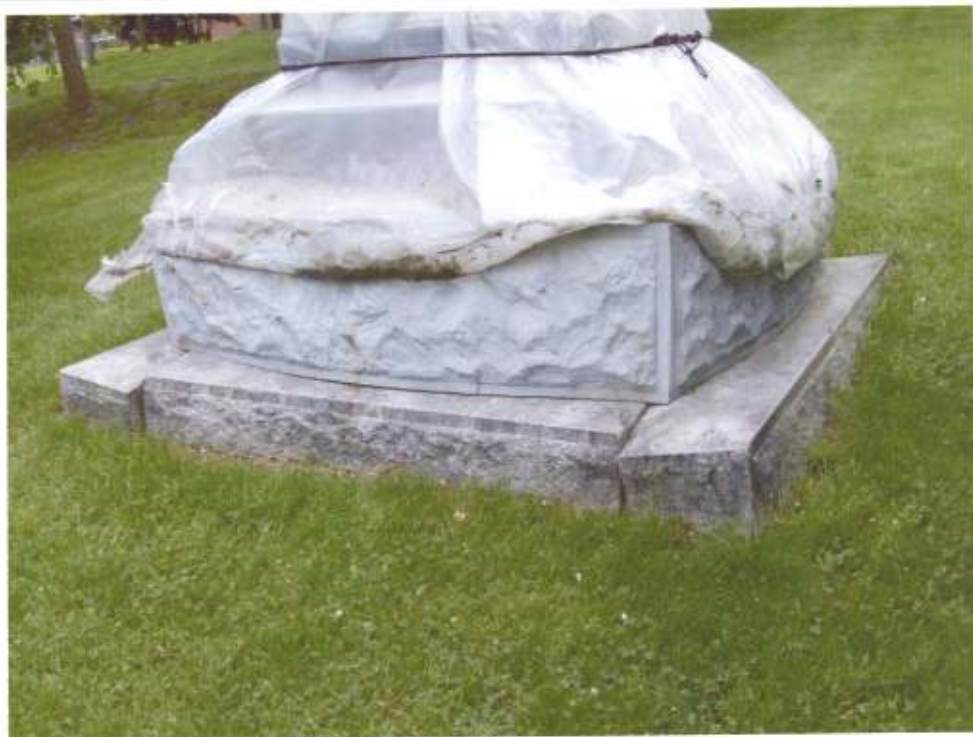
3

CLOSE UP OF GRANITE BASE STONES IN  
NEED OF RE-SEATING; REAR OF MONUMENT

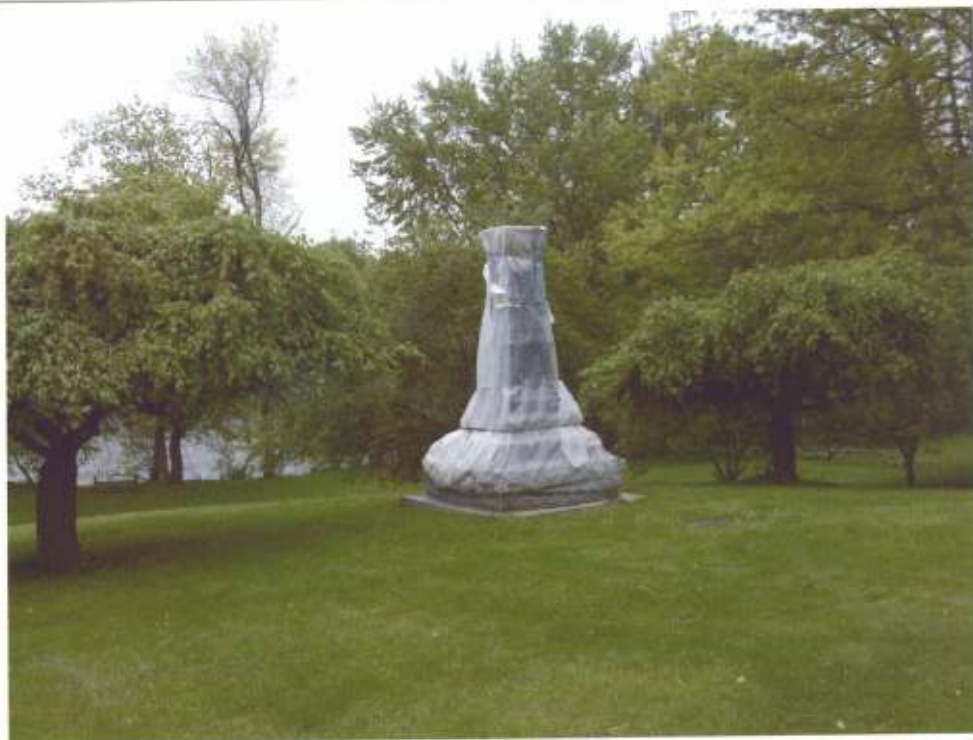
4

GENERAL VIEW OF MONUMENT SITE LOOKING  
SOUTH. MONUMENT IS UNDER RESTORATION.  
STATUE IS REMOVED FOR RESTORATION.
