CIVIL WAR MEMORIAL ASSESSMENT FORM

"THE VICTORIOUS CHARGE"
MILWAUKEE'S CIVIL WAR MEMORIAL
WEST WISCONSIN AVENUE

TREATMENT PROPOSAL

FOR
CIVIL WAR MONUMENT
IN
MILWAUKEE WISCONSIN

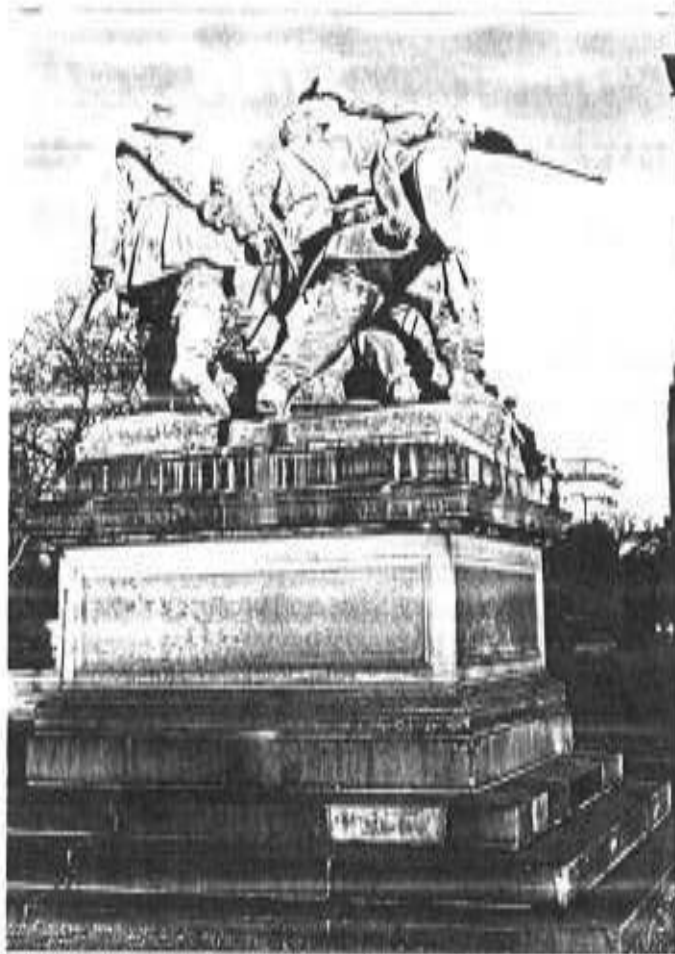
Wisconsin's grandest sculpture tableau is in terrible condition. A sad trail of rust runs down the trouser of one of the soldiers, revealing the deterioration of the iron armature that supports and holds together the elaborate monument. The sculpture is at risk of collapse. The entire surface is covered with dirt, dust and corrosion. Incorrect attempts at the monument's restoration resulted in poor alignment of the sections of bronze, allowing water to enter the inside, where corrosion is hidden. Some worry that the work of art may implode.

The City of Milwaukee is fiscally conservative and cannot allocate funds for the restoration of the monument. Estimates for the work on the monument run between \$100 to 120,000, as the sculpture would need to be removed from its pedestal and a major project enacted to restore the monument by qualified bronze conservators. Work would include replacement of all corroding iron with copper alloys, cleaning of the interior of the sculpture and replacement of the internal armature where needed, replacement of the missing scabbard, bayonet tip and monocular, cleaning of the bronze, repatination, and cleaning the granite pedestal and tuck point.

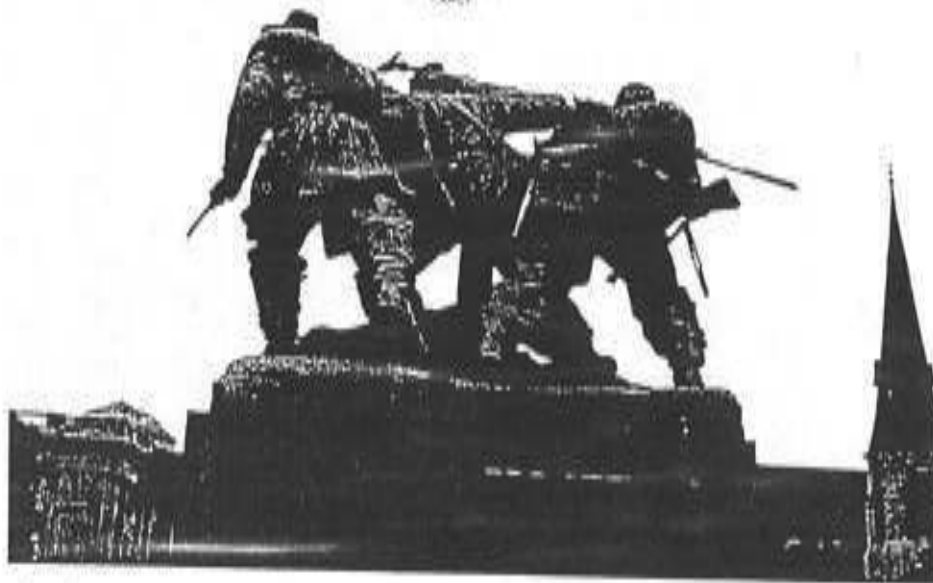
Fig. 1. Back view. The entire surface is corroded - disfiguring green, black and rusty streaking. Please note, tar-like material joining the base of the bronze. Please also note the streaking and severe discoloration of the stone base.

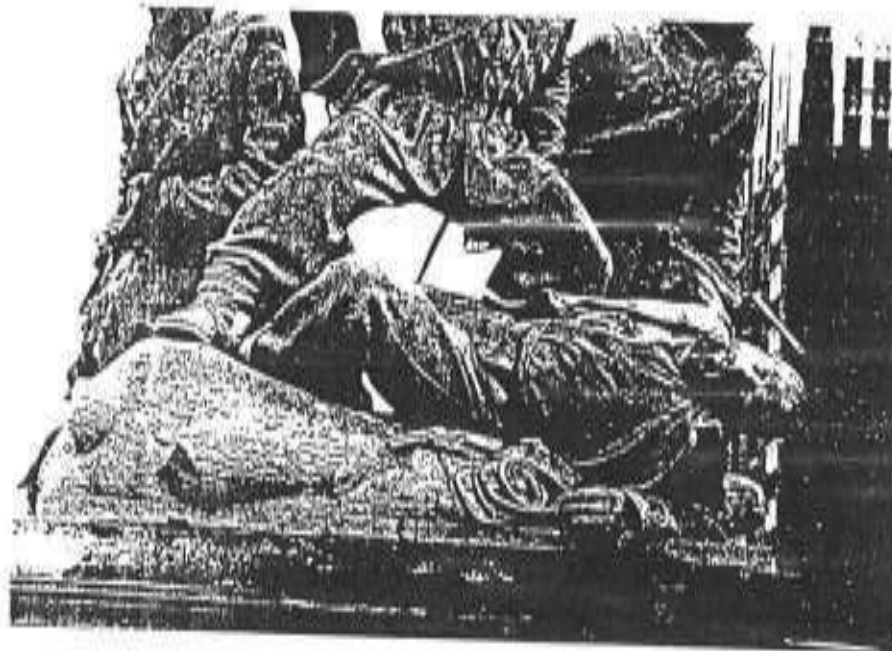
Fig. 3. Detail of the front - showing a very unevenly corroded surface of the bronze. The streaking seriously disfigures the aesthetical design of the sculpture. Note, the iron impurities are staining numerous areas of the cast. It appears that casting chaplets (core pins) have not been removed by the foundry, and they are severely corroded at the present time.

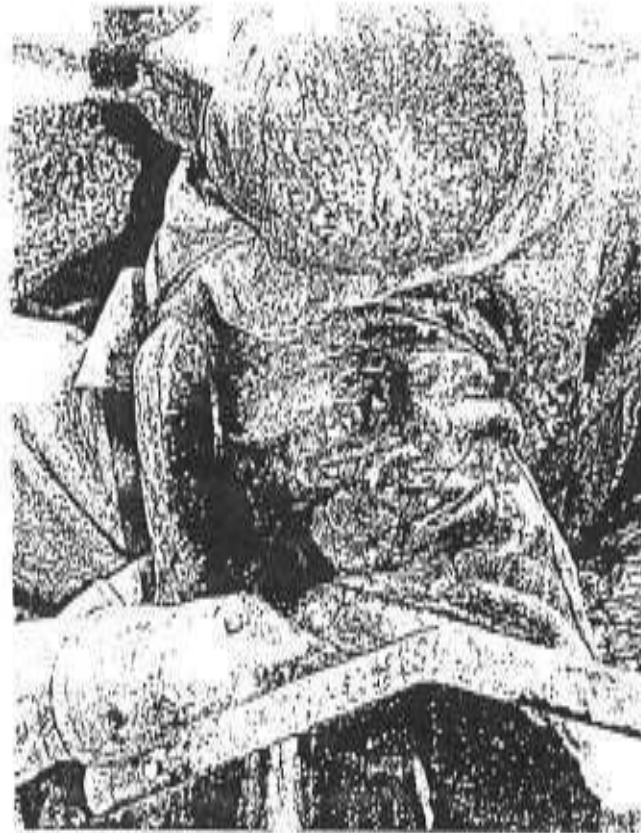
Fig. 6. Detail of the wounded soldier. Note, the unevenly corroded surface, and white material leaching from the inside of the sculpture.

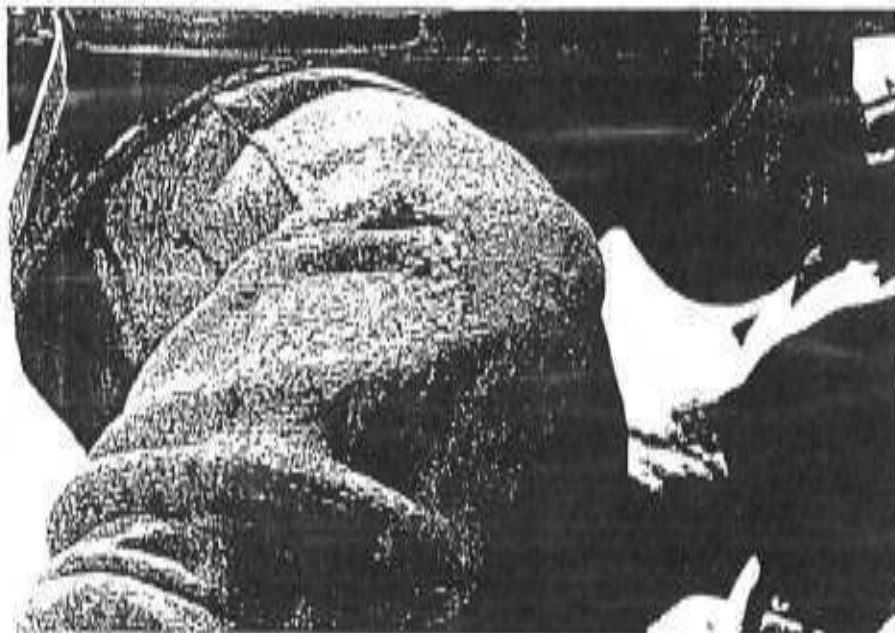
Fig. 7. Proper right soldier - proper right knee. Note, a gray core material is leaching from the inside of the sculpture.

9. Drill weep holes, and flush-out the interior of the sculpture to remove any remaining core material, and loose corrosion.
10. Wash with warm water (approx. 170 deg. F) and 5% solution of Orvus Non-Ionic Detergent using tampico scrub brushes.

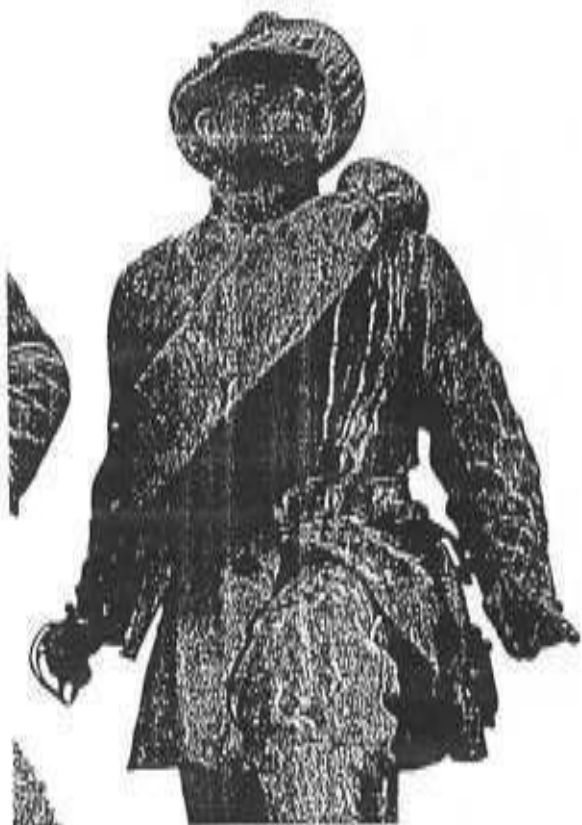
Fig. 11. Front view - proper left side soldier. Please note severe streaking, and missing sword.

7. Prepare and install replacement parts. A photographic documentation showing the missing elements should be provided by the owner.
8. Remove loose corrosion products through walnut shell blasting.

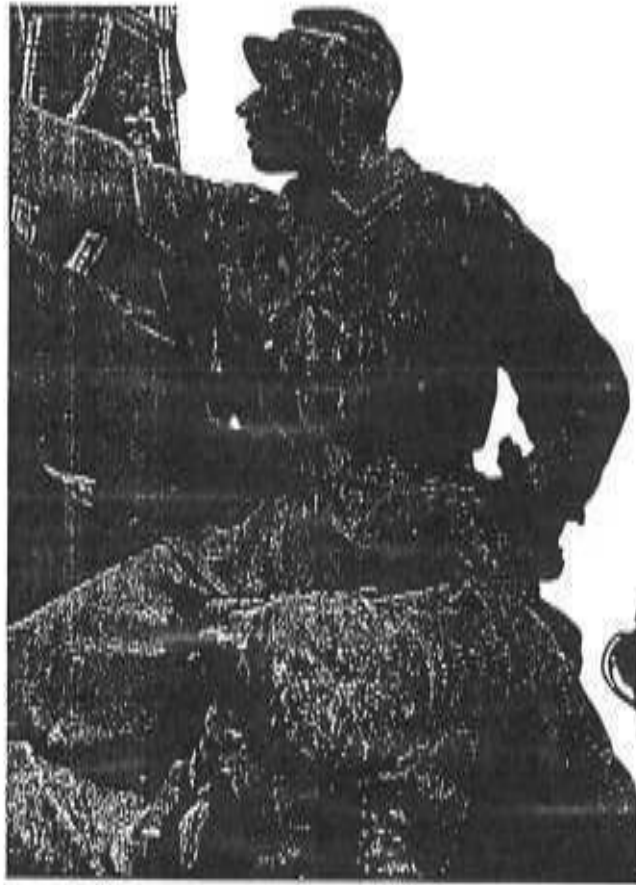
Fig. 13. Soldier with the flag - missing upper section of the monocular.

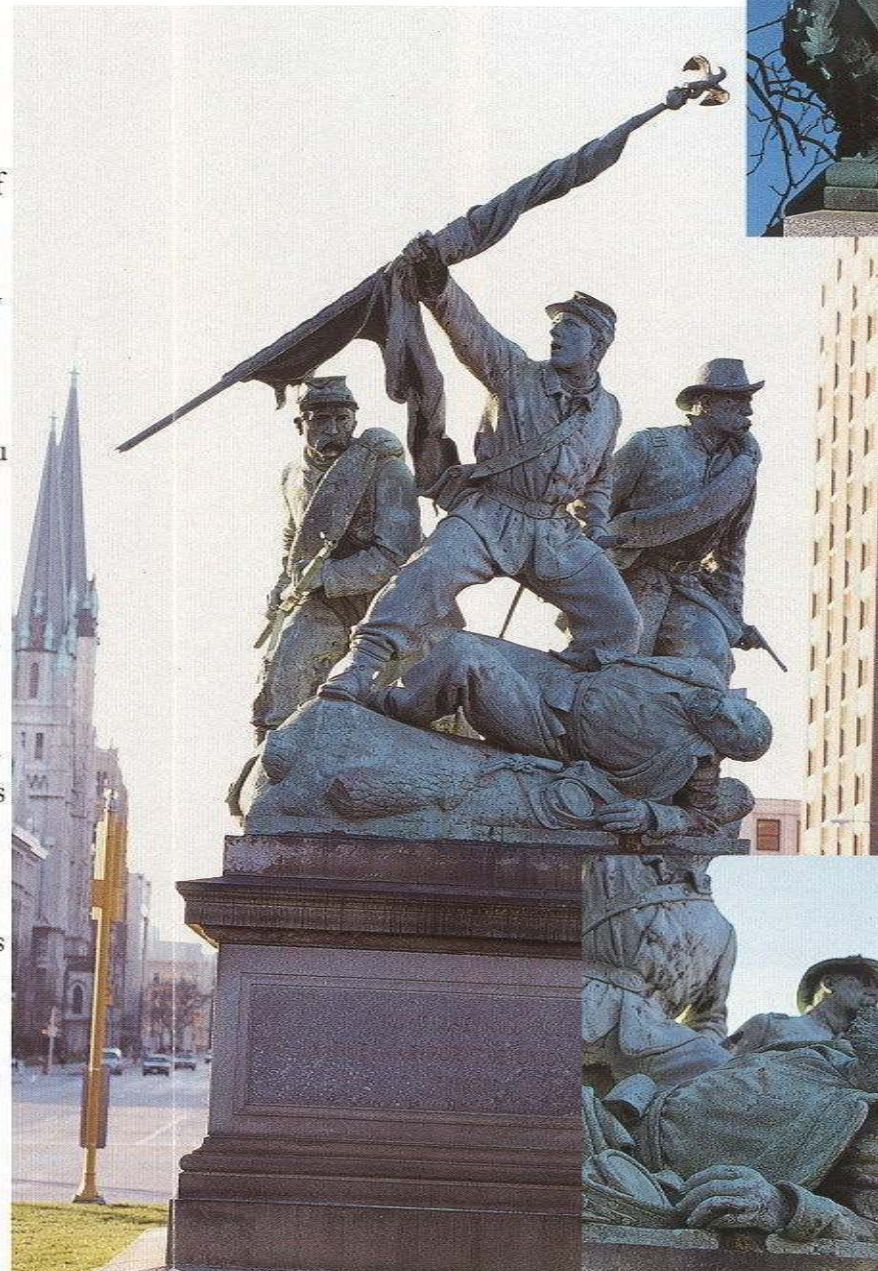
The Victorious Charge, 1898

John S. Conway (1852-1925) Court of Honor, West Wisconsin Avenue between 9-10th Streets. Milwaukee's most at risk monument is in a serious state of deterioration. The entire surface is covered with dirt, dust and corrosion. Incorrect attempts at restoration of this Civil War monument have made for poor alignment of the sections of the bronze, allowing water to enter the inside. (left)

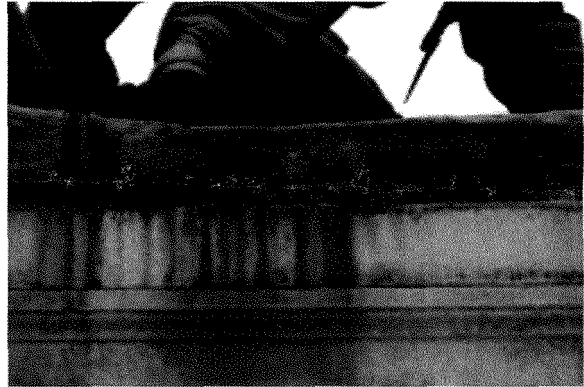
While this memorial is in good condition, there are sections of the base of the rear of the statue along with blocks in the stone foundation that need new mortar or caulk to prevent further damage by the elements.

Rear view of statue shows mortar repair issue.

The caretakers of this site, assumed to be the City Of Milwaukee, should be contacted to inspect and address the stone foundation of this memorial.

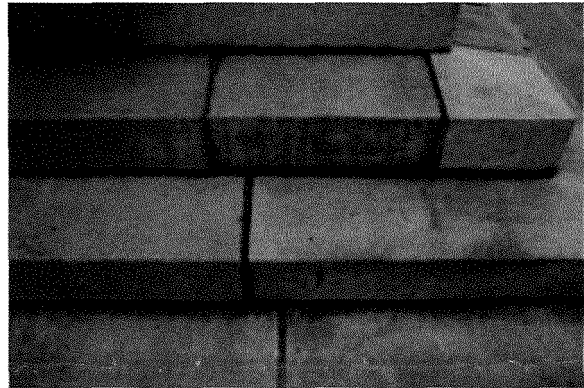
Steps show caulking issue.

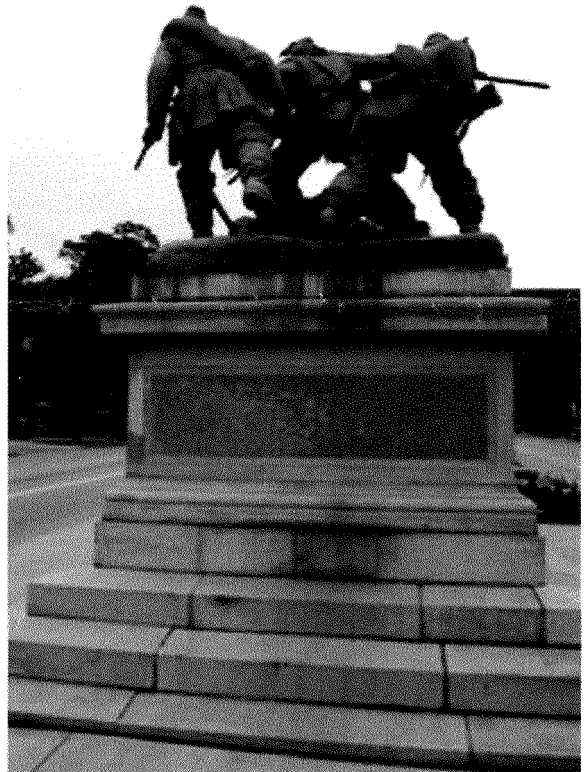
Rear of statue.
