**CIVIL WAR MEMORIAL ASSESSMENT FORM**

Object: Erastus B. Wolcott, 1920.  
Artist: Francis H. Packer  
Material: Bronze, Granite.  
Owner: Milwaukee County  
Examined: 06/04 and 08/94

### CONDITION

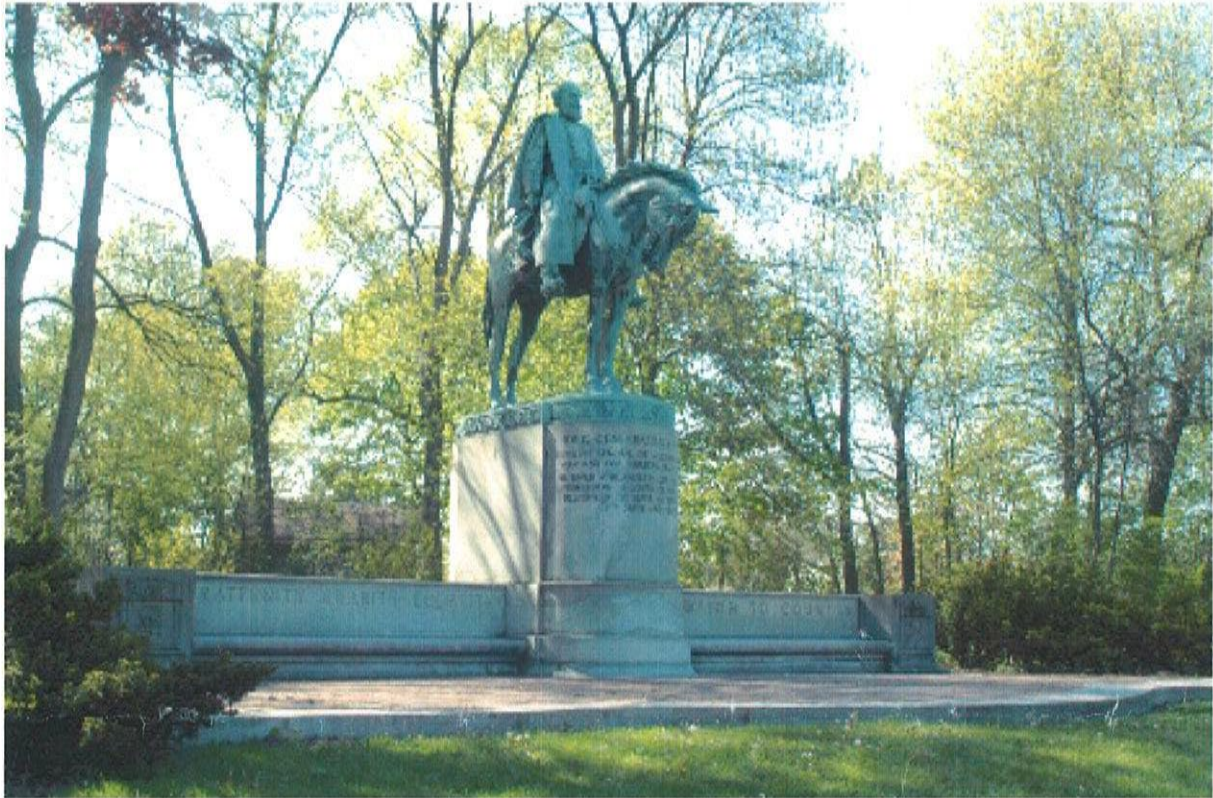
The sculpture has been exposed to an outdoor environment for 84 years. The entire surface of bronze is covered with dirt, dust, and corrosion. The bronze elements present typical green, and black corrosion products which disfigure the design of the monument. The surface is corroded unevenly. The disfiguring streaking is scattered over the entire surface of the sculpture. The inscription at the front of the base is missing bronze letters. The stone base and exedra are dirty and covered with biologic growth. This monument is surrounded by trees, and overgrown grass, and plants.

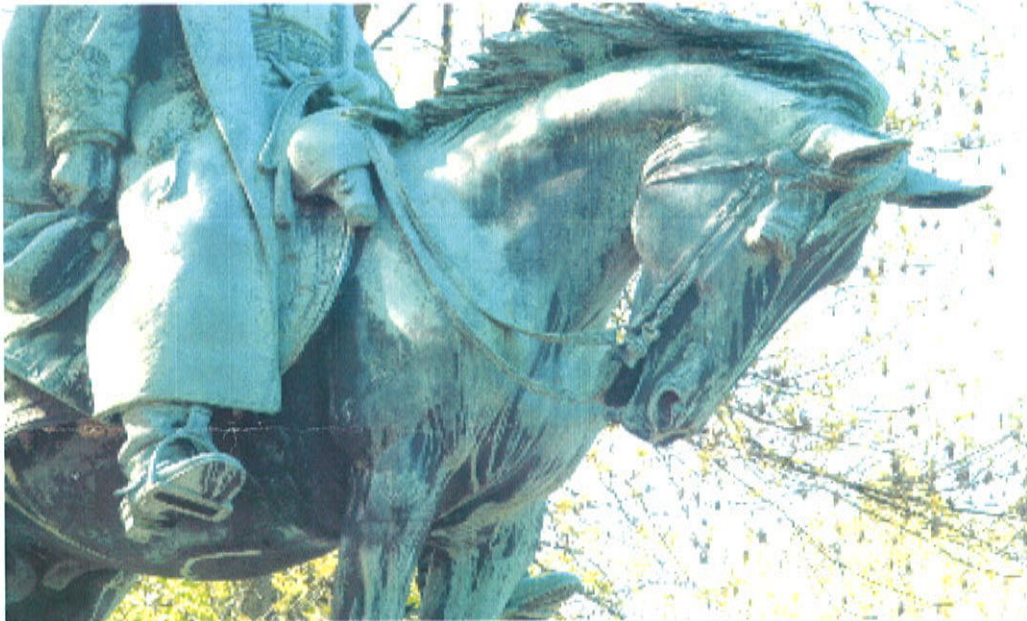
Fig. 1. View of the proper right side of the sculpture. The entire surface is corroded. Vertical streaking, and visual loss of detail caused by corrosion covering fine tool marks with disfiguring green, and black corrosion are found on the entire surface of the sculpture.

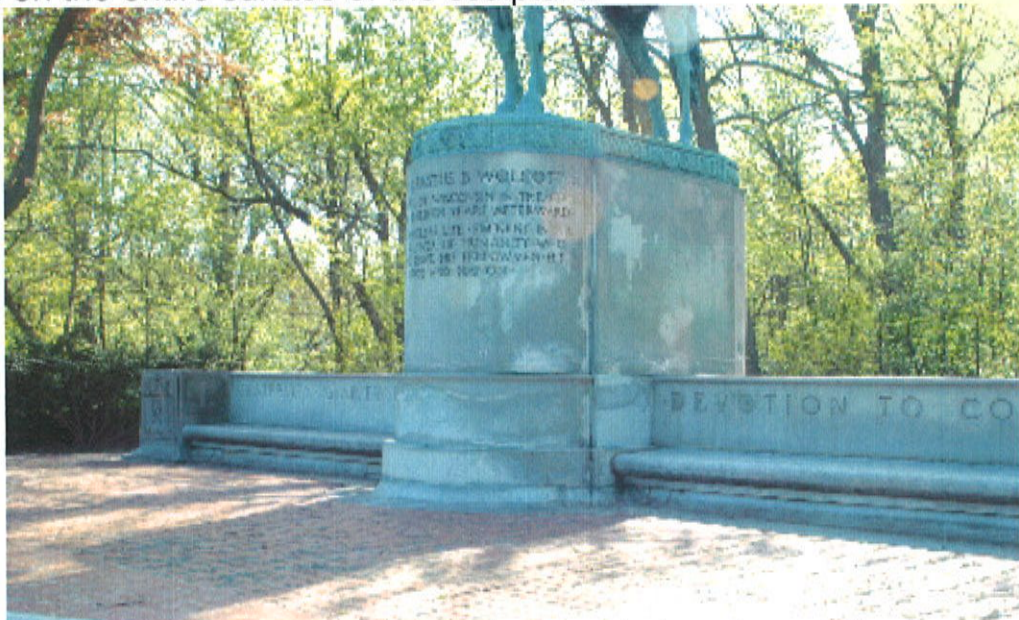
Fig. 2. Front view - showing unevenly corroded surface of the bronze, and inscription on the pedestal. Please also note uneven coloration of the stone. This appearance of the stone indicates salt and moisture contamination of the stone. The salt contamination and moisture are

related to the surrounding ground which is holding water and as a result allowing dissolution of salts and their migration into and in the stone.

I would like to strongly recommend installation of new drainage system which would drain the water around the monument. This is very important step in the treatment of the stone. Water provides perfect environment for salt migration. It is very disfiguring and also damaging for the stone. Major spalling will develop if this problem is not addressed. The stone is severely contaminated with water solvable salts.

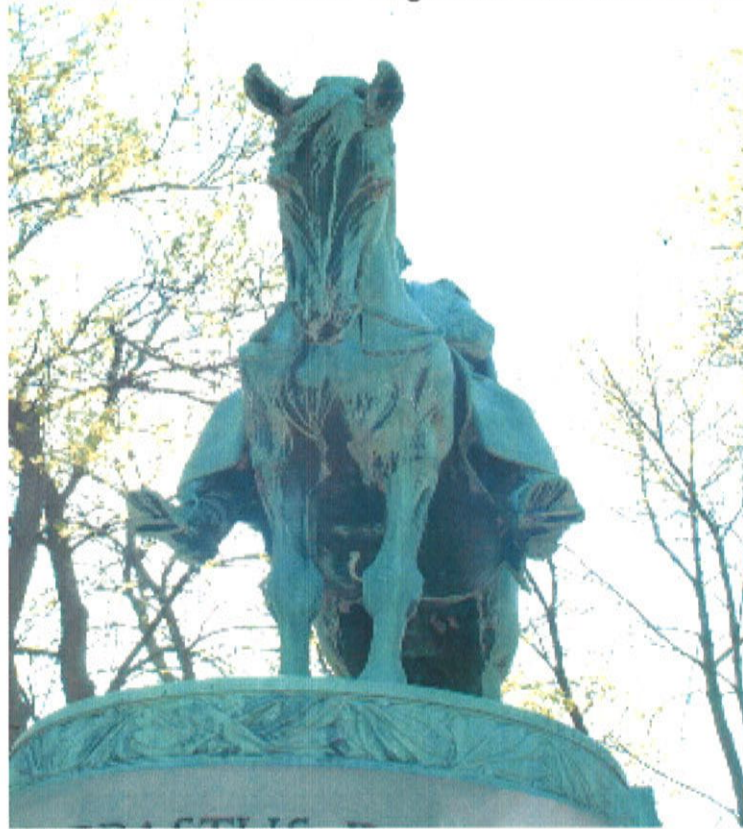
Fig. 3. Detail of the front - showing very unevenly corroded surface of the bronze.

The streaking seriously disfigures the aesthetical design of the sculpture.

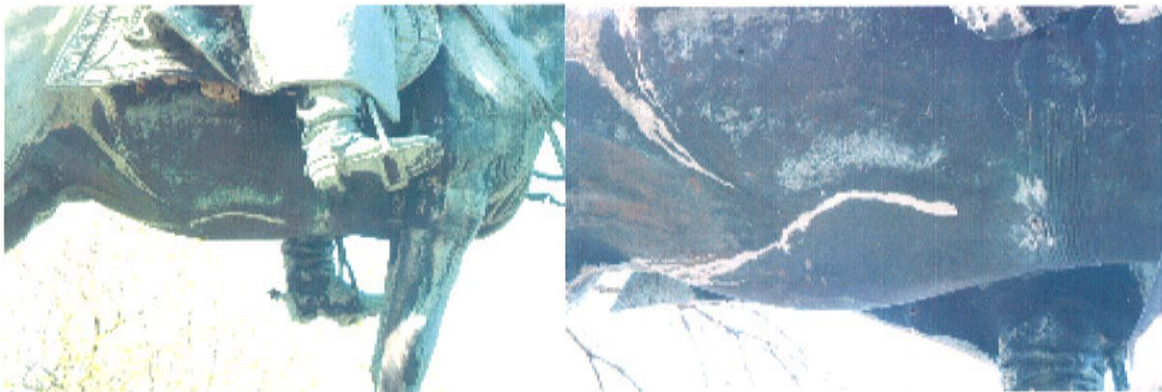
Fig. 4. Detail of the belly of the horse - showing streaking, mud wasp nests, and large areas of contrasting black, and green corrosion.

Please also note brighter green spots of corrosion on the belly of the horse, and darker small pin-hole in size corrosion spots. These areas appear to be chemically active which indicates presence of chlorides. Chlorides when in contact with copper will continuously corrode. As a result the surface of the sculpture will erode away.

The best way to treat this kind of corrosion problem is to remove the chlorides from the surface. There are a few ways of achieving that. The most effective is electrolytic reduction. In this process chlorides are removed, but most of the other corrosion products are left in place.

The other way of solving this situation is mechanical removal of corrosion from the contaminated area. Unfortunately this effective process is the most aggressive. Glass bid pining (needed for this process) removes the chlorides very effectively. Treated surface is stripped of all corrosion to bare metal.

Glass bid pining is quick, and effective, but very aggressive and damaging the surface. The electrolytic reduction is preferred by most conservators, but it is very difficult, and time consuming therefore expensive process.

Starting in 2004 we are able to provide a completely new process not available until this year. We are able to remove the chlorides and treat the entire surface of the sculpture using a laser. This process is very gentle. We can remove chlorides and all other undesirable corrosion products without any damage to the bronze. With laser it is possible to uncover oxide layers which represent the first and most stable corrosion layer on the surface of the sculpture. It could be considered as the original patina in most cases.

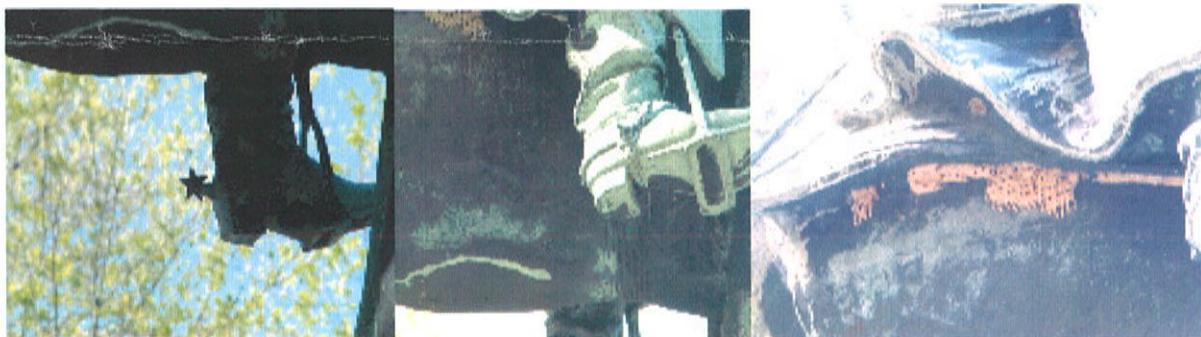
Fig 5. Detail of the proper right leg of Wolcott - showing streaking, four mud wasp nests, and leaching of what appears to be a core material from

the inside of the sculpture. Please note brighter green spot at the lowest point of the belly of the horse. This spot, and neighboring areas are in my opinion covered with chlorides. Please note missing spur / rowel at the proper right leg of the figure. The spur at the proper left leg is in good condition. It should be reproduced and a copy welded in place of the missing one on the right leg.

6. Make a copy of the missing spur and weld it in place.
7. Patinate the bronze according to the owners color specifications.
8. Wash using hose pressure, and tampico scrub brushes.

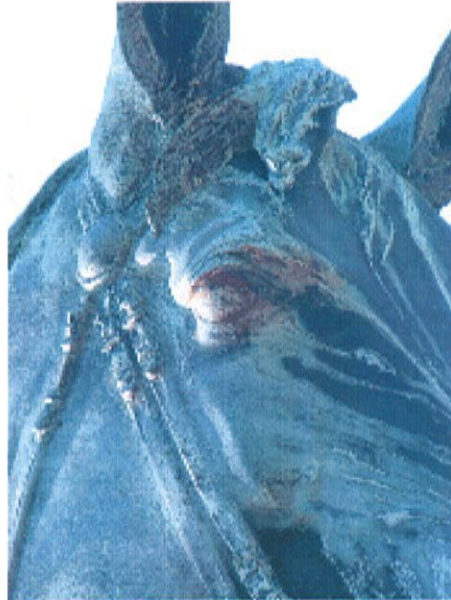
Fig. 6. View of the proper right side of the head of the horse. Please note the streaking, and contrast between the green and black corrosion which is disturbing the design of the sculpture. Please also note large brown areas. It appears that these spots were recently abraded to bare metal either by incorrect graffiti removal, or someone climbing the sculpture.

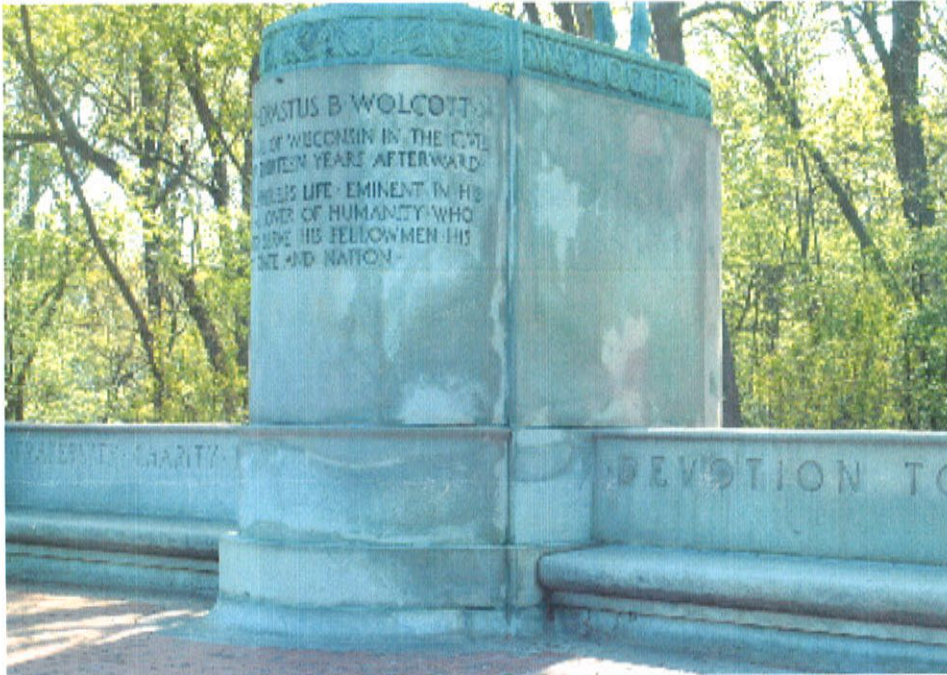
Fig. 7. Detail of the inscription. The stone is unevenly stained. None of the original bronze letters are found at the moment on the monument. Only indentations in the stone are present, but the inscription is readable due to precise carving in the stone.

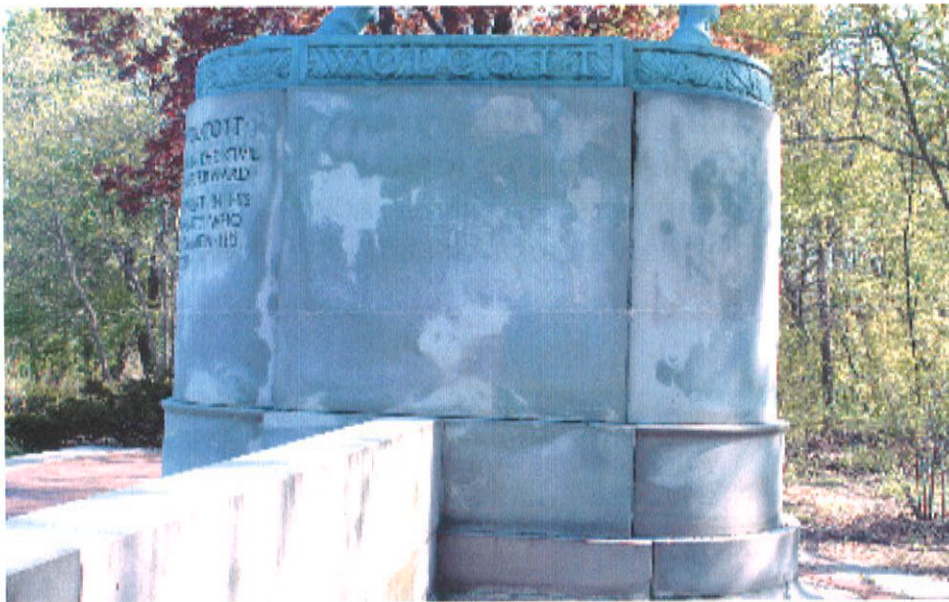
Fig. 9. Proper left side view of the pedestal with inscription. Please see discoloration of the stone. The staining is very uneven and disfiguring.

1. Test, and after owners approval of the test results clean the stone.
  - A. Wash with steam and a 5% solution of Orvus Non-Ionic detergent using low pressure washing (under 300 psi).
  - E. Wash with water using medium pressure washing (@500psi).
  - F. Remove the deteriorated tuckpointing, and tack point the stone joints.
2. Extract salts from the stone. This step can be undertaken only if the drainage of the area is done. Ground water has to be eliminated before the salts are extracted. Complete salt extraction may not be possible. This process is very time consuming and difficult, but it would improve the appearance of the stone and prolong its life.

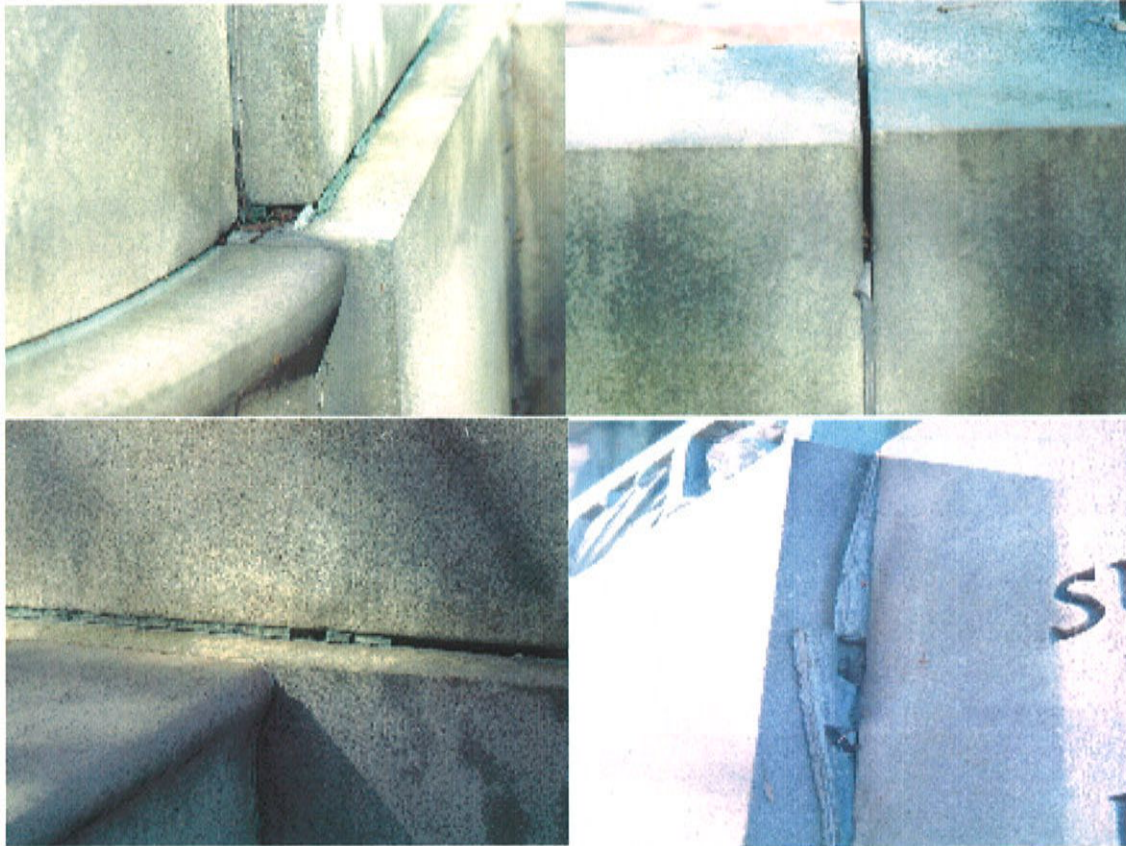
Fig. 10. Details showing severely deteriorated tuck pointing, and dirty stone.

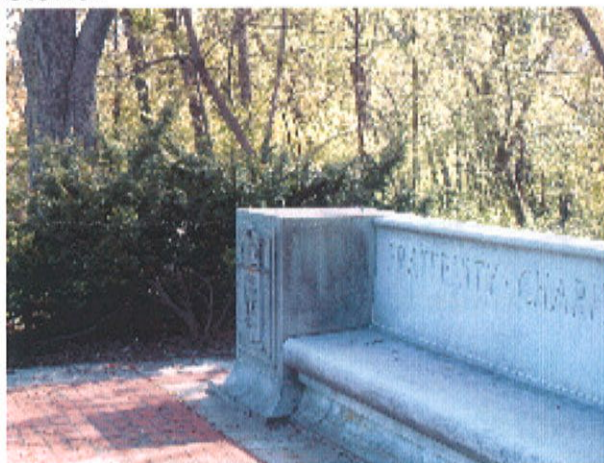
Fig. 11. Detail of the proper right side of the decorative wall/bench showing pins used for attachment of presently missing eagle.

12. Recreate and install the missing eagles.

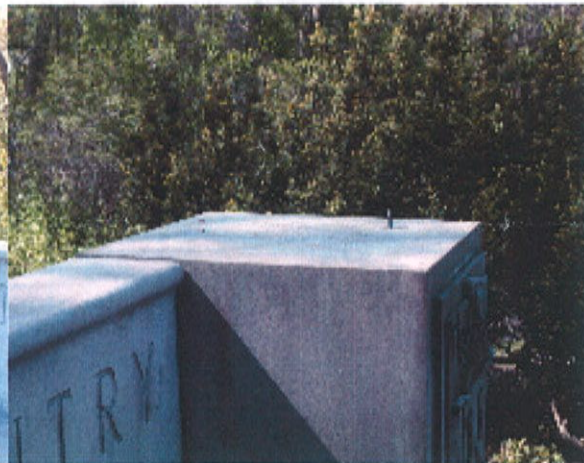
Fig. 12. Detail of the proper left side of the wall showing missing eagle, stained stone, failed joints, and overgrown vegetation

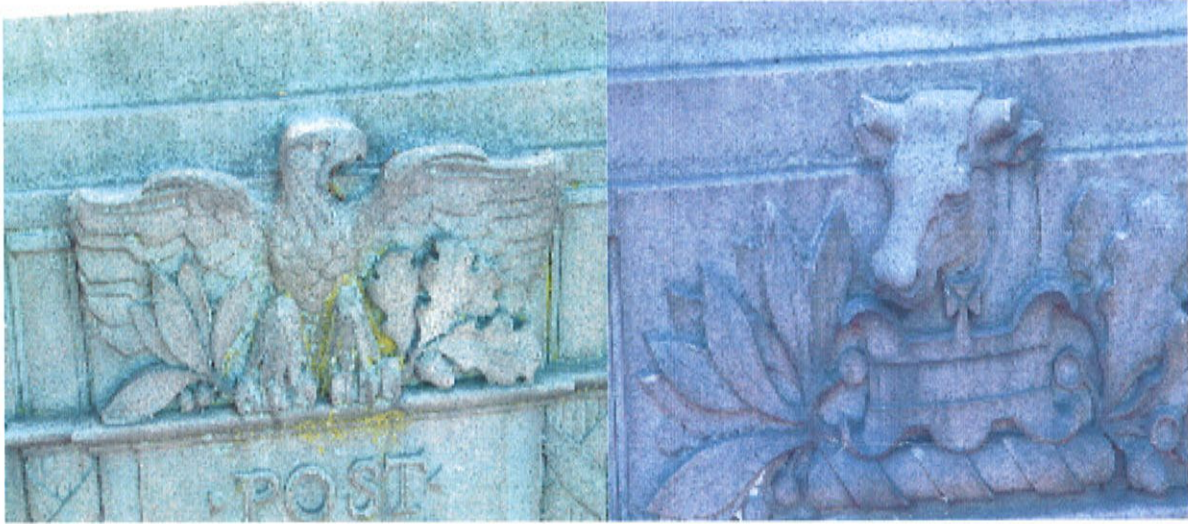
Fig. 13. Detail of the carved stone from the proper left and right side of the bench. Please note discoloration of the stone, and missing horns of the bull. The surface of the stone is covered with biota.

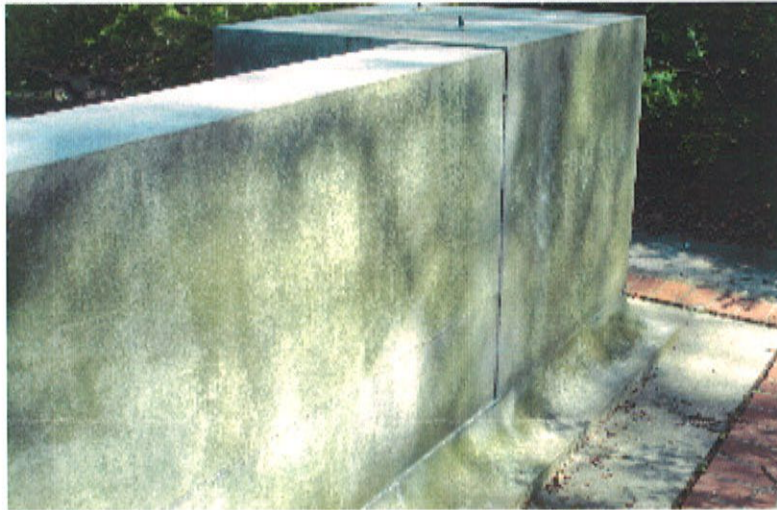
Fig. 14. Detail of the back of the monument showing discolored stone, biota, and graffiti. This monument suffered a lot of damage caused by overgrown trees, and vegetation.

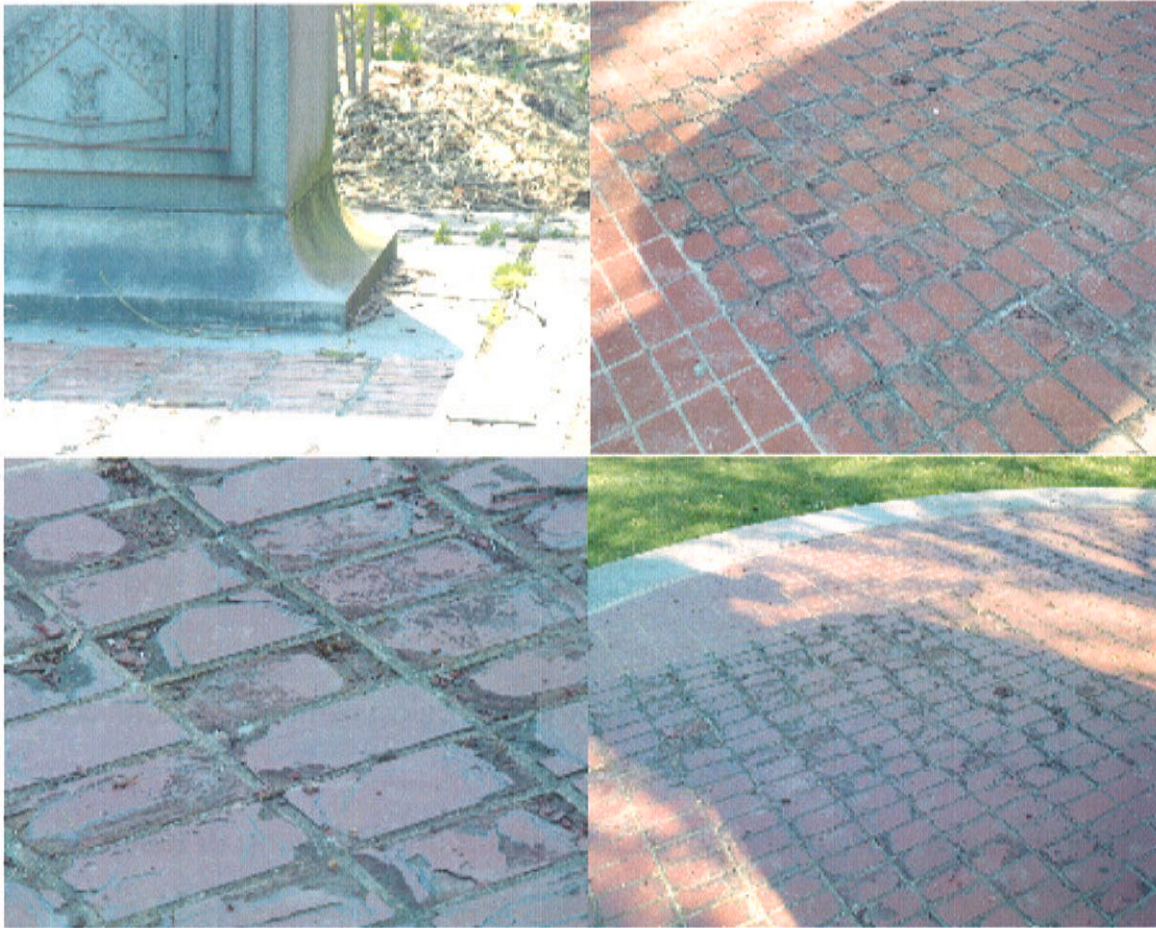
Fig. 15. Deteriorated pavement. These problems will not be included in the treatment proposal, because they can be dealt with by the owner. However, if requested we can address this problem also.
