SONS OF UNION VETERANS OF THE CIVIL WAR
National Civil War Memorials Committee

THE SOLDIERS AND SAILORS MONUMENT

Boston Common,

**Soldiers and Sailors Monument
Boston Common,
Boston, Massachusetts**

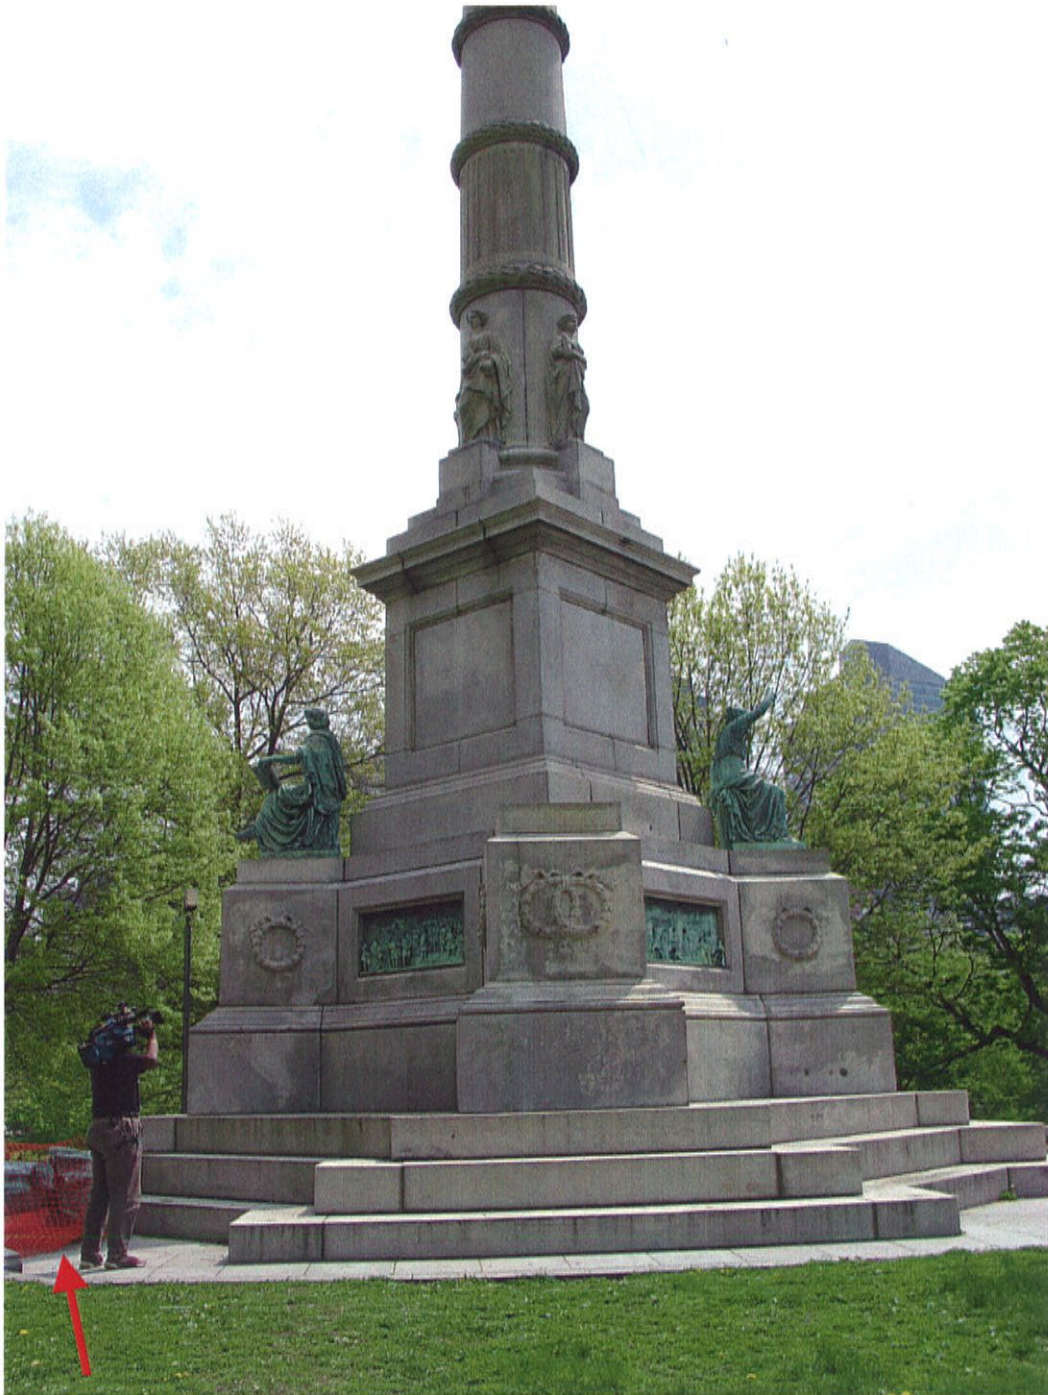
Shown: Soldiers and Sailors Monument, Boston, MA. Pedestal from which “The Soldier” statue was pushed down. Note fallen Statue on lower left, wrapped in orange mesh.

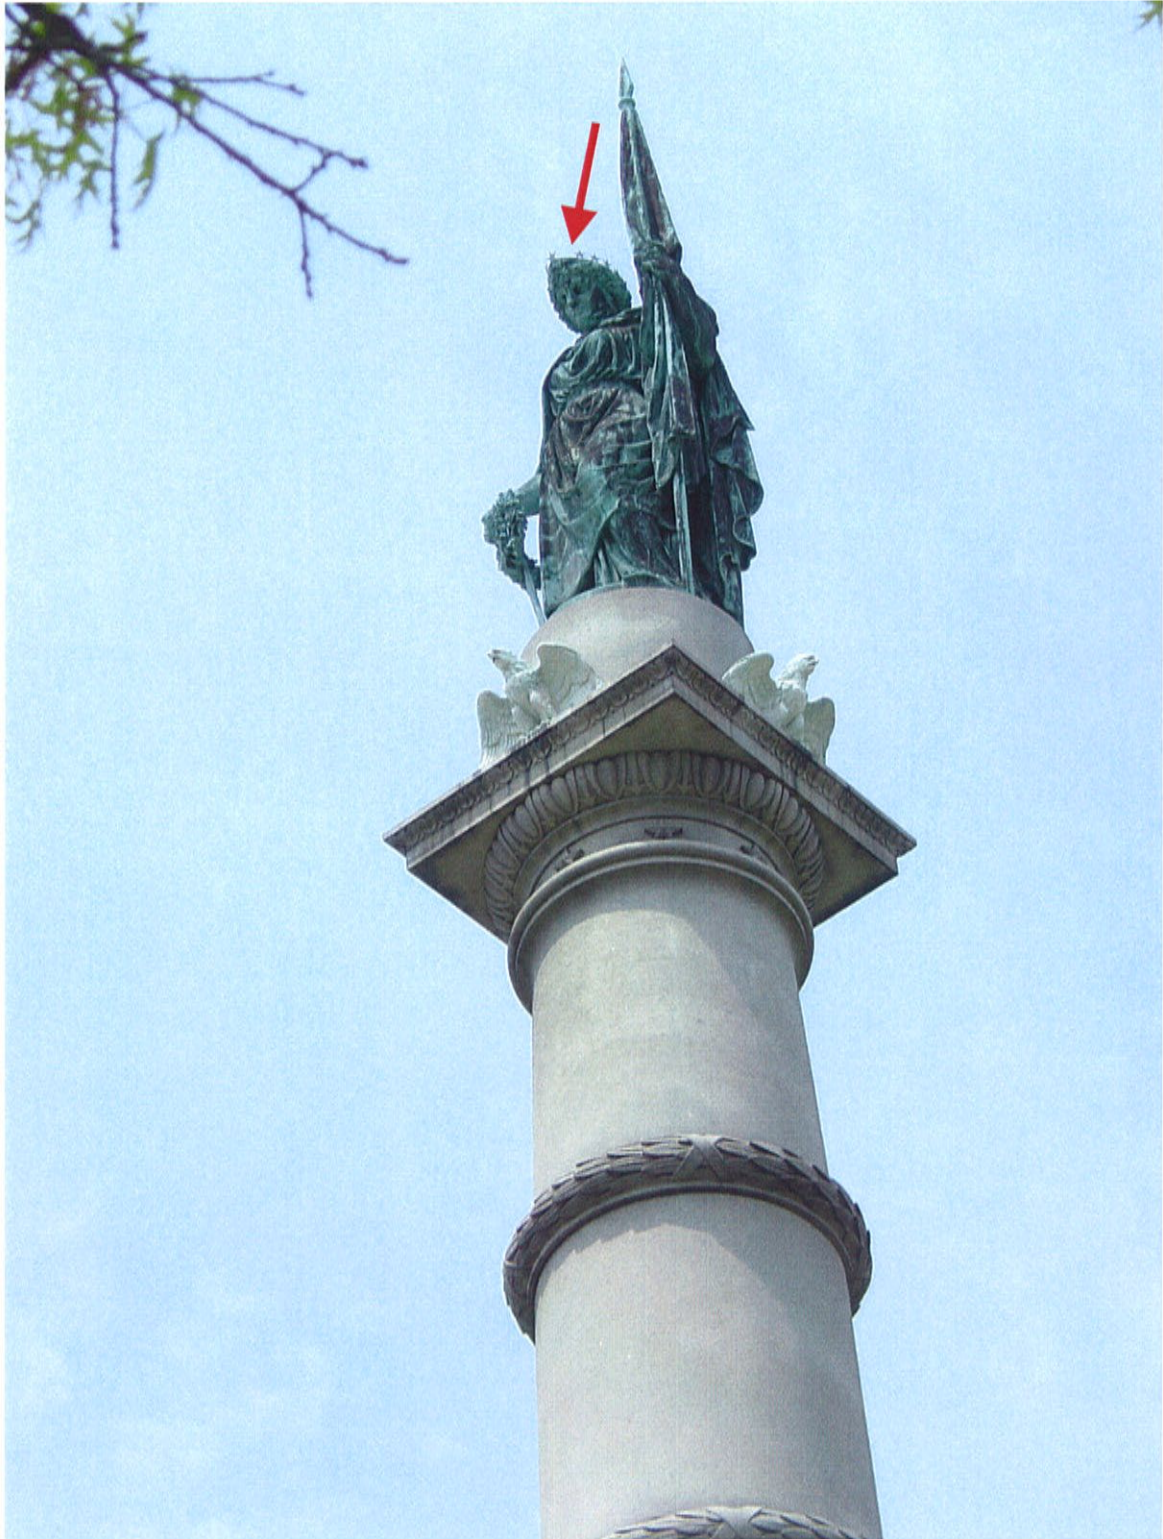
Shown: Soldiers and Sailors Monument, Boston, MA. "Genius of America" statue atop monument column. Note: Star missing in crown on statue. Some corrosion damage.

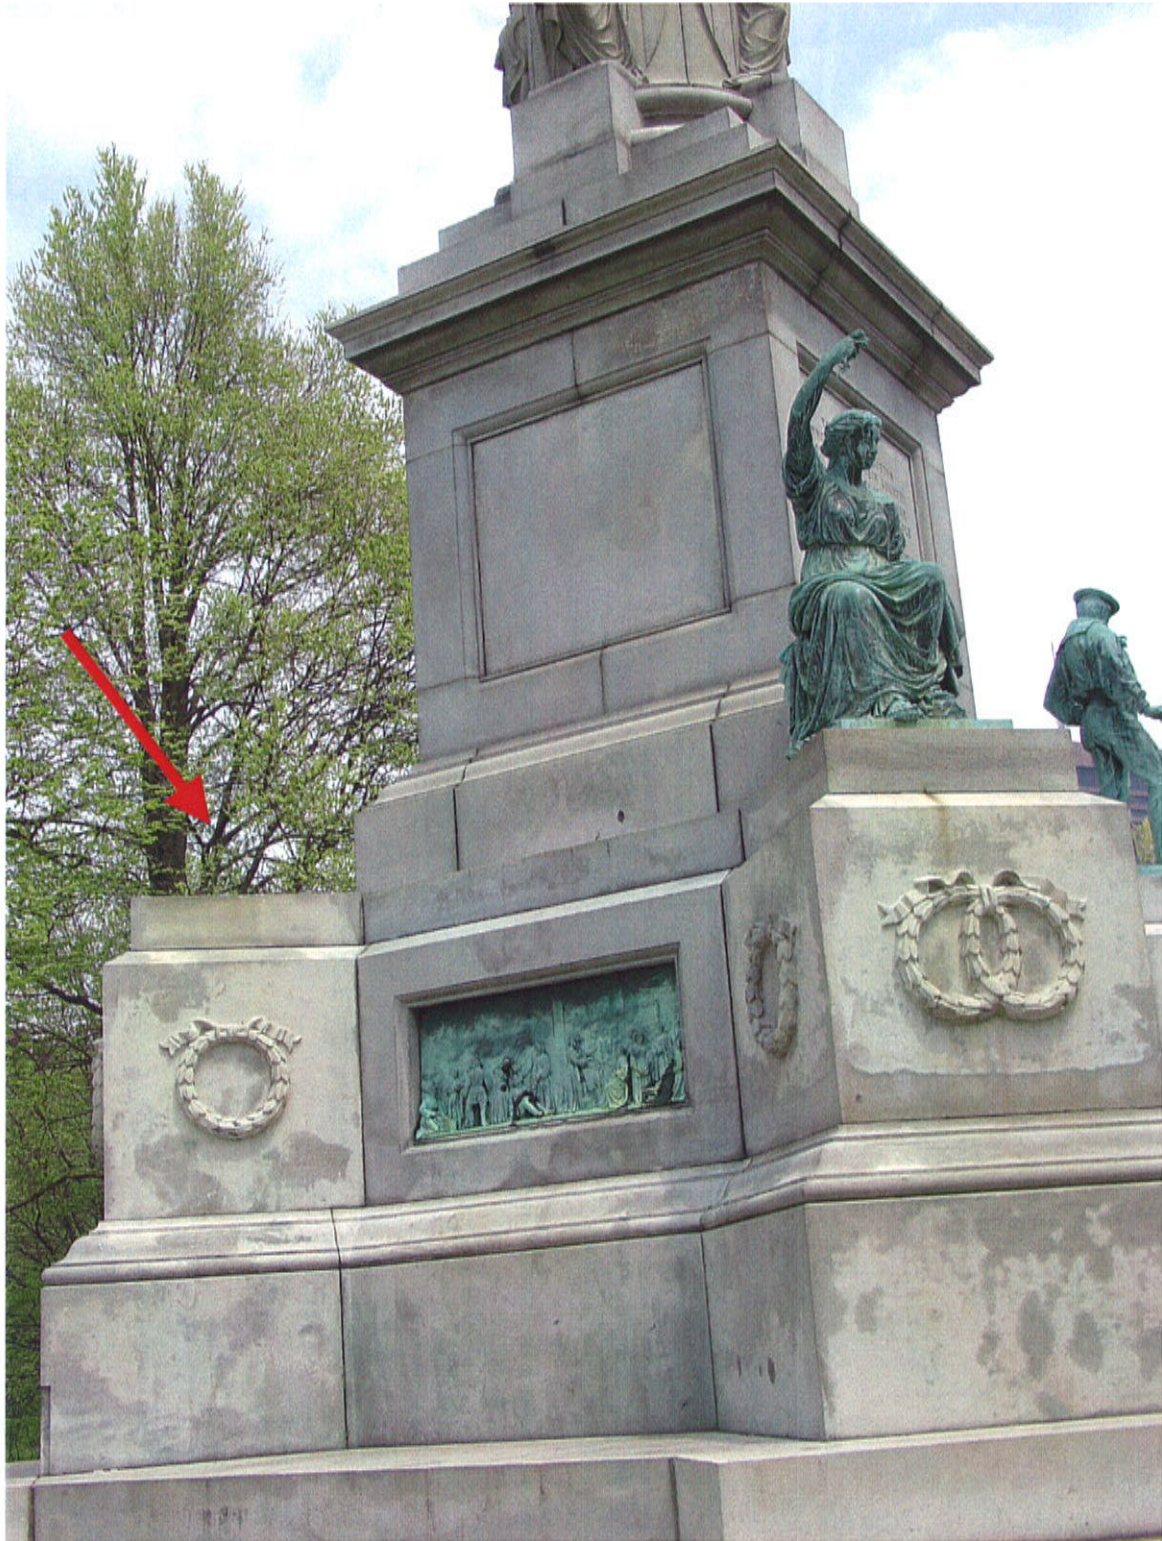
Shown: Soldiers and Sailors Monument, Boston, MA. West side view of pedestal from which "The Soldier" statue was pushed down.

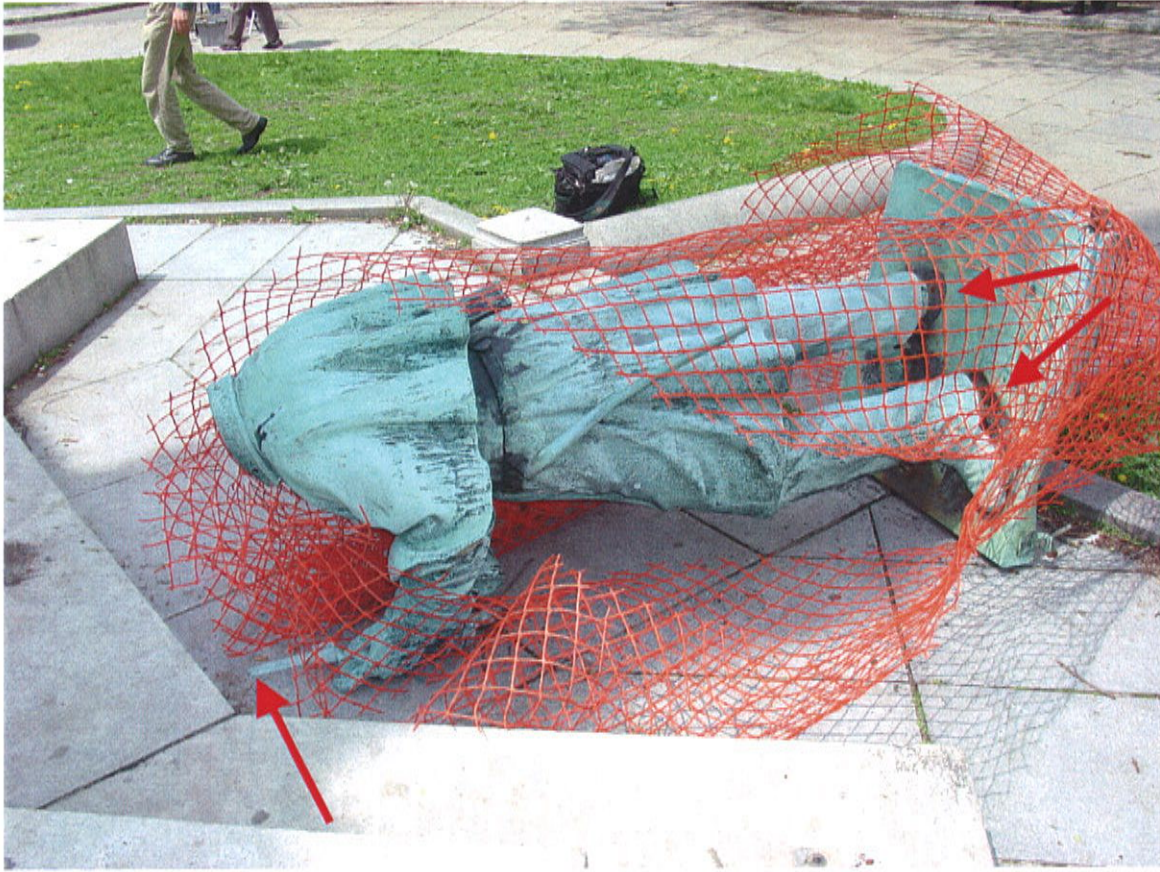
Shown: Soldiers and Sailors Monument, Boston, MA. Vandalized “The Soldier” statue. Note: Statue head and rifle part recovered. Part of bayonet is broken off, and feet pulled away from base. Some corrosion and staining damage.

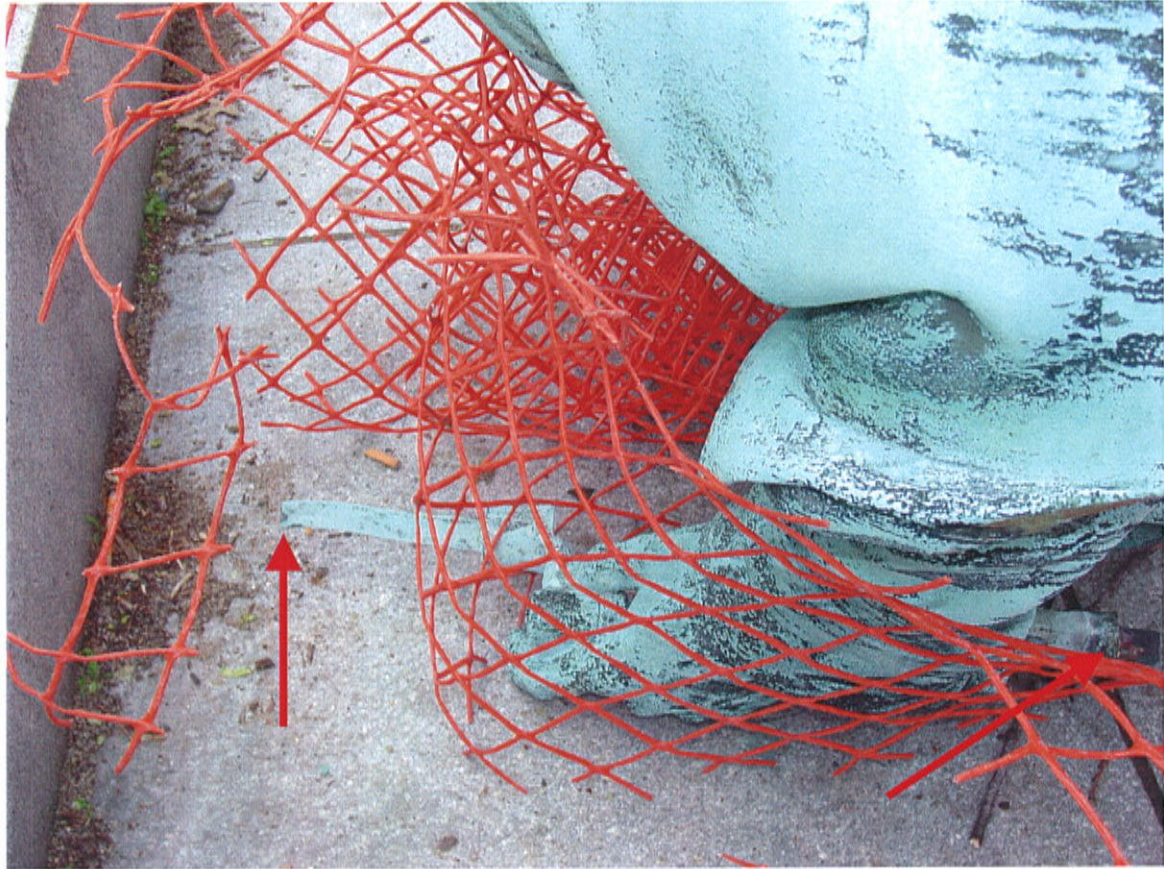
Shown: Soldiers and Sailors Monument, Boston, MA. Vandalized “The Soldier” statue. Note: Part of bayonet is broken off, and rifle broken away from hand. Rifle part recovered. Corrosion and staining damage.

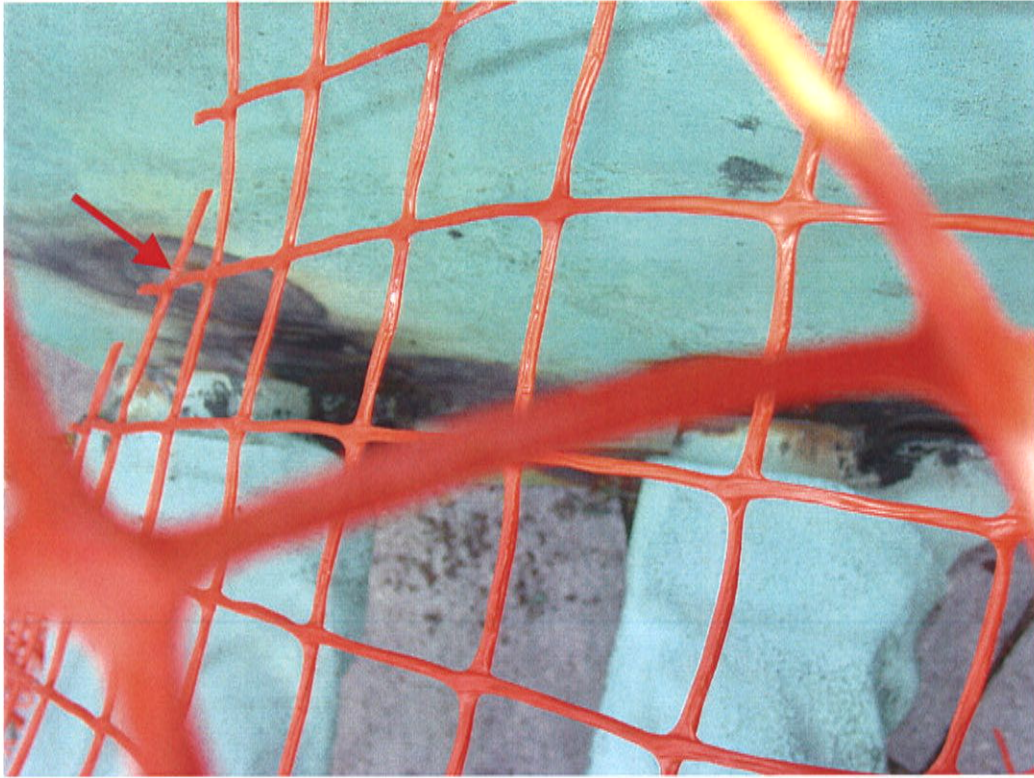
Shown: Soldiers and Sailors Monument, Boston, MA. Vandalized “The Soldier” statue. Note: Statue feet pulled away from base. Base bent and stressed at toe of shoes. Some corrosion damage.

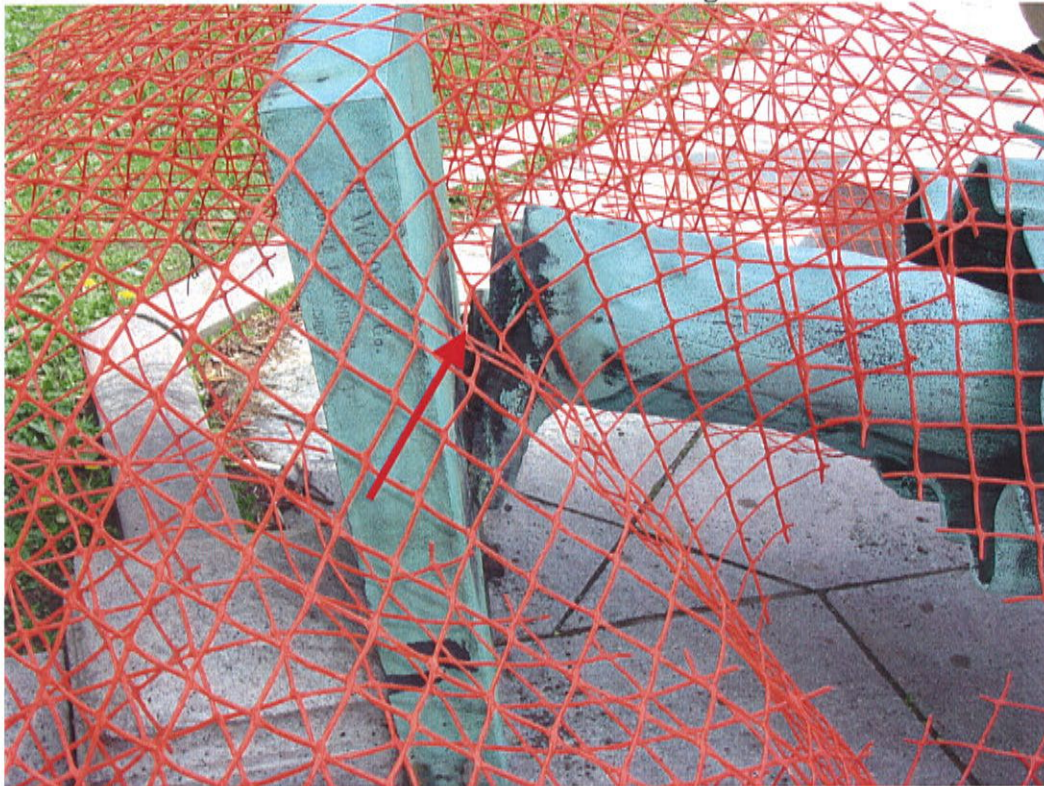
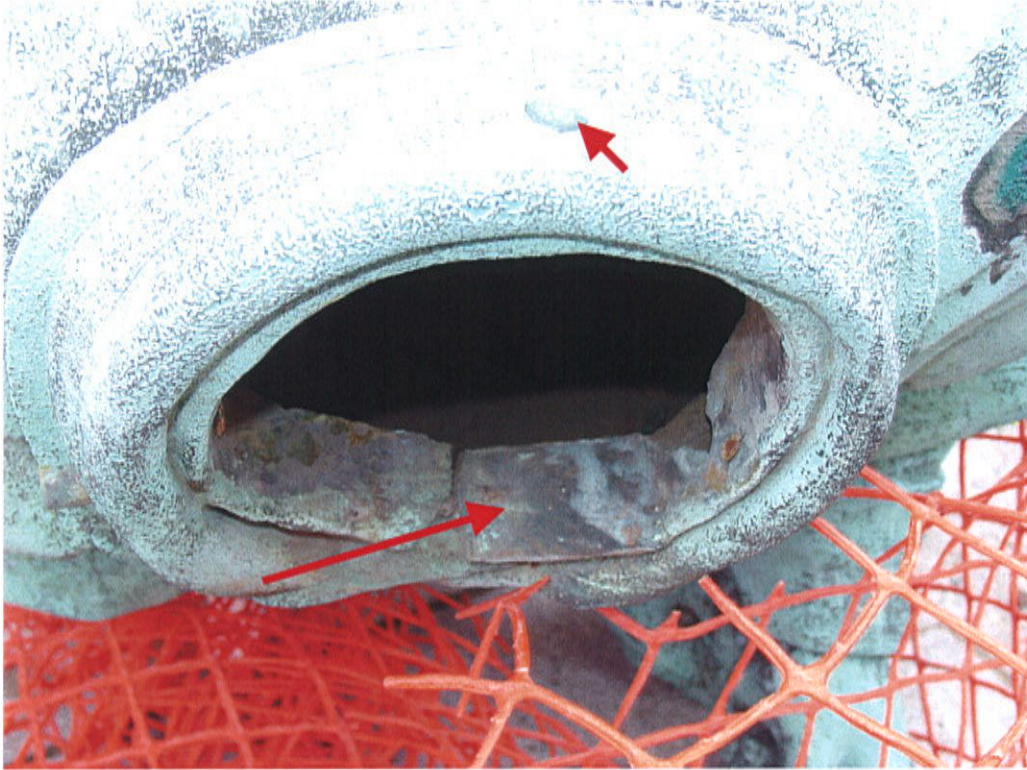
Shown: Soldiers and Sailors Monument, Boston, MA. Vandalized “The Soldier” statue. Note: Corrosion inside collar. Bolt holding head on was snapped. Statue head was recovered. Corrosion and staining damage.

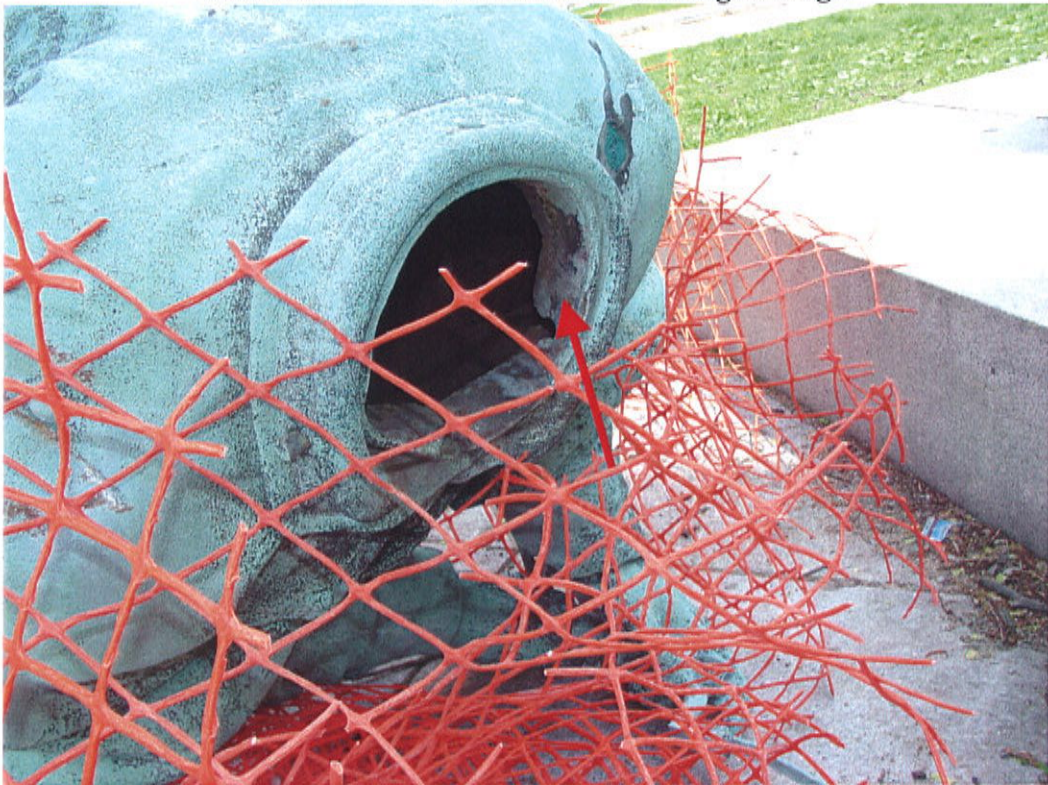
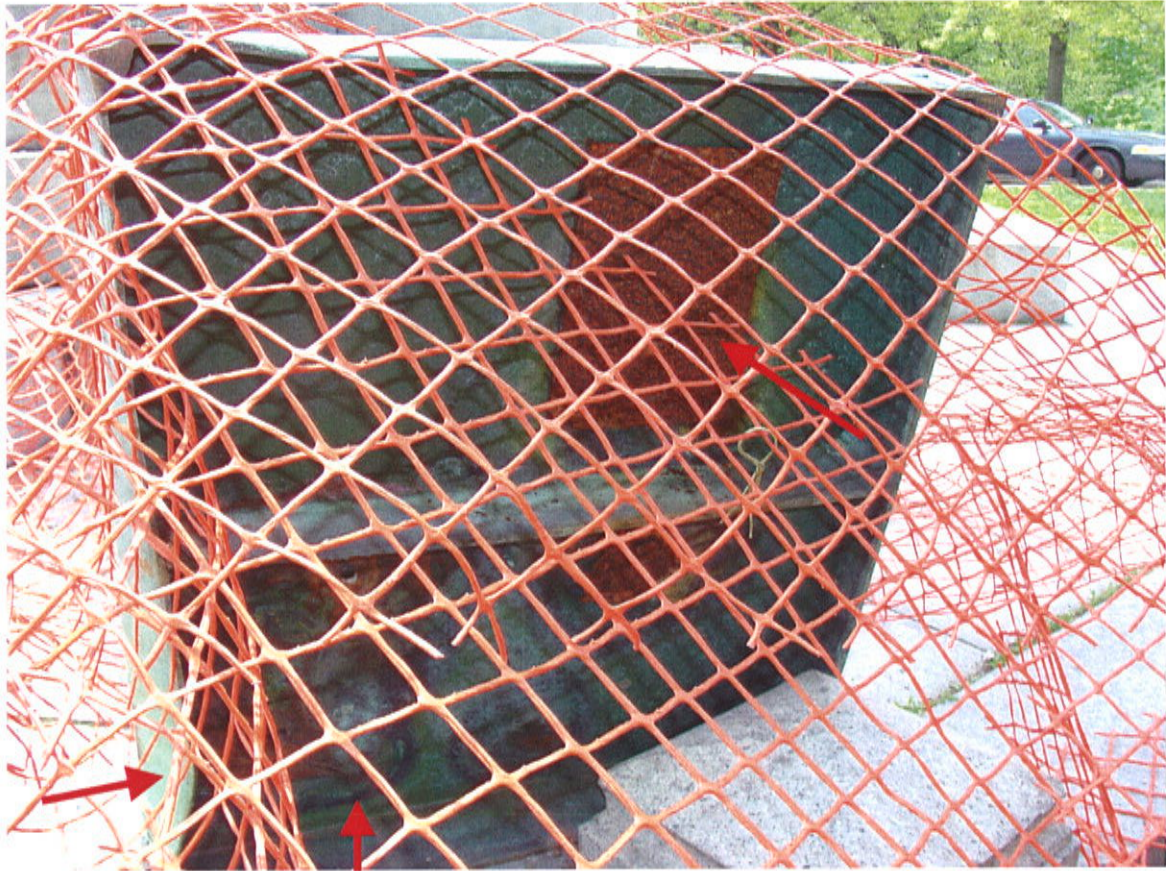
**Shown: Soldiers and Sailors Monument, Boston, MA. Vandalized Soldier statue.
Note: Base bent and damaged by vandals. Rusted plate is from a previous repair.
Some corrosion and metallic stress damage.**

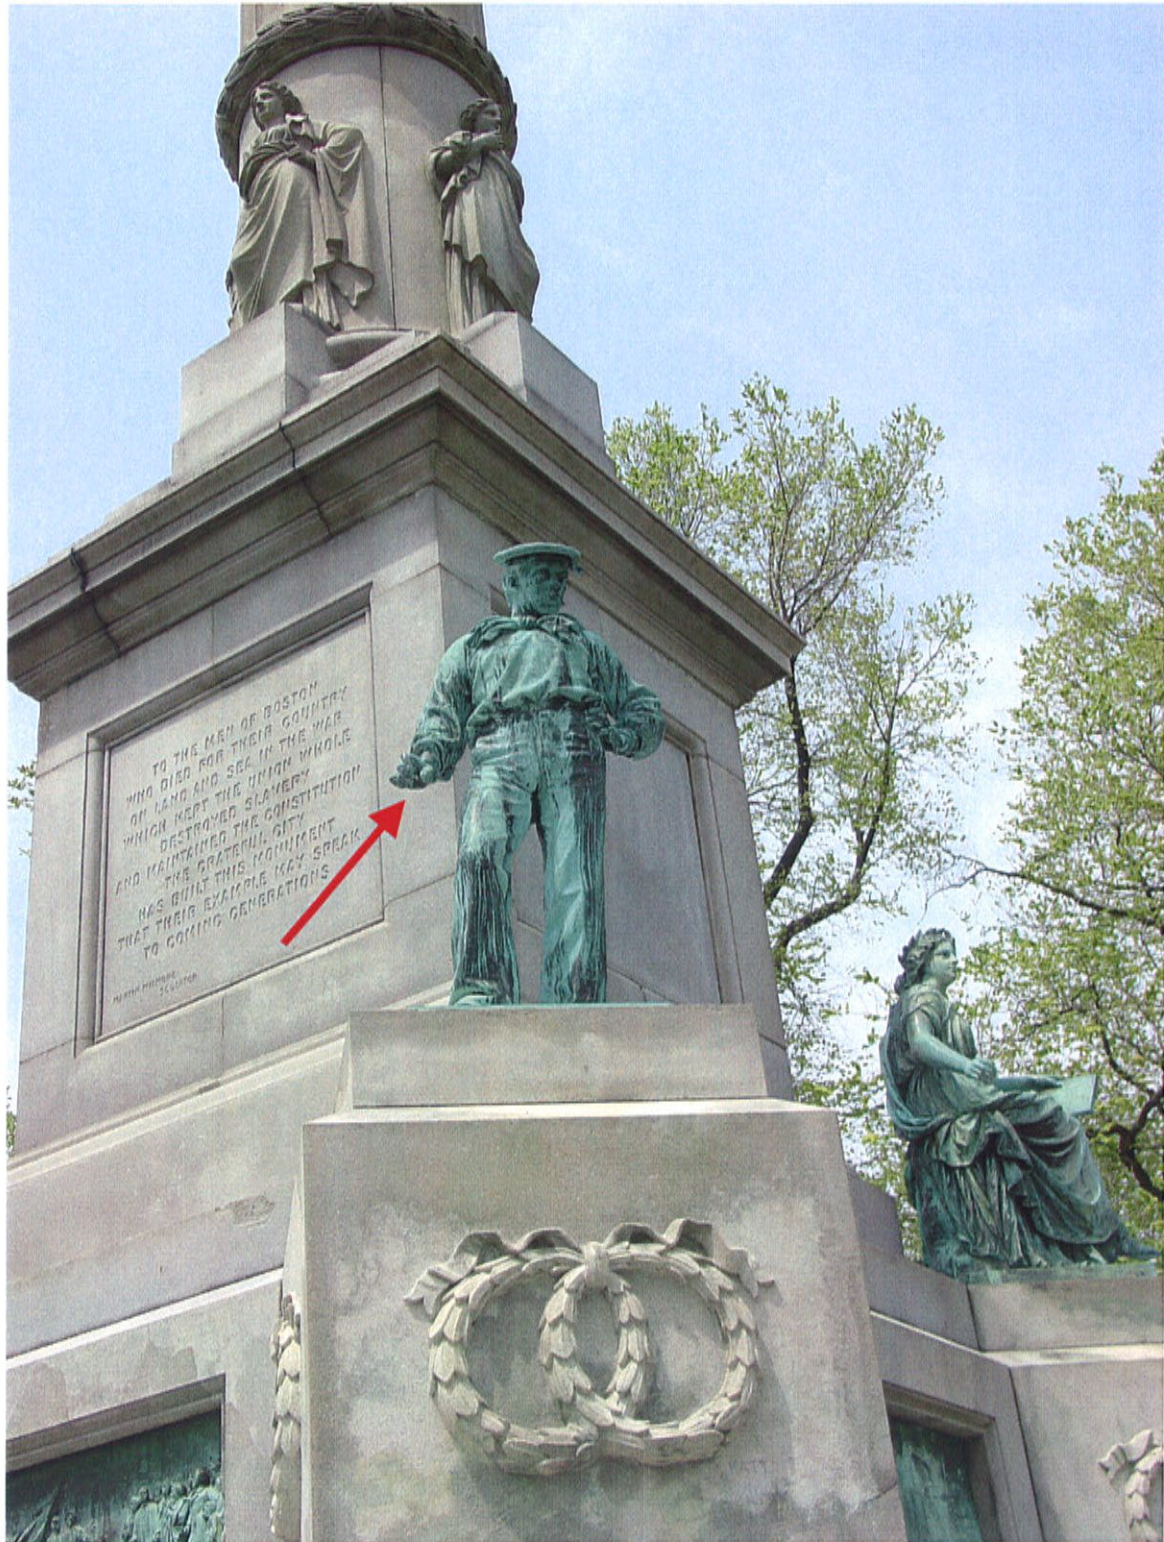
Note: "The Sailor" statue missing cutlass, which extended down from right hand. Some corrosion and staining damage.

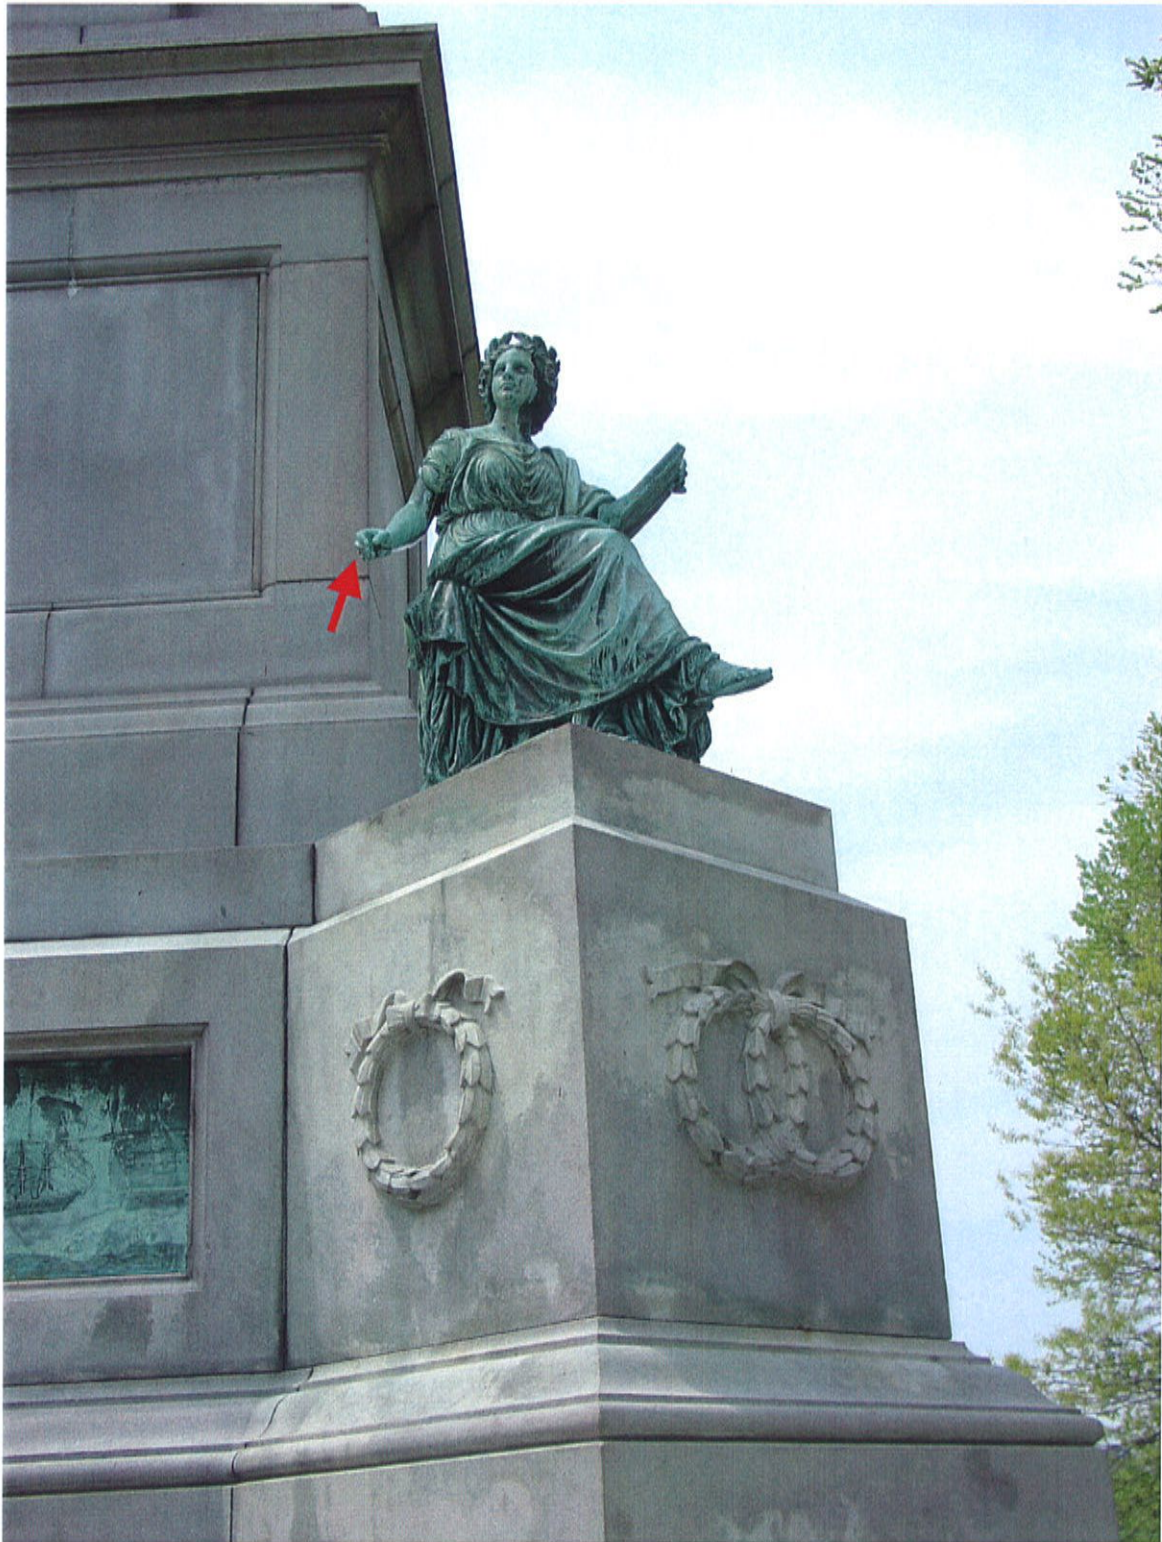
**Shown: Soldiers and Sailors Monument, Boston, MA.
Note: "History" statue missing stylus from right hand. Some corrosion and staining damage.**

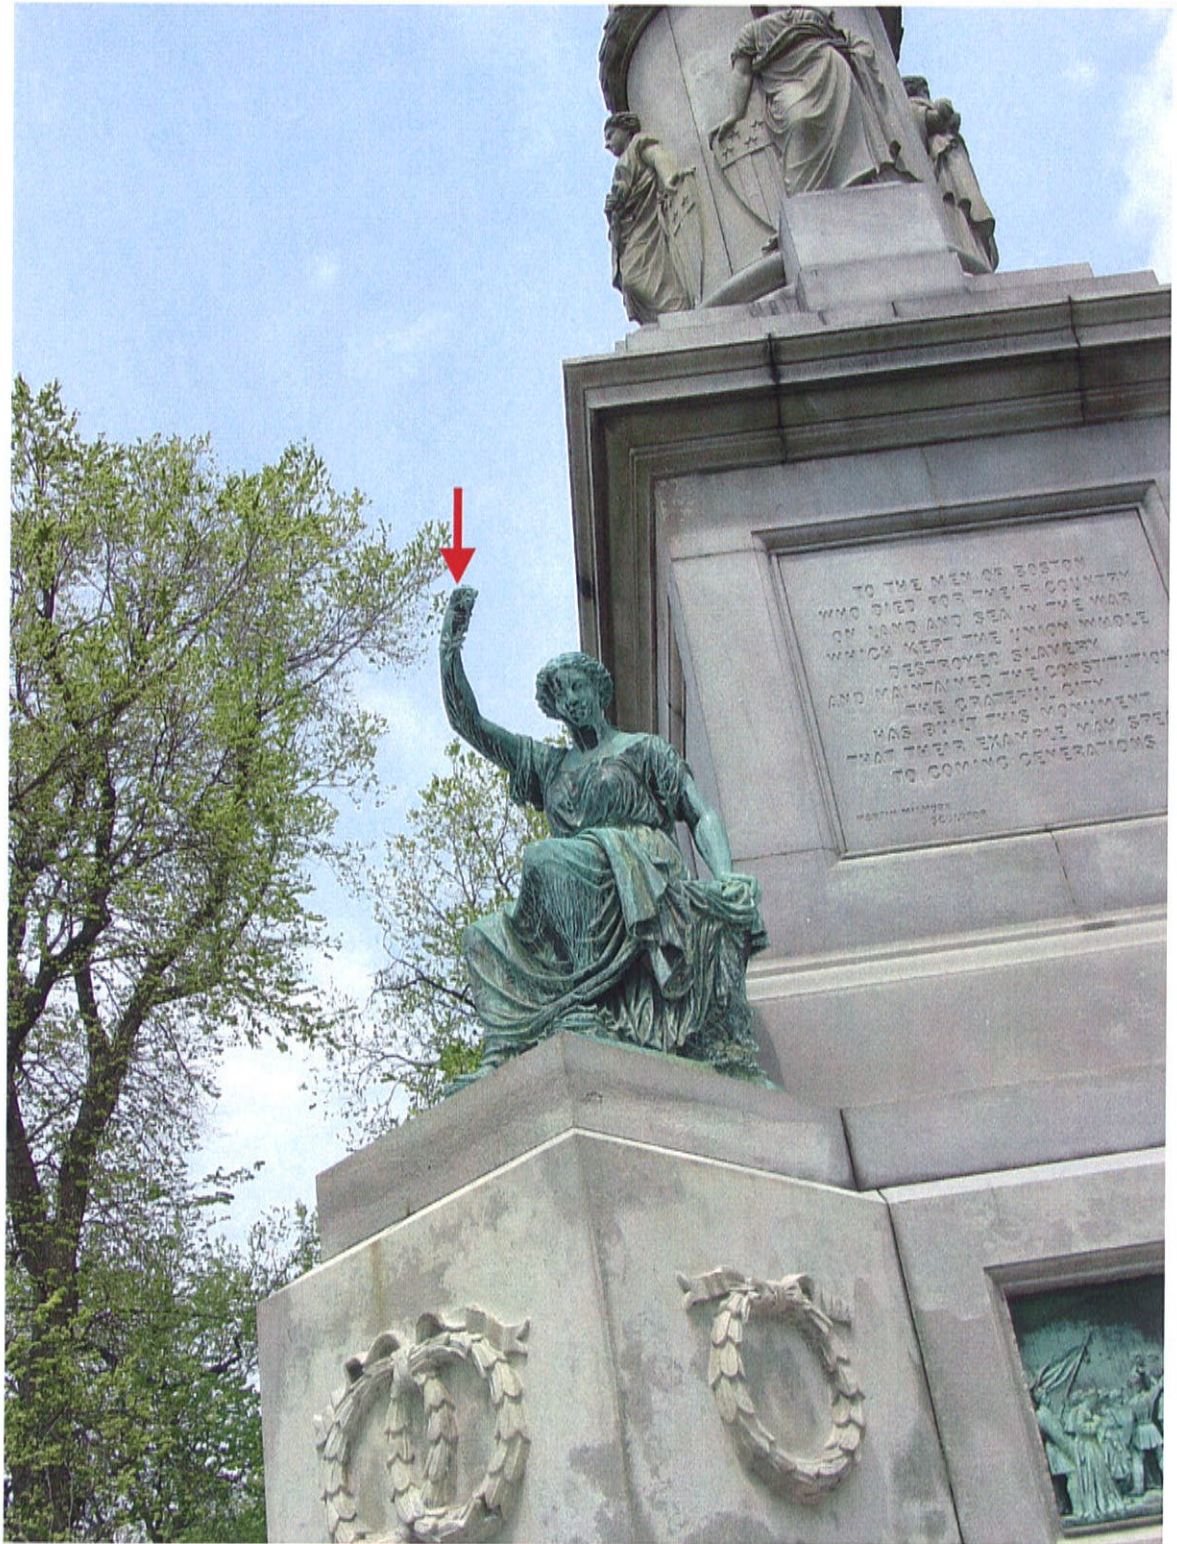
Shown: Soldiers and Sailors Monument, Boston, MA. Note: “Peace” statue missing part of olive branch, which extended from right hand. Some corrosion and staining damage.

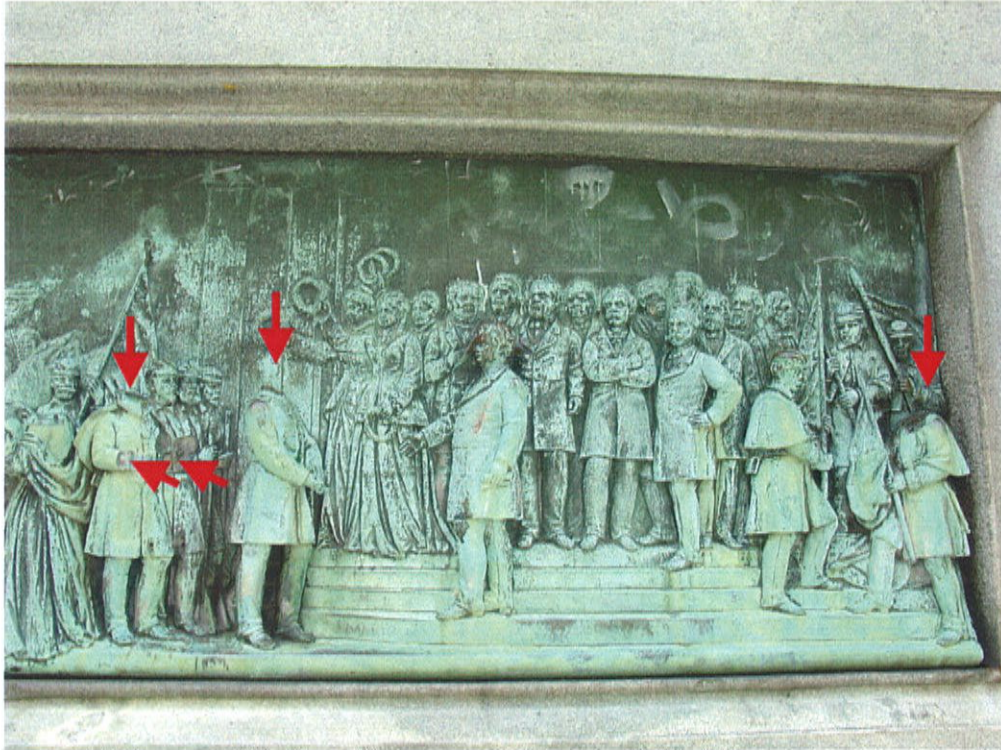
Shown: Soldiers and Sailors Monument, Boston, MA. "Departure for the War" bronze relief. Note: Numerous heads, arms, legs, rifles are missing. Some corrosion and graffiti damage.

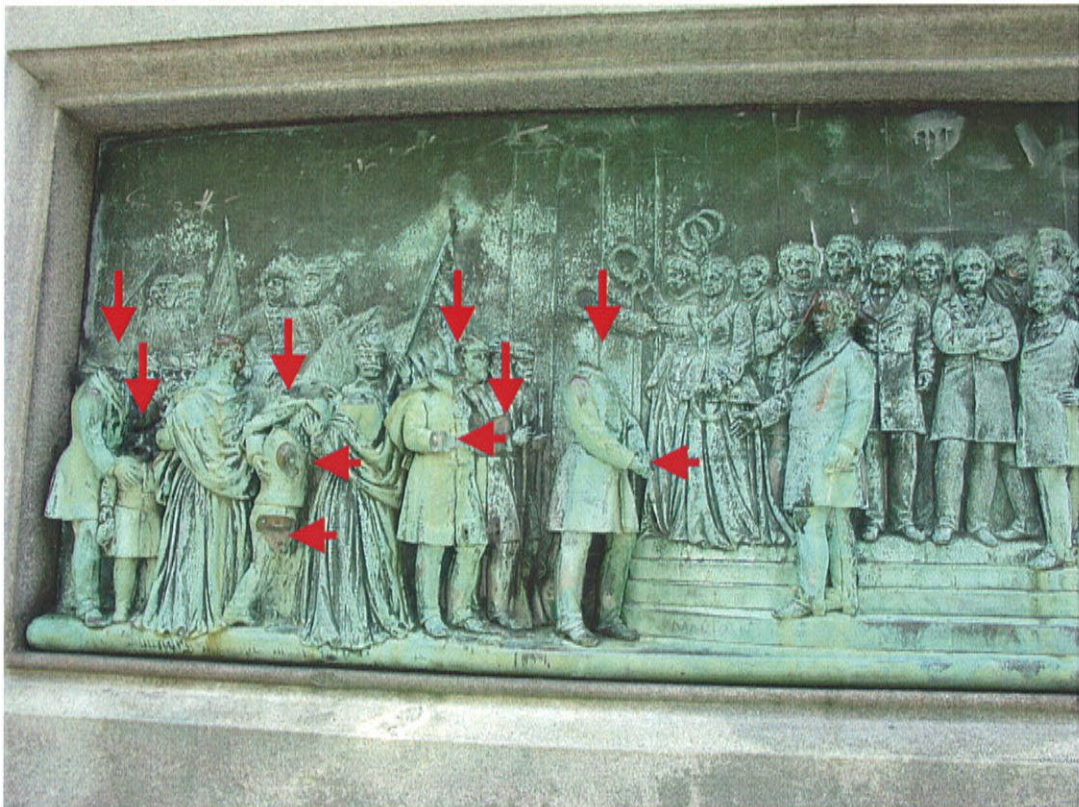
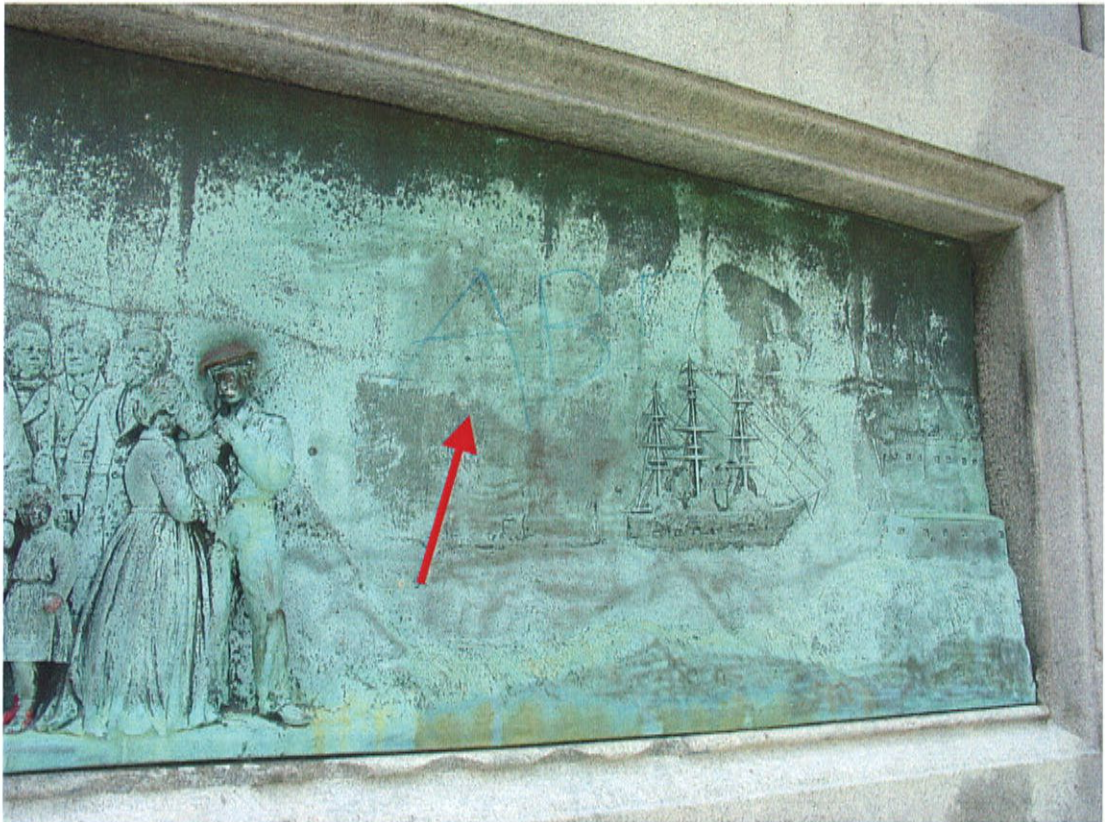
Shown: Soldiers and Sailors Monument, Boston, MA. "The Navy" bronze relief.
Note: Corrosion and graffiti damage.

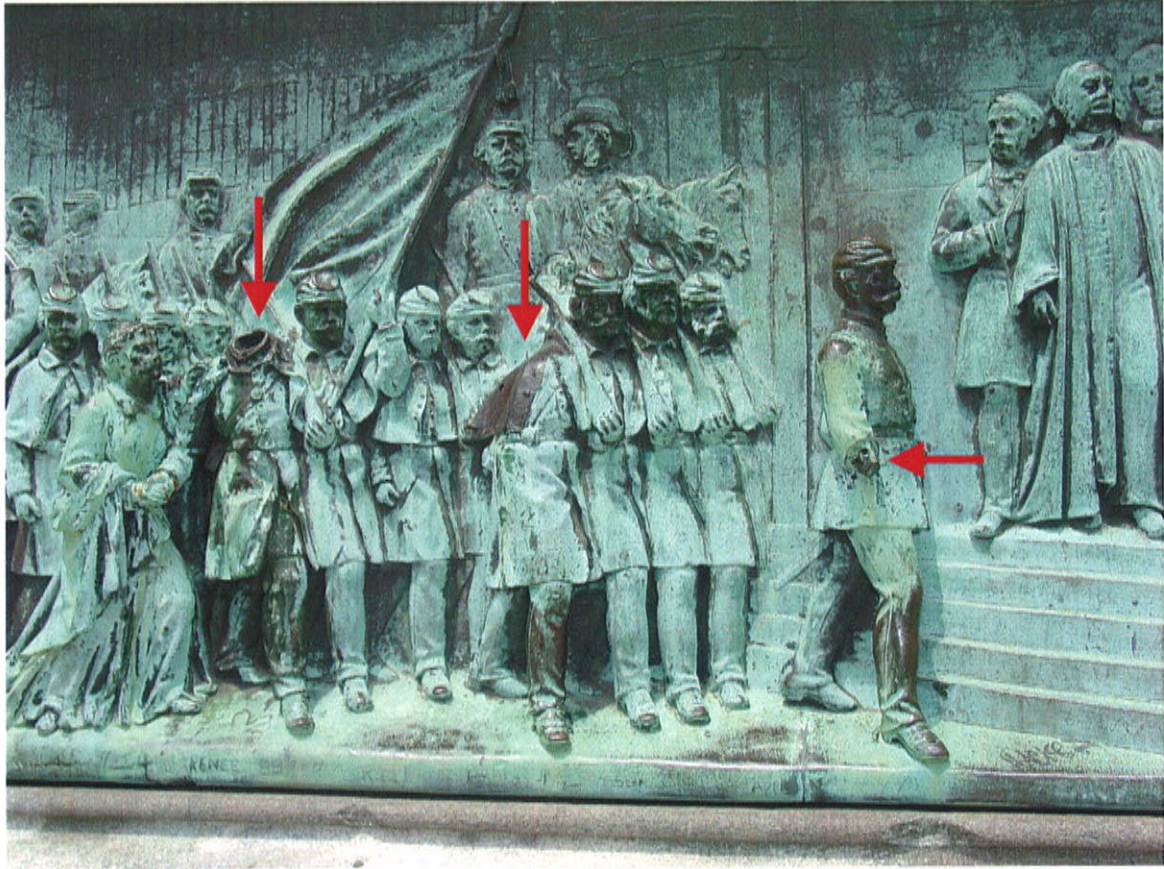
Shown: Soldiers and Sailors Monument, Boston, MA. "Return from the War" bronze relief. Note: Heads, arms and part of a torso missing. Some corrosion damage.

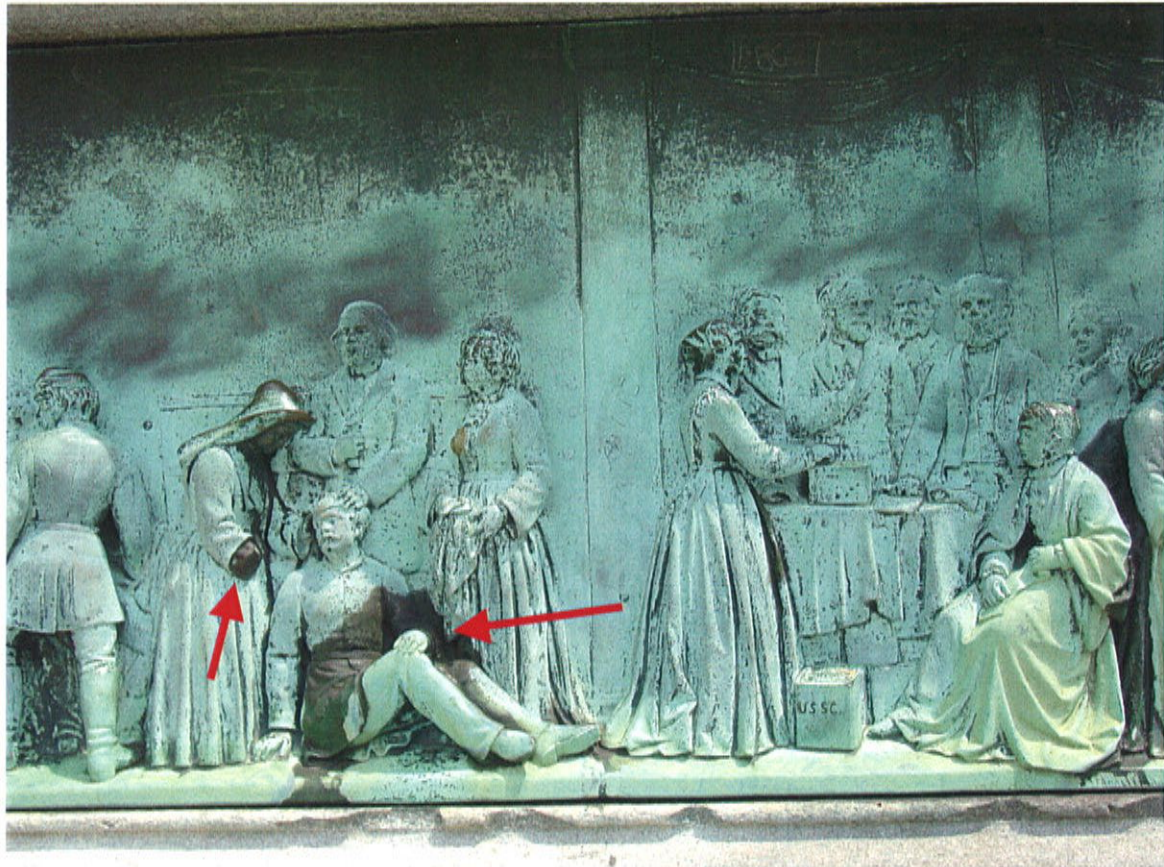
Shown: Soldiers and Sailors Monument, Boston, MA. "The Sanitary Commission" bronze relief. Note: Arm missing. Some corrosion damage and staining.

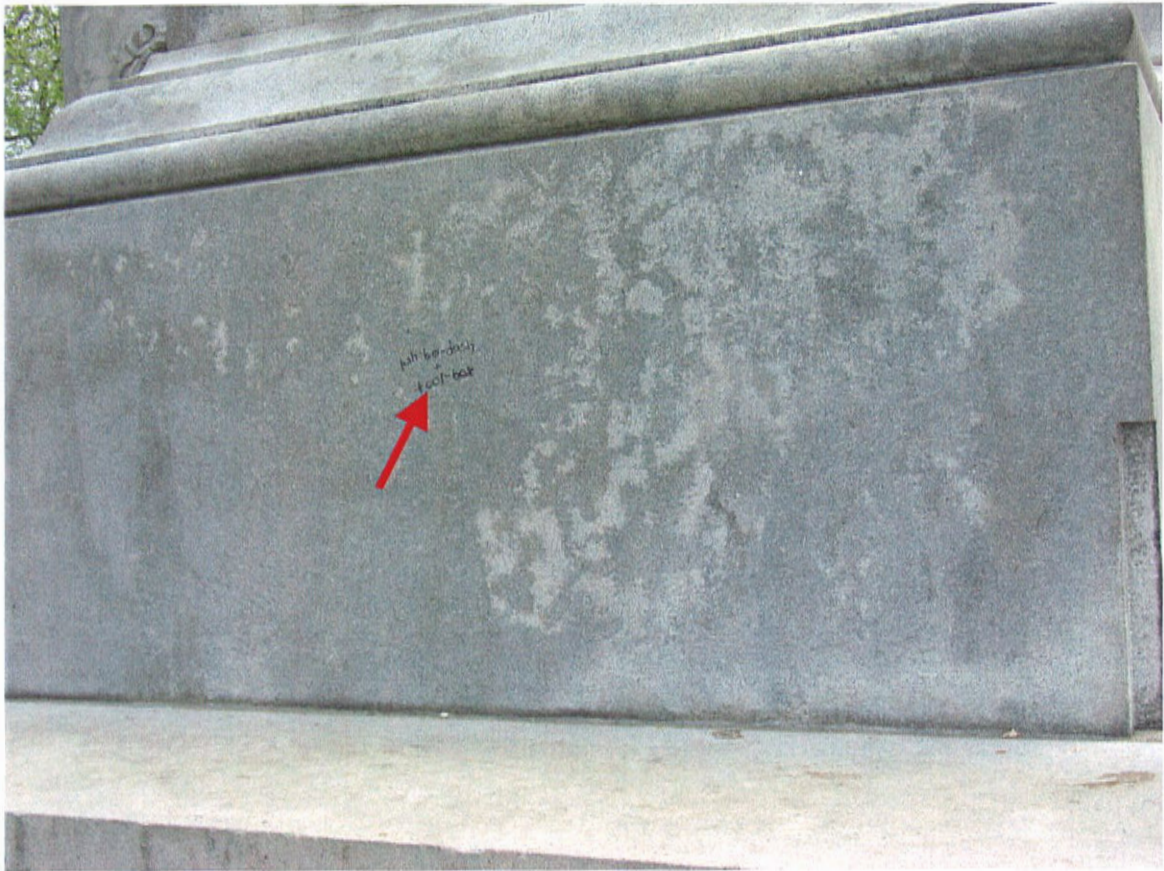
Shown: Soldiers and Sailors Monument, Boston, MA. Detail of monument base. Note: Graffiti damage, cracked seams, staining, chips and deterioration of the granite material.
