SONS OF UNION VETERANS OF THE CIVIL WAR
National Civil War Memorials Committee

THE SOLDIERS AND SAILORS MONUMENT

Boston Common,

**Soldiers and Sailors Monument
Boston Common,
Boston, Massachusetts**

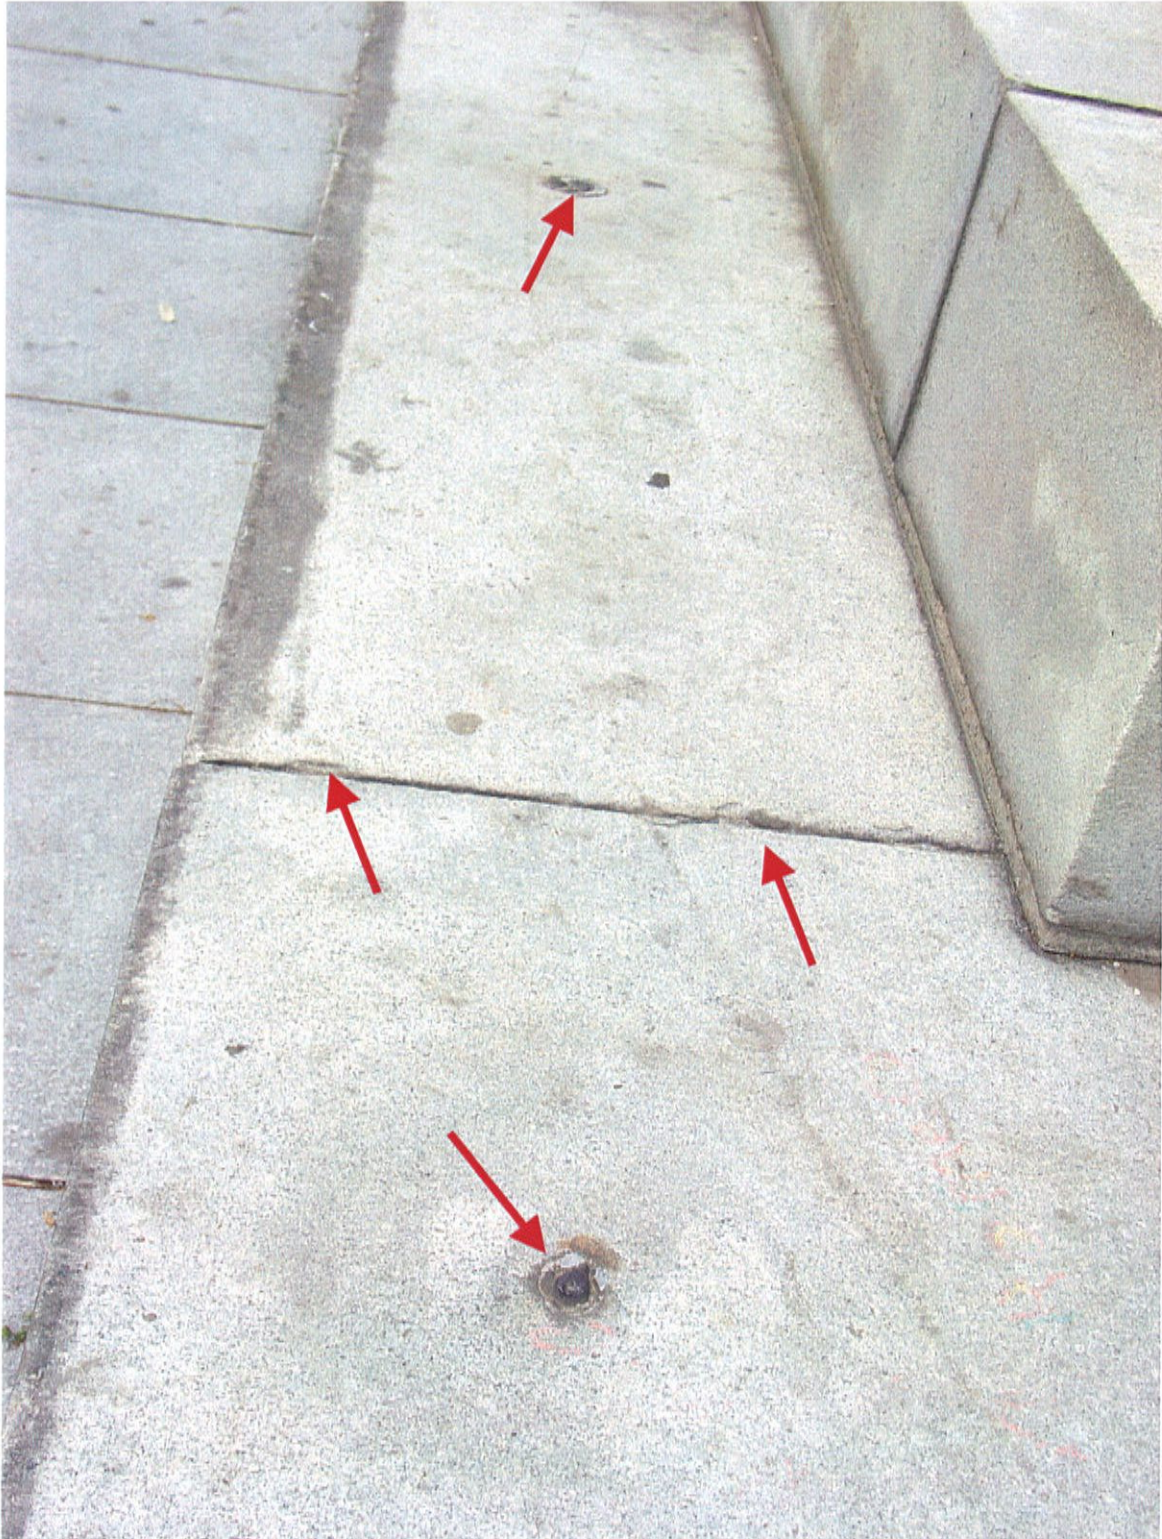
**Shown: Soldiers and Sailors Monument, Boston, MA. Detail of monument base.
Note: Pieces of iron railing, (which was removed) imbedded in granite base.
Cracked seams, staining, chips and deterioration of the granite material.**
