**SONS OF UNION VETERANS OF THE CIVIL WAR  
CIVIL WAR MEMORIAL FUND REQUEST**

NAME OF MEMORIAL: Watertown Soldier/Sailor Statue

**GRANT REQUEST # 2010-2011-11****Project Name: Watertown Soldier/Sailor Statue**

**CONDITIONS ASSESSMENT REPORT**  
*of the*  
**SOLDIERS AND SAILORS MONUMENT**  
*located in*  
**WATERTOWN, NEW YORK**

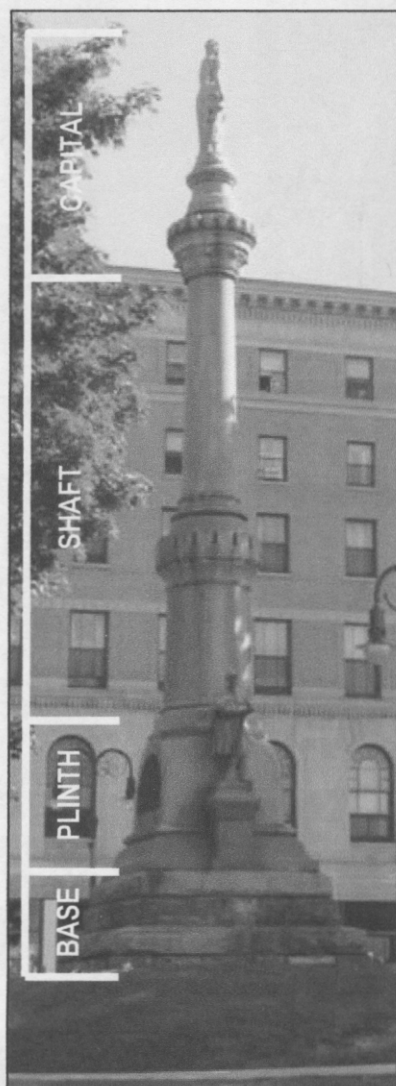
**Figure 1.** The north elevation of the Soldiers and Sailors monument.

The Soldiers and Sailors monument stands approximately 50 feet tall atop a berm, itself rising approximately five feet above street grade. Part of the foundation is visible, consisting of coursed rubble stone. The base is composed of three separate tiers of pitch-faced granite, each a solid slab. Atop this is a decorative plinth, consisting of a cyma and a four-sided die, six tall and wide. The cyma and die are flanked on the north and south elevations by a smaller plinth block; atop each stand the life-sized bronze sailor (north) and soldier (south). The east and west elevations of the die are each ornamented with a decorative bronze plaque. From the plinth rises an octagonal shaft, capped with a crenellated turret; this continues as an unfluted shaft, which is capped with a crenellated capital. This is surmounted by the over life-sized allegorical figure of *Victory*, facing west.

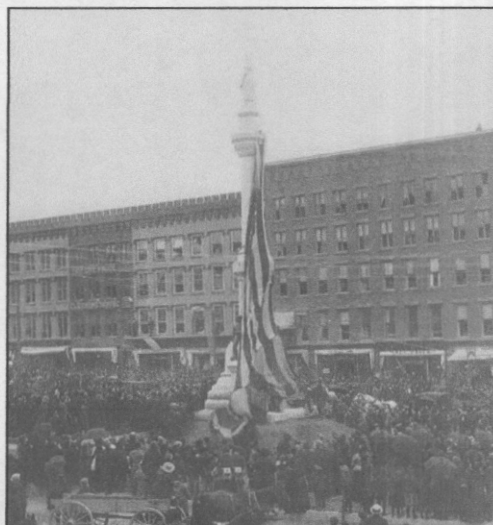
**Figure 3.** Historic photograph depicting the unveiling of the monument, June 3, 1891 (image provided by the client).

An undated article from the *Watertown Daily Times* entitled, "Soldiers' Monument Here is Nearly 50 Years Old" states that, "Now that the soldiers' monument on Public Square has been restored to its original beauty, interest has been awakened in this gift." From the stated age of the monument, the article should have been written in the late 1930s or very early 1940s. Unfortunately, no further description of the restoration that occurred at that time was provided.

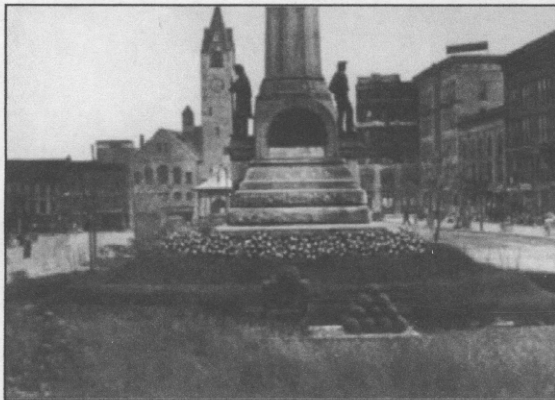
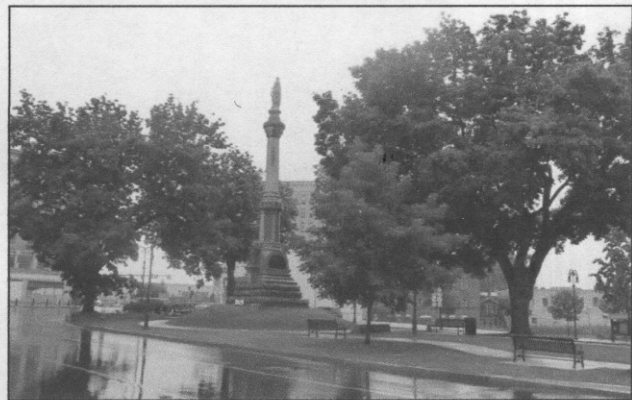
An historic photograph from the day of the monument's dedication shows that the rubble foundation course was not originally intended to be seen, but has been revealed due to soil erosion. Recent photographs supplied by the client showed a small bed of flowers encircling the base of the monument (now absent), probably an effort to partially camouflage the foundation. Landscape fabric had become partially exposed, suggesting an effort to mitigate erosion. An undated photograph, probably taken in the early twentieth century, also shows that the berm had at one time been noticeably terraced, and the site ornamented with at least one mortar and a pyramid of cannon balls. No documentation had been found to explain the removal of these elements.

**Figures 6 and 7.** An historic photograph (left; undated) illuminates some of the changes the site has undergone over the years. [Photo care of Donna M. Dutton, *Images of America: Watertown* (Mount Pleasant, SC: Arcadia Publishing, 2001), 14.]

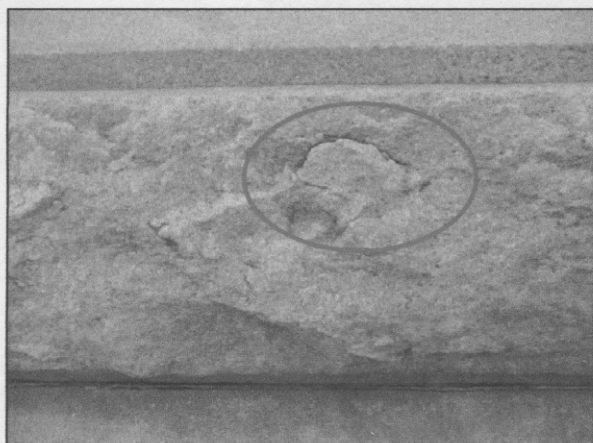
The stonework of the monument is in fair to good condition. The massive granite blocks generally remain quite sound. The three rusticated tiers of the base as well as the octagonal segment of the plinth exhibit mild to moderate surface deterioration due to the development of microfissuring caused by the original pitch-faced dressing of these stones. These minor losses and

**Figure 9.** Minor incipient spalls on the face of the base stones are due to the original technique used to create the pitch-faced finish of the stone.

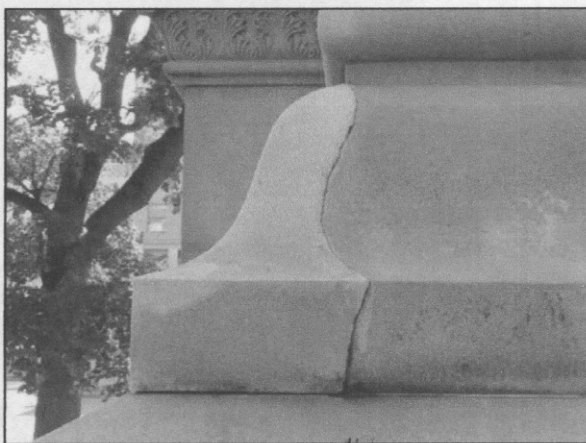
The southeastern corner of the cyma has cracked due to point-loading, resulting in fractured piece which remains in place. This piece, approximately 6" x 12" x 18," does not appear to be in immediate danger of falling off the monument but should be stabilized.

**Figure 10.** Point-loading has caused one corner of the cyma level to separate at a fracture line.

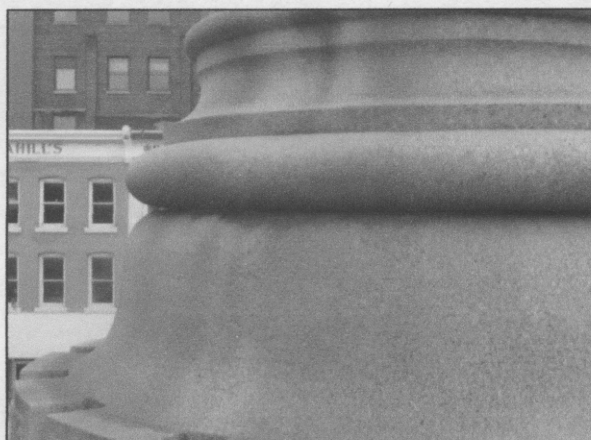
Soiling of the monument is fairly mild. Black soiling has accumulated in the recesses around joints and below the crenellation, in predictable patterns indicating the path of water run-off. The greatest concentration occurs on the three rusticated tiers of the base, where atmospheric and biological soiling (both green and black) has accumulated on the undulating surfaces and along the edges of emerging flakes. Moist, green biological matter and moss are growing out of the wide, damp joints of the foundation as well as the narrow joints of the base and lower plinth. Soiling generally tends to be heavier on the north and west elevations, which receive less sun light and will stay damp longer. The figure of *Victory* exhibits bird droppings and limited yellow/orange discoloration of the stone, which may be mild rust staining.

**Figures 11 and 12.** Soiling and biological matter has accumulated in the recesses approaching joints (left), and in joints which remain damp.

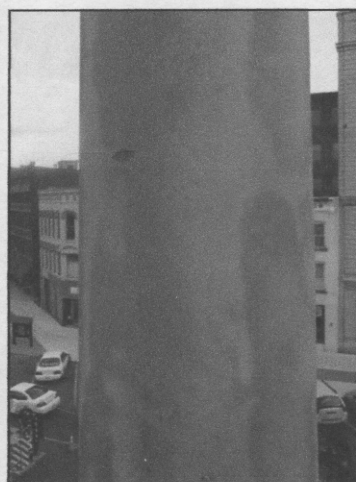
The granite exhibits some unevenness of color, in areas such as the “backsplash” behind each of the bronze figures. The shape of a monument will necessarily encourage water to dwell longer on some areas of the stone than others; through weathering and exposure, feldspar in the granite will be converted into kaolinite (clay). The clay subsequently washes out of the stone, leaving the darker minerals present. The resulting coloration is a direct result of the stone’s morphology and should not be considered a fault or problem, nor is it a condition which can be reversed.

**Figures 13-15.** The stone exhibits some unevenness of color due to variations in weathering (left and center), leaving some minerals more exposed (detail, right).

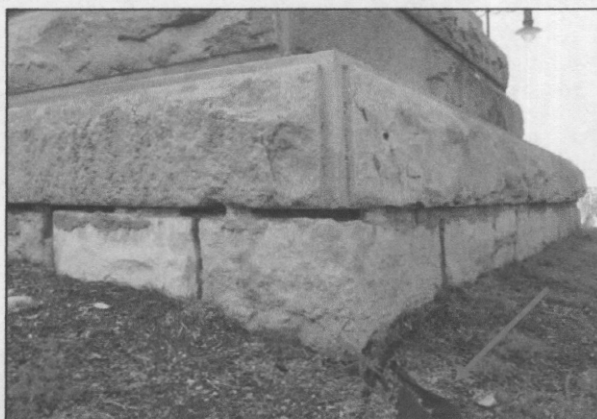
The joints of the rubble foundation course are wide, ranging in width from approximately 3/4" to 1 1/2". The condition of the mortar is generally poor. The joints have probably been re-pointed multiple times, with significant overruns beginning to accumulate on the adjacent stone. This is the only significant evidence of any prior treatment or intervention. Approximately one-third of the pointing mortar is missing; a significant portion of the bedding mortar has been lost as well, up to a depth of 1 to 2 inches. However, the foundation does not otherwise exhibit any signs of movement or failure.

**Figure 16.** General condition of the foundation (lower course). Also note the emergence of the landscape fabric.

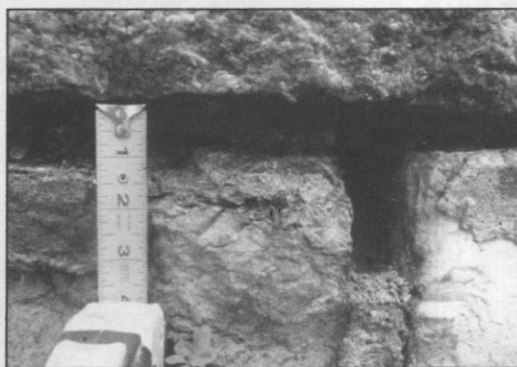
The joints between granite units are generally narrow, typically 1/8". It is likely that the granite blocks were dry set on lead buttons after which each joint was pointed with a lead strip. The joints are in poor condition. The existing lead is deteriorating, displaced or wholly missing from many of the joints, particularly between the second and third tiers of the base, as well as at various heights along the length of the shaft. The lead between each bronze figure and its granite plinth has also generally failed.

**Figures 17 and 18.** Example of a typical lead strip caulk dislodged from its joint (left) and one of the many wide, open joints of the foundation (right).

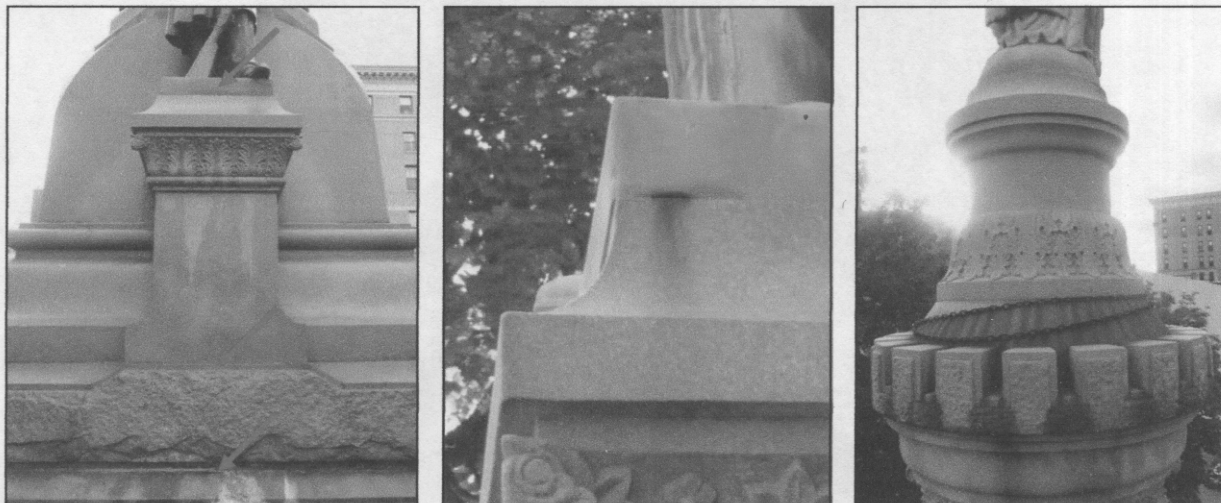
Metallic staining has occurred at various locations from two sources. Copper staining has predictably occurred on the granite immediately below the bronze figures and plaques, and is visible as a light blue-green wash on the faces of the stone.

Significant iron staining was observed concentrated on the upper level of crenellation, with a lesser, minor stain visible near the foot of the sailor. Subsequent observations made from the aerial lift showed that an iron chain, approximately four feet long, is wrapped around the pedes-

**Figures 21-23.** Examples of copper staining (left), mild and significant rust staining (center and right, respectively) on the monument.

tal of *Victory*, resulting in the staining below. The representative of the fire department did not consider it safe to attempt to remove the chain at this time. From this vantage point, we also observed that a ferrous shim used to level the figure of the sailor is causing that stain.

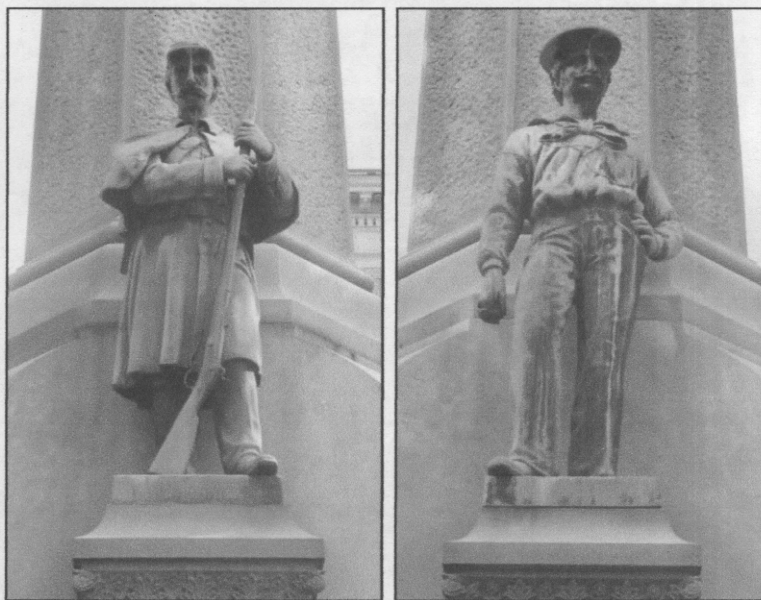
Both sculptures possess an appearance and condition similar to that of other unmaintained bronzes of the same age in an outdoor environment. Active corrosion of the bronze surface is visible by its pale green appearance, streaking, and pitting of the surfaces.

Figures 24 and 25. The cast bronze soldier (left) and sailor (right).
