NATIONAL ORGANIZATION SONS OF UNION VETERANS OF THE CIVIL WAR

CIVIL WAR MEMORIAL ASSESSMENT FORM

SUVCW -- Civil WAR MEMORIAL ASSESSMENT FORM (CWM #61)

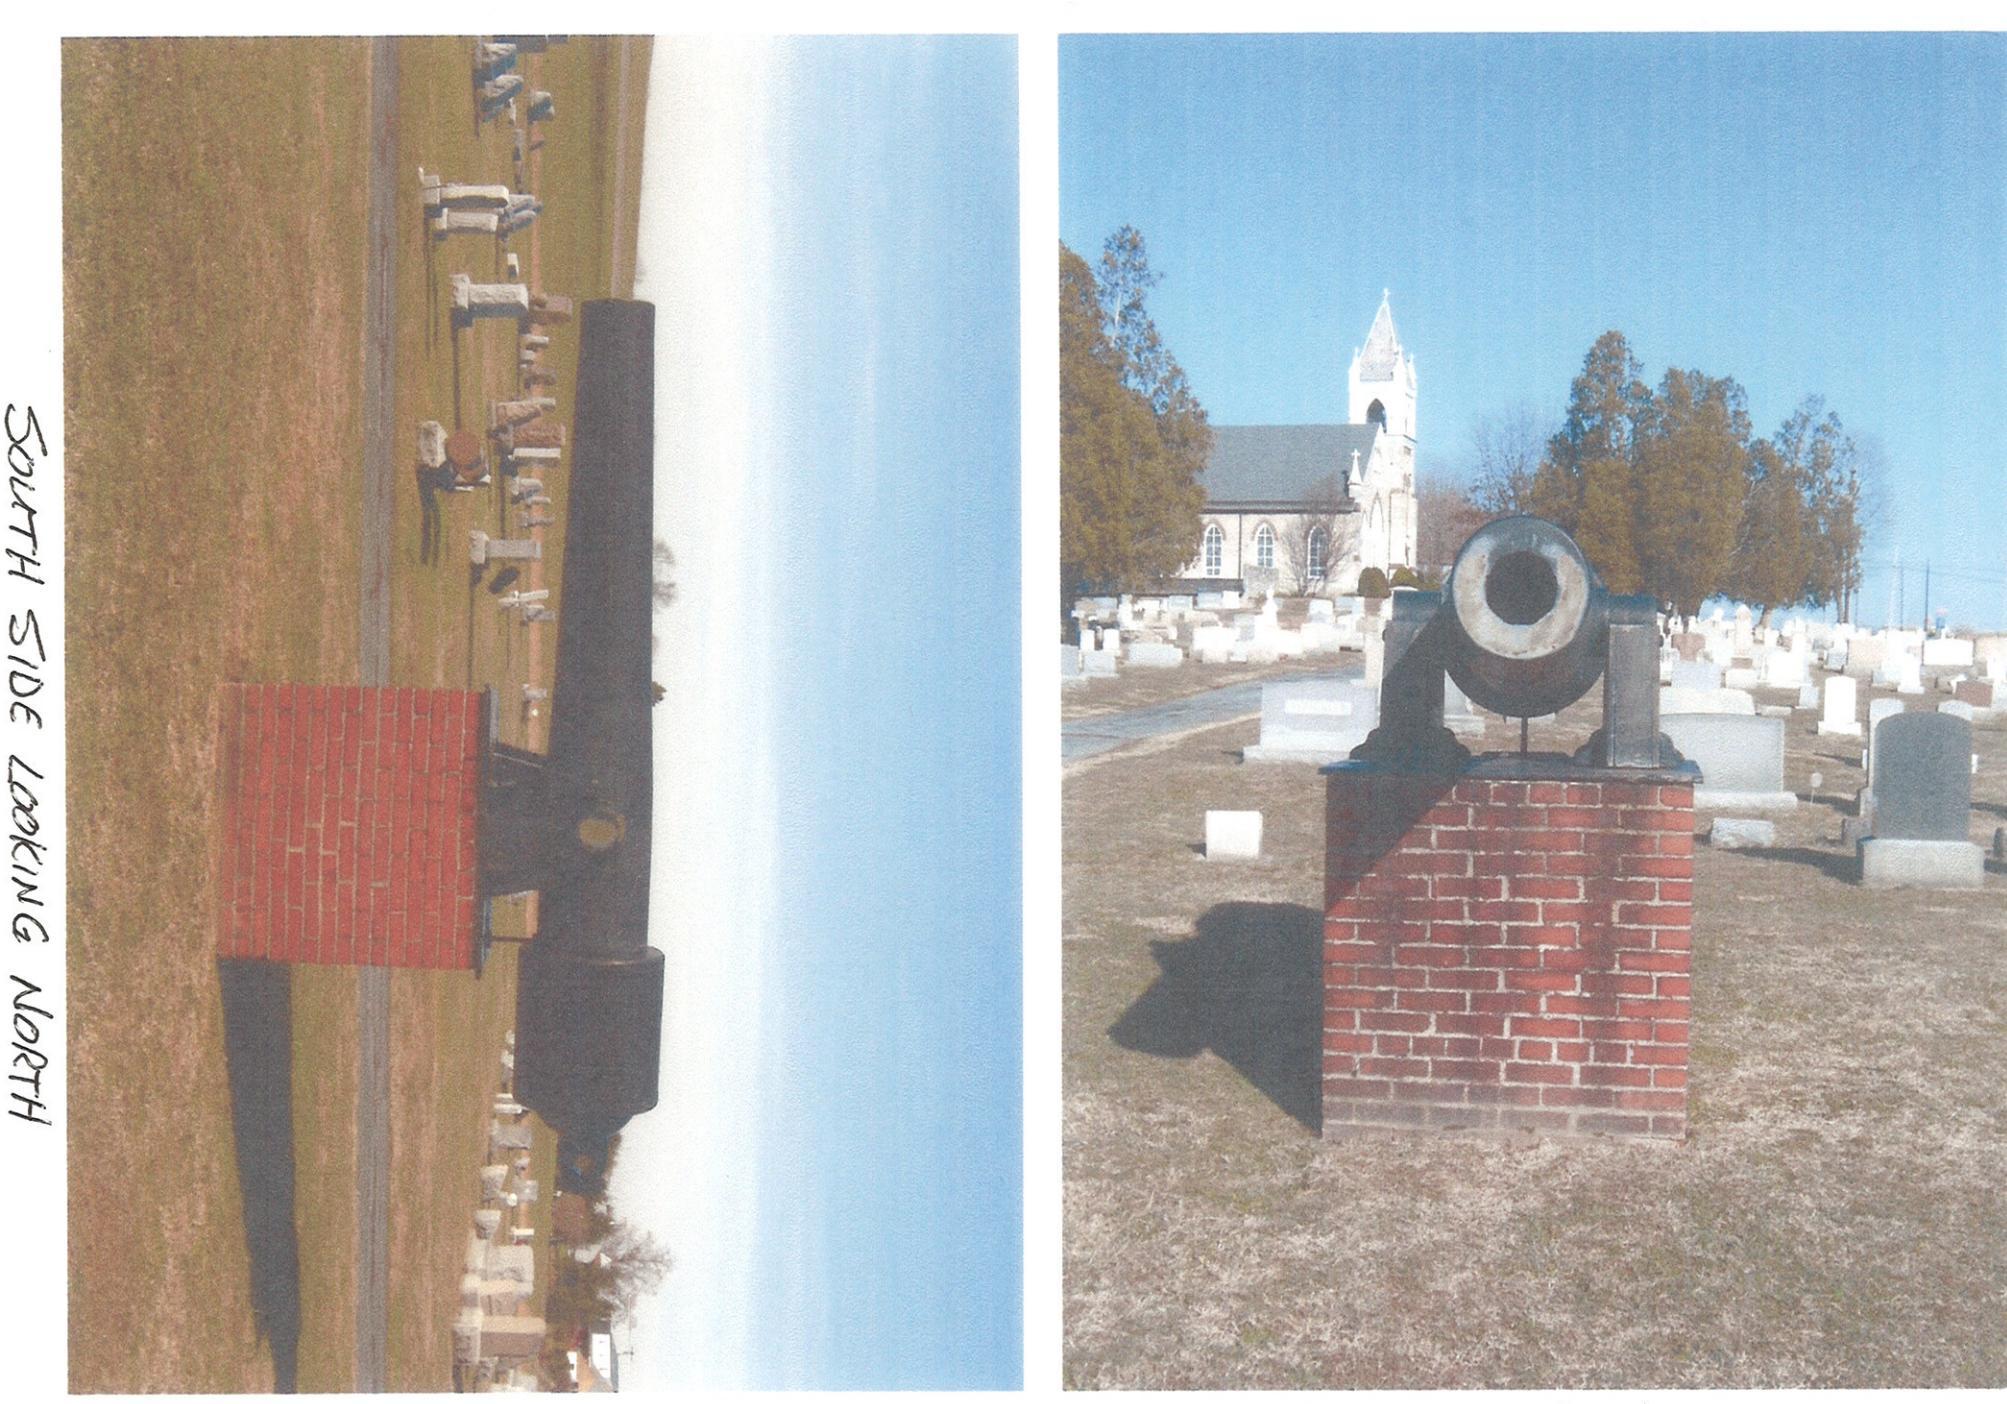
Barrel Facing West

The bore of the cannon barrel is littered with trash and because of rain water	going into the barrel the bo	re and rifling are
becoming badly rusted.

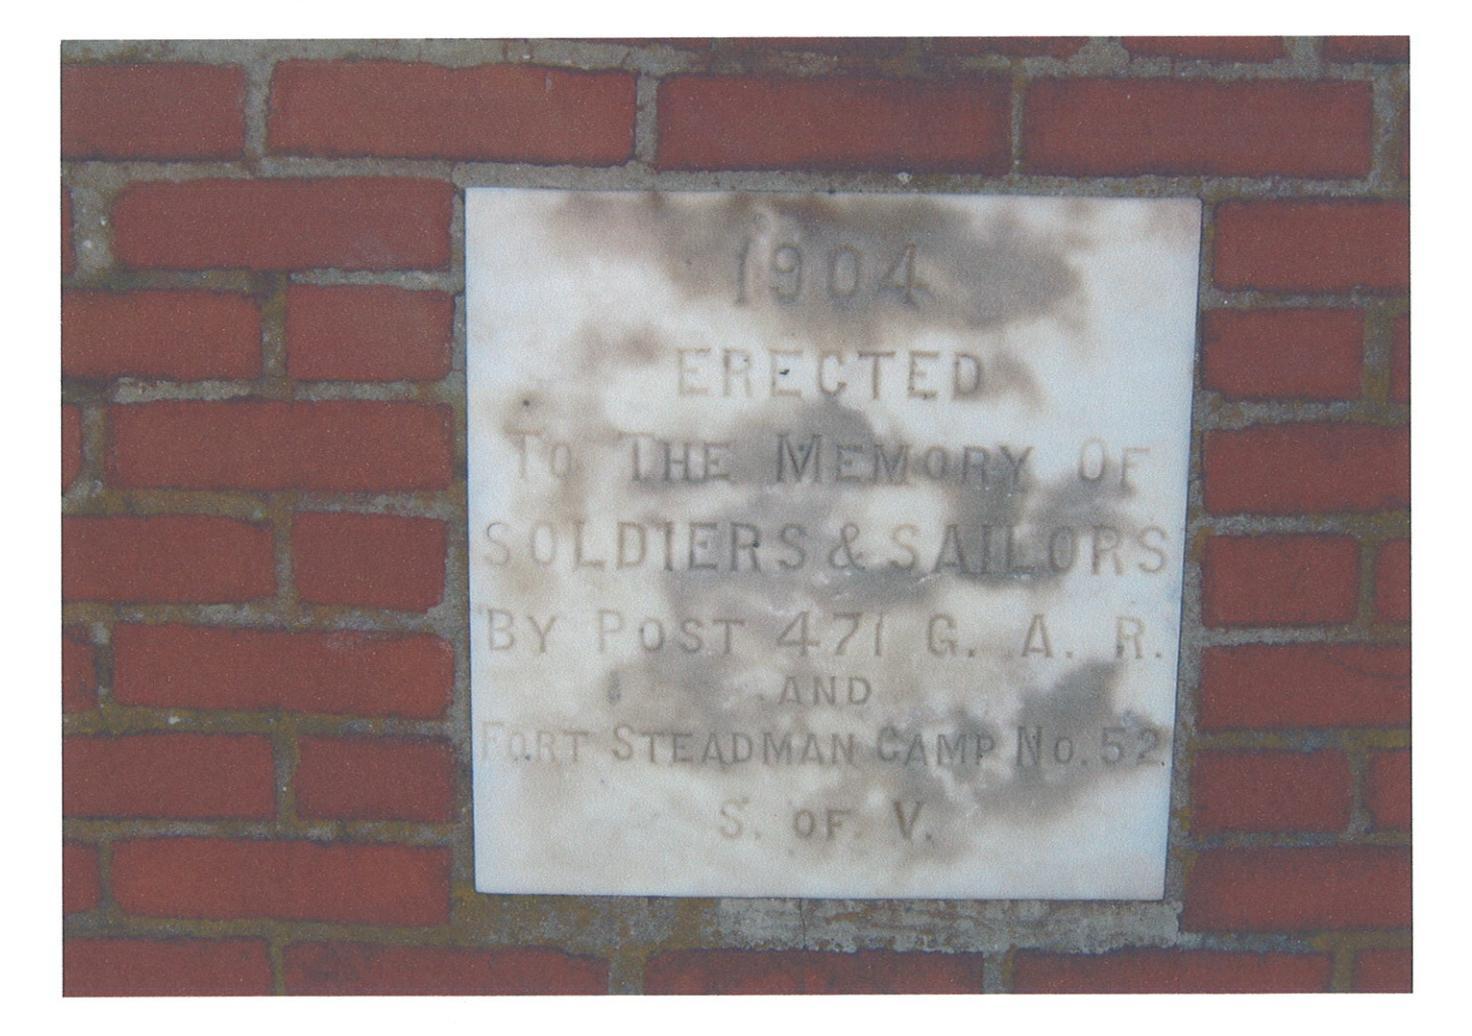
East Side of Base

Briefly describe the Memorial (affiliation / overall condition & any concern not already touched on). The Memorial consists of a 100 pounder Parrott Rifle mounted to an iron base plate situated on a brick pedestal. The bricks have some spalling on several of them and there are some cracked joints. There is also some moss growing on the bricks. The marble plaque shows signs of wear from the weather. The paint on the barrel is starting to show signs of wear and some areas of the barrel are starting to rust. The brick base should be repaired soon so that it's condition does not worsen, because of the weight of the barrel which is almost 10,000 lbs. any faults in the base could result in collapse.
