NATIONAL ORGANIZATION
SONS OF UNION VETERANS OF THE CIVIL WAR
CIVIL WAR MEMORIAL ASSESSMENT FORM

The Memorial is currently located at:
Street/Road address or site location 420 N. WISCONSIN
City/Village BERLIN Township County GREEN LAKE

CANNON DISPLAY BERLIN WE VFW GROUNDS

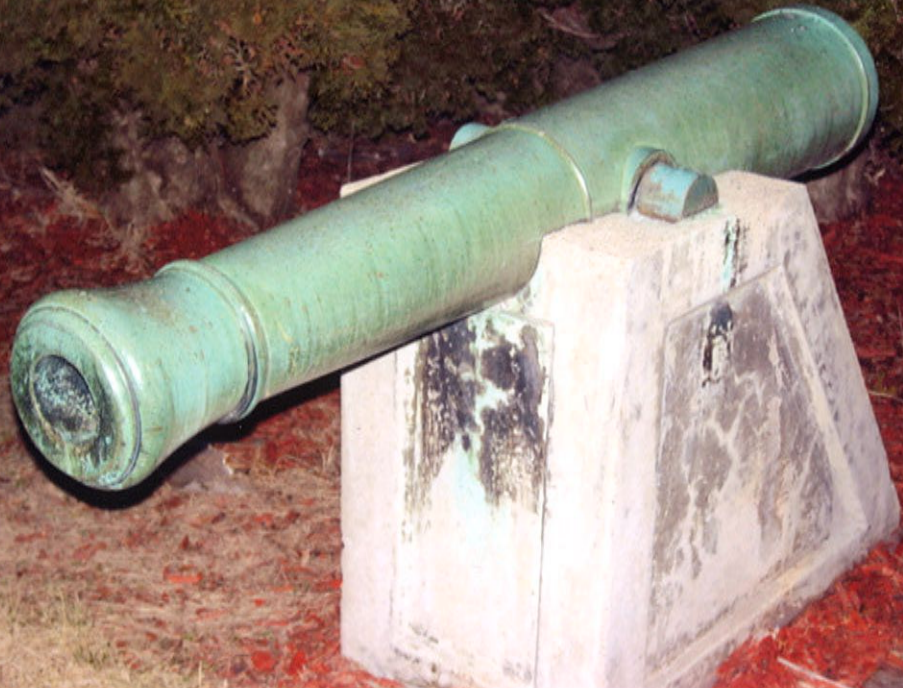
CANNON TUBE SET INTO CONCRETE BASE BUT NOT SECURED WITH IRON STRAPS OVER THE TRUNNIONS. IT WOULD NOT BE DIFFICULT TO BREAK THE TUBE FREE FROM THE BASE. THIS TUBE WAS THE SUBJECT OF A SALE FROM OUT - OF -STATERS. SALE WAS DENIED BY THE VFW BASED ON LACK OF OWNERSHIP CLARITY. THIS MONUMENT WILL HAVE TO KEPT ON A 'WATCH LIST' - IT WAS STATED TO ME THAT AS LONG AS THE OLDER MEMBERS ARE ALIVE IT WILL STAY PUT. OUR CAMP #8 WILL REMAIN IN CONTACT WITH THIS VFW POST. ORIGNIALLY, THIS TUBE WAS FOUND IN THE FOX RIVER AND REMOVED BY THE CITY. IT WAS THEN TURNED OVER TO THE VFW WITHOUT CLEAR DISTICION OF OWNERSHIP

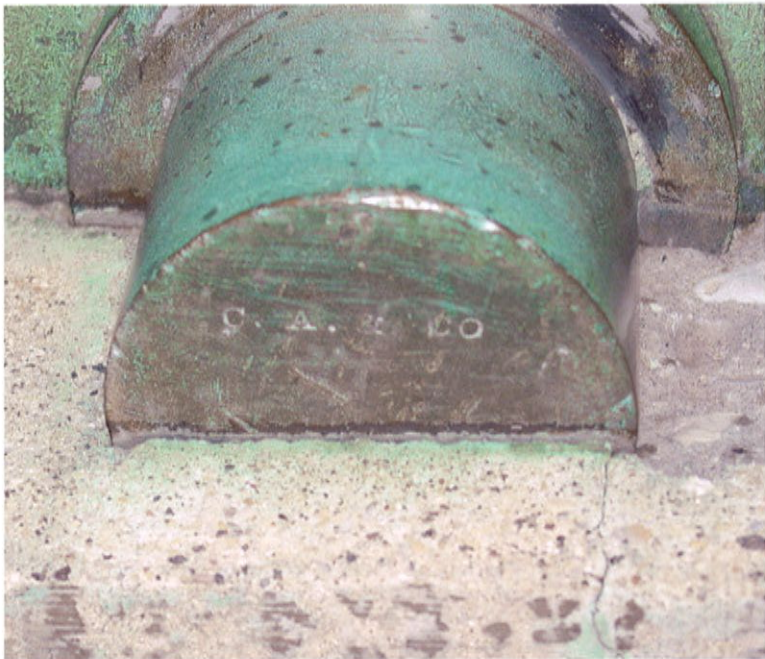
CANNON TUBE, BERLIN, WI
VFW GROUNDS

Markings on Left Trunion C.A. & Co Right Trunion 1844
