CIVIL WAR MEMORIAL ASSESSMENT FORM

CA-Sonoma-Healdsburg-Oak Mound Cem.- 1862 Matheson Mon. SUVCW -- CIVIL WAR MEMORIAL ASSESSMENT FORM (CVM #61)

Col. Matheson Stela Monument Oak Mound Cemetery, 601 Piper Street, Healdsburg, Sonoma County, CA

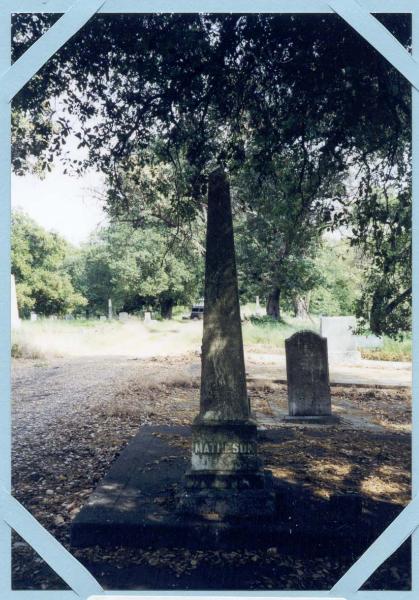
MATHESON MEMORIAL
OAKMOUND CEMETERY
HEALDSBURG, SONMA COUNTY, CA
PHOTO TAKEN 1 APR 2004 BY
JAMES SPENCER, SUVCW
101 SUNRISE MOUNTAIN ROAD
CAZADERO CA 95421
NORTH FACE LOOKING SOUTHERLY

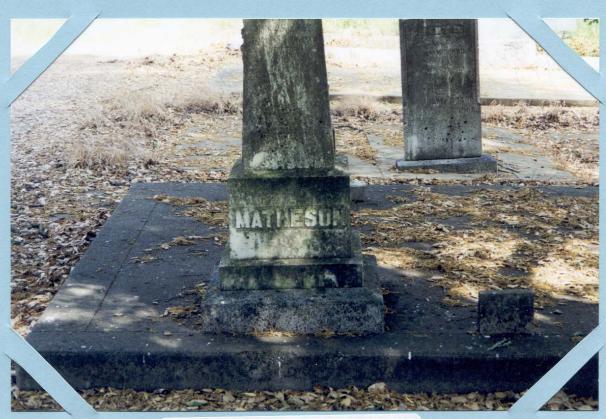
NORTH FACE - MONUMENT BASE

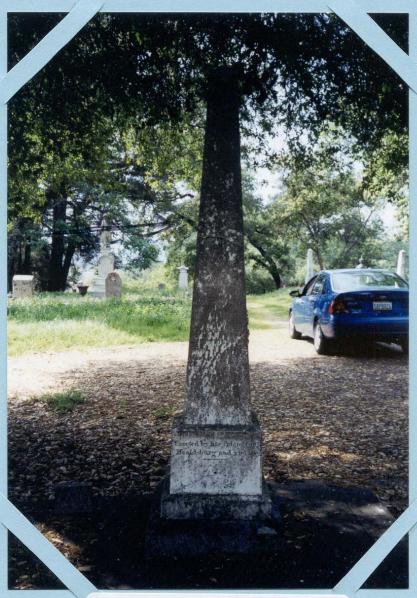
and waxing. The middle of the shaft is crac			
needs repair to stabalize. See pictures.			
Does water collect in recessed areas of the Memor			Unable to tell
	In t	he cracked are	a.

SOUTH FACE - SHOWING SHAFT SPLIT

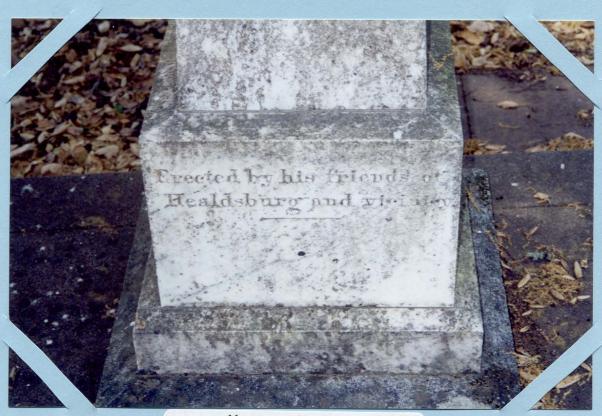
The "Dedication Text" is formed: X		
Record the text (indicate any separation is South side of base block, "Mathe	f on different sides) Please soon" has cut away back	use aggmonar sneet it necessary.
in the base material. North side of	of base block has cut in	
"Erected by friends of Healdsburg	g and vacinity".	
East and West sides of polished	base block blank.	
A cement apron surrounds the m site.	onument and covers the	e grave
Environmental Setting		
(The general vicinity and immediate locale sur Type of Location	rrounding a memorial can play a r	najor role in its overall condition.)
X Cemetery "Town Square" Municipal Building Courthouse Traffic Circle	Park Post Office State Capitol College Campus Library	Plaza/Courtyard School Other:

MATHESON MEMORIAL
OAKMOUND CEMETERY
HEALDSBURG, SONMA COUNTY, CA
PHOTO TAKEN 1 APR 2004 BY
JAMES SPENCER, SUVCW
101 SUNRISE MOUNTAIN ROAD
CAZADERO CA 95421
SOUTH FACE - BASE TEXT

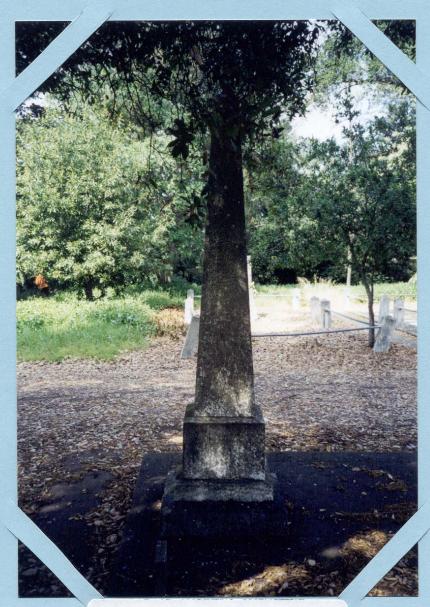
Matheson Memorial
Oakmound Cemetery
Healdsburg, Sonoma County, CA
Photo Taken 1 Apr 2004 by
James Spencer, SUVCW
101 Sunrise Mountain Road
Cazadero, CA 95421
East Face - Looking Westerly
