Civil War Memorial Assessment Form
(Form CWM #61)

**WATER FOUNTAIN
TO THE SOLDIERS AND SAILORS OF THE PAST CIVIL WAR
OAKMOUND CEMETERY
HEALDSBURG, SONOMA COUNTY, CALIFORNIA**

1876 VETERANS MEMORIAL FOUNTAIN
OAKMOUND CEMETERY
HEALDSBURG, SONOMA COUNTY, CA
PHOTO TAKEN 8 APR 2004 BY
JAMES SPENCER, SUVCW
101 SUNRISE MOUNTAIN ROAD
CAZADERO, CA 95421
NORTH SIDE - LOOKING SOUTHERLY

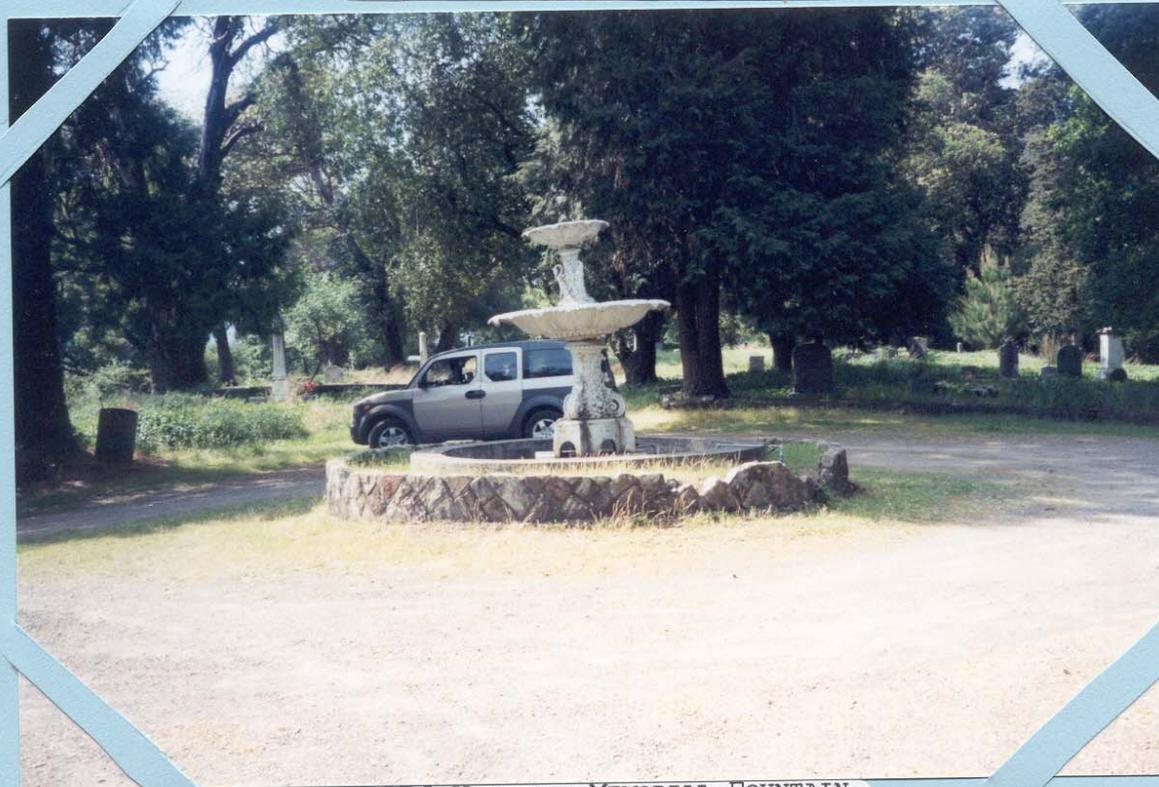
1876 VETERANS MEMORIAL FOUNTAIN
OAKMOUND CEMETERY
HEALDSBURG, SONOMA COUNTY, CA
PHOTO TAKEN 8 APR 2004 BY
JAMES SPENCER, SUVCW
101 SUNRISE MOUNTAIN ROAD
CAZADERO, CA 95421
SOUTH SIDE - LOOKING NORTHERLY

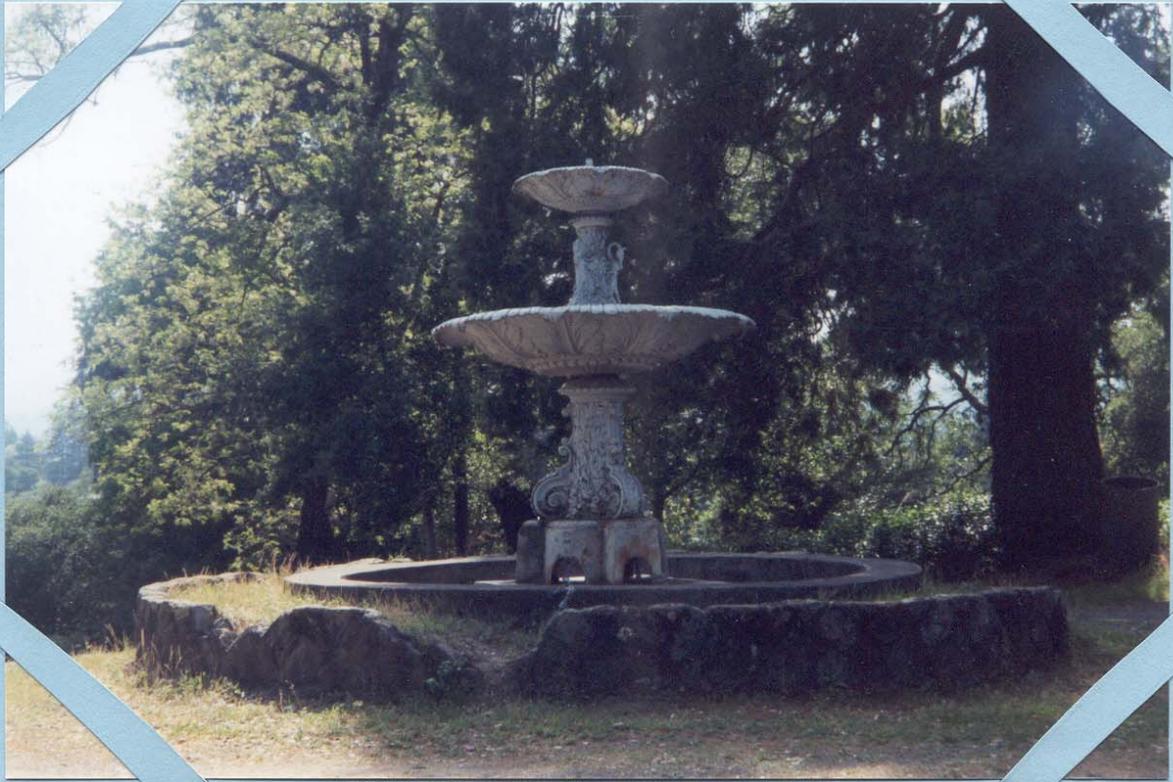
1876 VETERANS MEMORIAL FOUNTAIN
OAKMOUND CEMETERY
HEALDSBURG, SONOMA COUNTY, CA
PHOTO TAKEN 8 APR 2004 BY
JAMES SPENCER, SUVCW
101 SUNRISE MOUNTAIN ROAD
CAZADERO, CA 95421
EAST SIDE - LOOKING WESTERLY

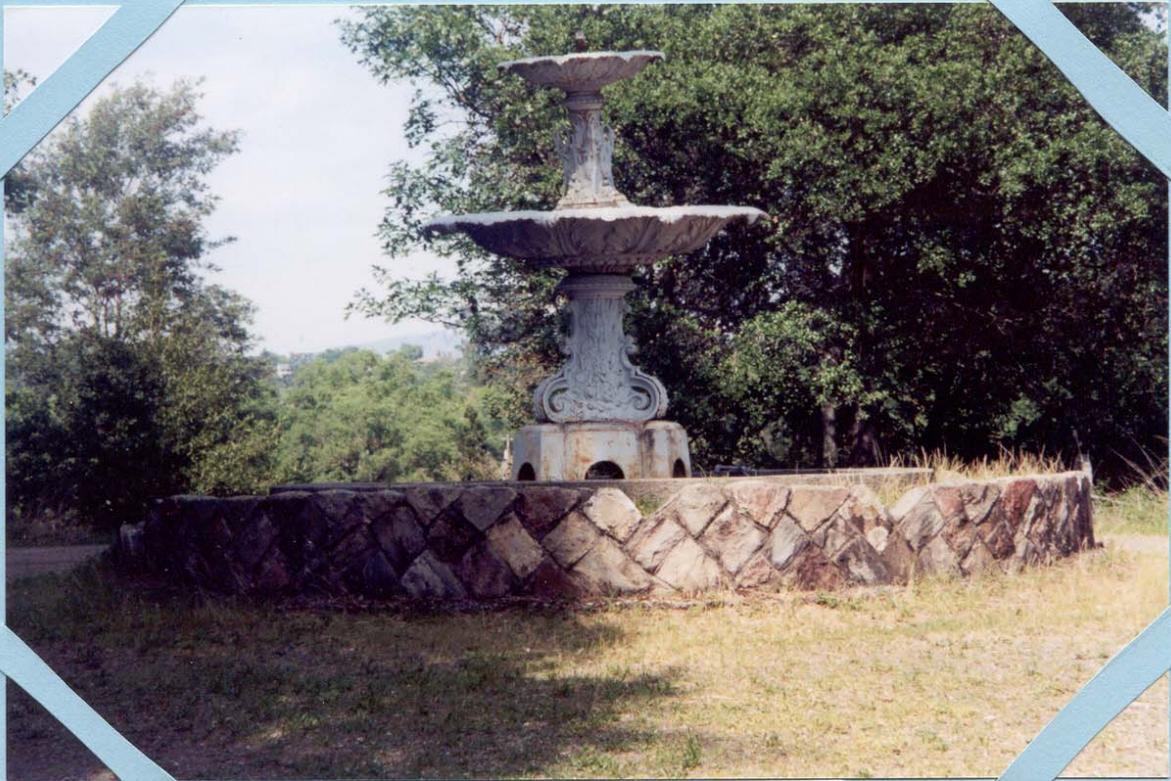
1876 VETERANS MEMORIAL FOUNTAIN
OAKMOUND CEMETERY
HEALDSBURG, SONOMA COUNTY, CA
PHOTO TAKEN 8 APR 2004 BY
JAMES SPENCER, SUVCW
101 SUNRISE MOUNTAIN ROAD
CAZADERO, CA 95421
WEST SIDE - LOOKING ~~E~~ASTERLY

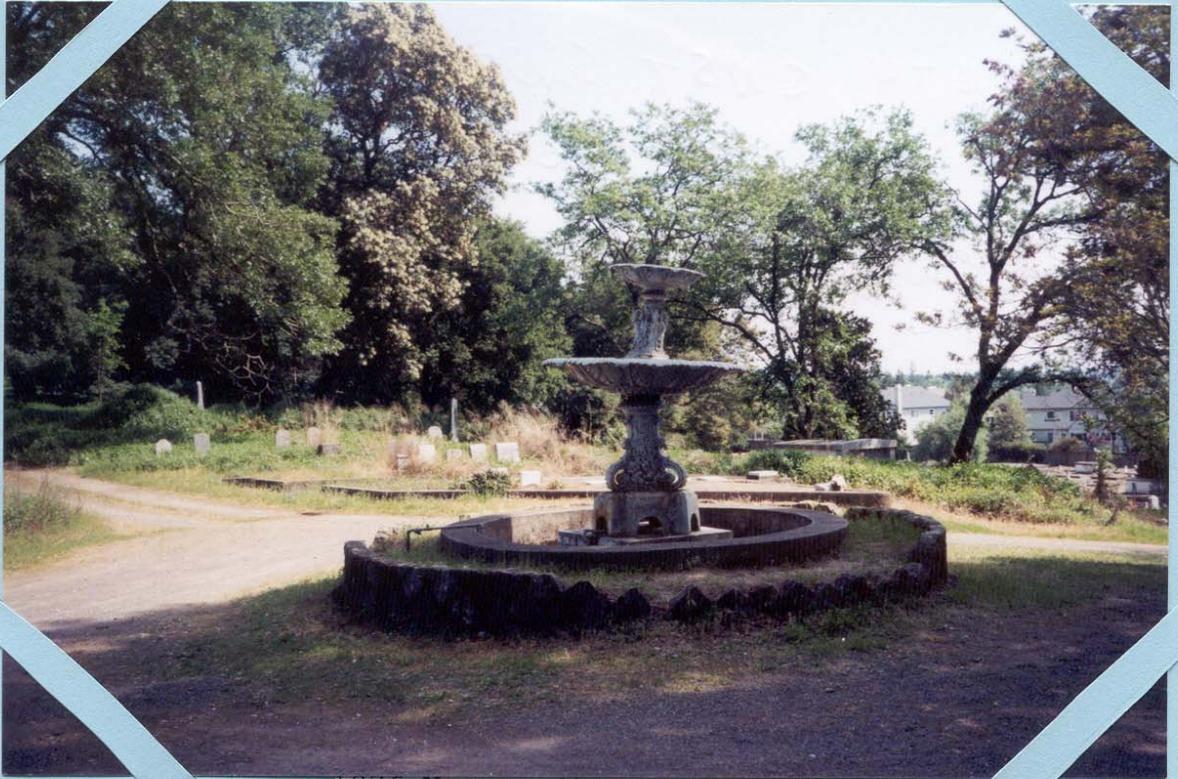
1876 VETERANS MEMORIAL FOUNTAIN
OAKMOUND CEMETERY
HEALDSBURG, SONOMA COUNTY, CA
PHOTO TAKEN 8 APR 2004 BY
JAMES SPENCER, SUVCW
101 SUNRISE MOUNTAIN ROAD
CAZADERO, CA 95421
NORTH SIDE-LOOKING SOUTH WESTERLY

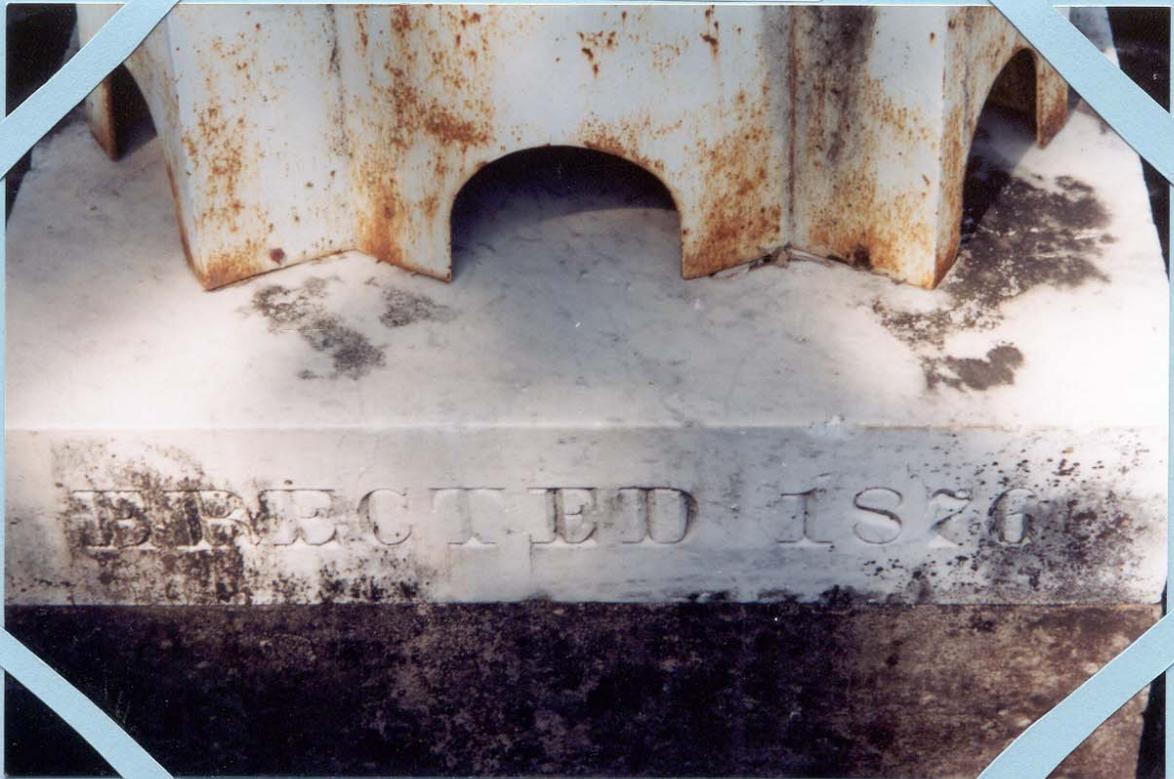
Markings/Inscriptions (on stone-work / metal-work of monument, base, sculpture)
Maker or Fabricator mark / name? If so, give name & location found Marble base
inscribed "Dedicated 1876". No marks on cast iron work found.

Record the text (indicate any separation if on different sides...) Please use additional sheet if necessary.
Old timers report there was a plaque present at one time,
believed to have been of brass, stolen years ago. No record
of text yet found.
Text on marble base heavily ingraved, see attached picture,

1876 VETERANS MEMORIAL FOUNTAIN
OAKMOUND CEMETERY
HEALDSBURG, SONOMA COUNTY, CA
PHOTO TAKEN 8 APR 2004 BY
JAMES SPENCER, SUVCW
101 SUNRISE MOUNTAIN ROAD
CAZADERO, CA 95421
EAST SIDE BASE WITH INSCRIPTION

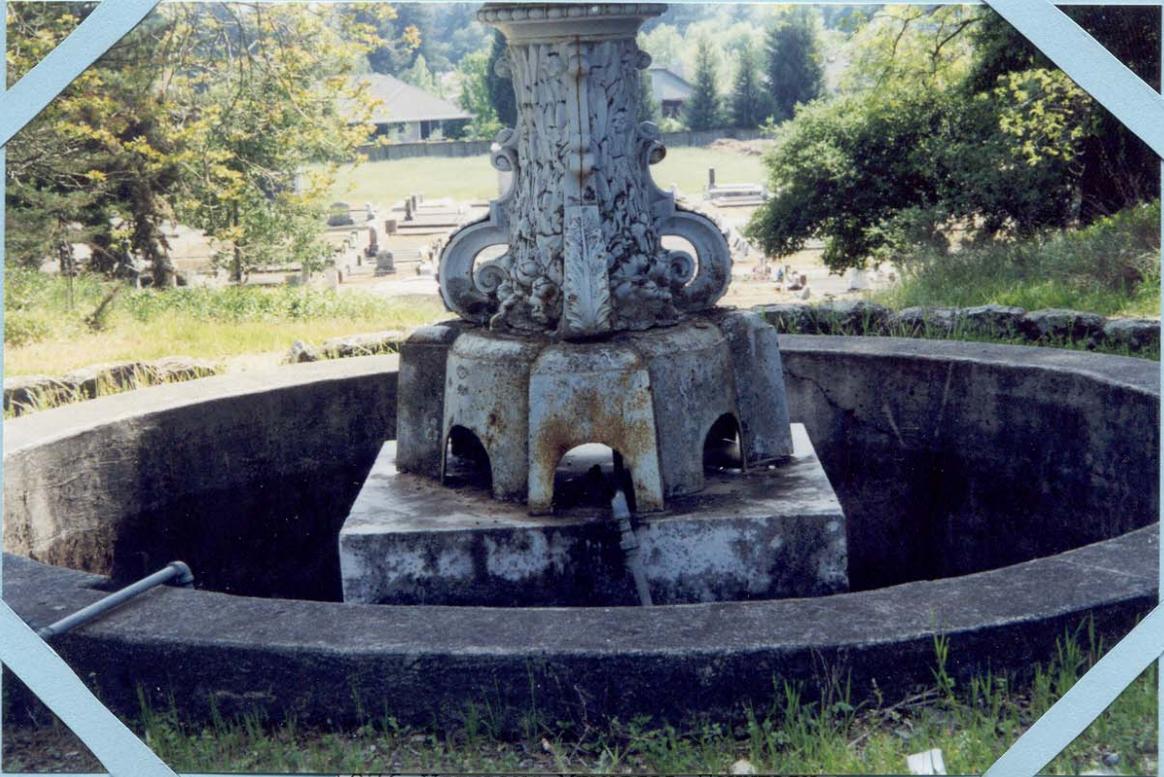
1876 VETERANS MEMORIAL FOUNTAIN
OAKMOUND CEMETERY
HEALDSBURG, SONOMA COUNTY, CA
PHOTO TAKEN 8 APR 2004 BY
JAMES SPENCER, SUVCW
101 SUNRISE MOUNTAIN ROAD
CAZADERO, CA 95421
WEST SIDE BASE LOOKING EASTERLY

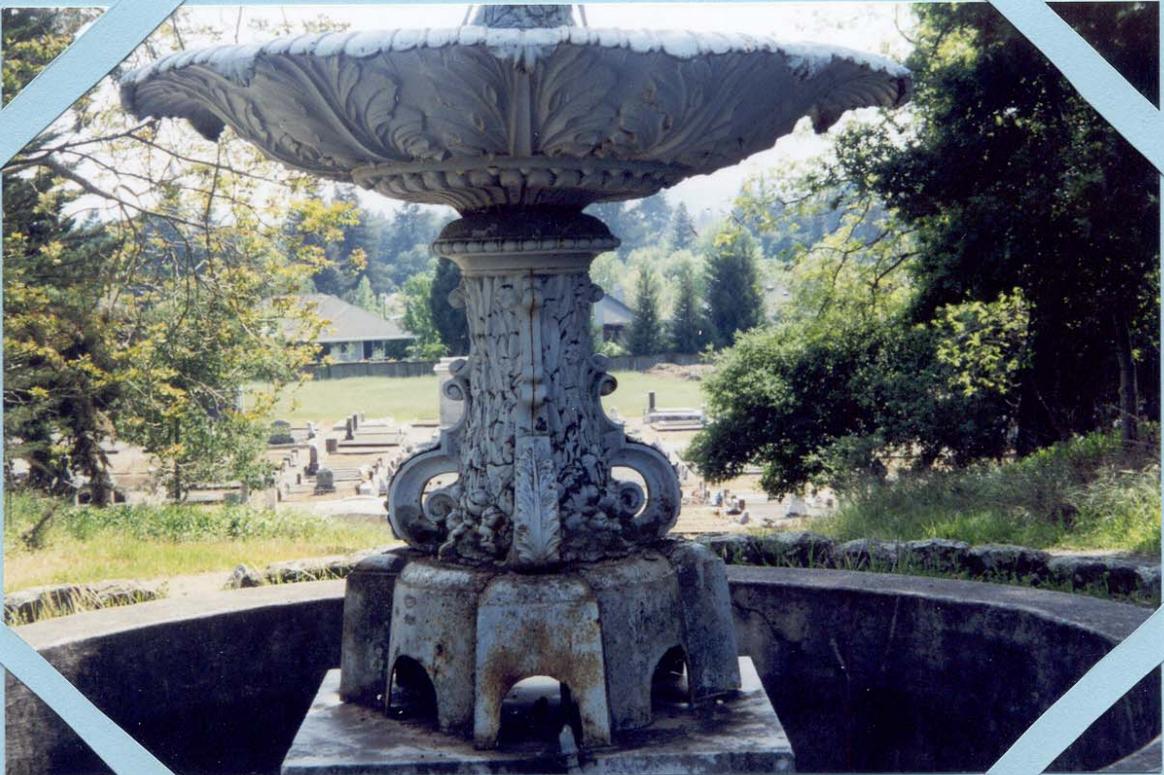
1876 VETERANS MEMORIAL FOUNTAIN
OAKMOUND CEMETERY
HEALDSBURG, SONOMA COUNTY, CA
PHOTO TAKEN 8 APR 2004 BY
JAMES SPENCER, SUVCW
101 SUNRISE MOUNTAIN ROAD
CAZADERO, CA 95421
WEST SIDE BASE SHAFT LOOKING EASTERLY

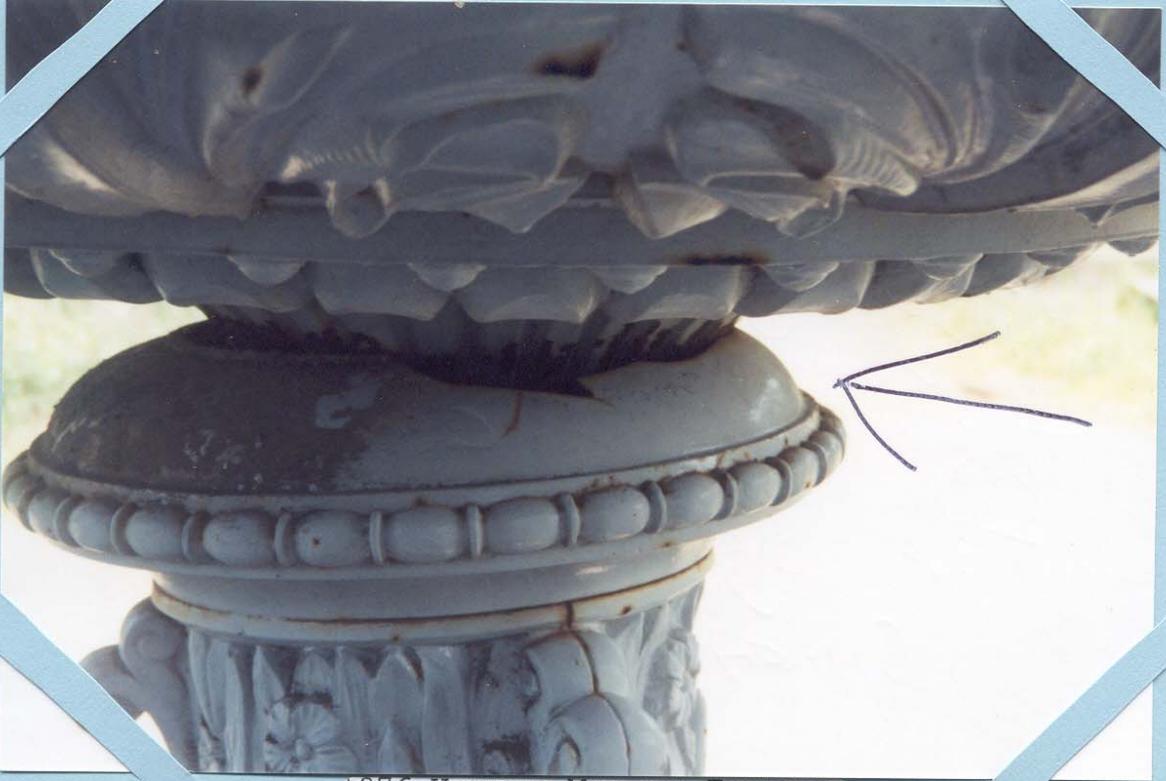
1876 VETERANS MEMORIAL FOUNTAIN
OAKMOUND CEMETERY
HEALDSBURG, SONOMA COUNTY, CA
PHOTO TAKEN 8 APR 2004 BY
JAMES SPENCER, SUVCW
101 SUNRISE MOUNTAIN ROAD
CAZADERO, CA 95421
**EAST SIDE FIRST BASIN SHOWING
SITE OF MISSING CAST IRON**

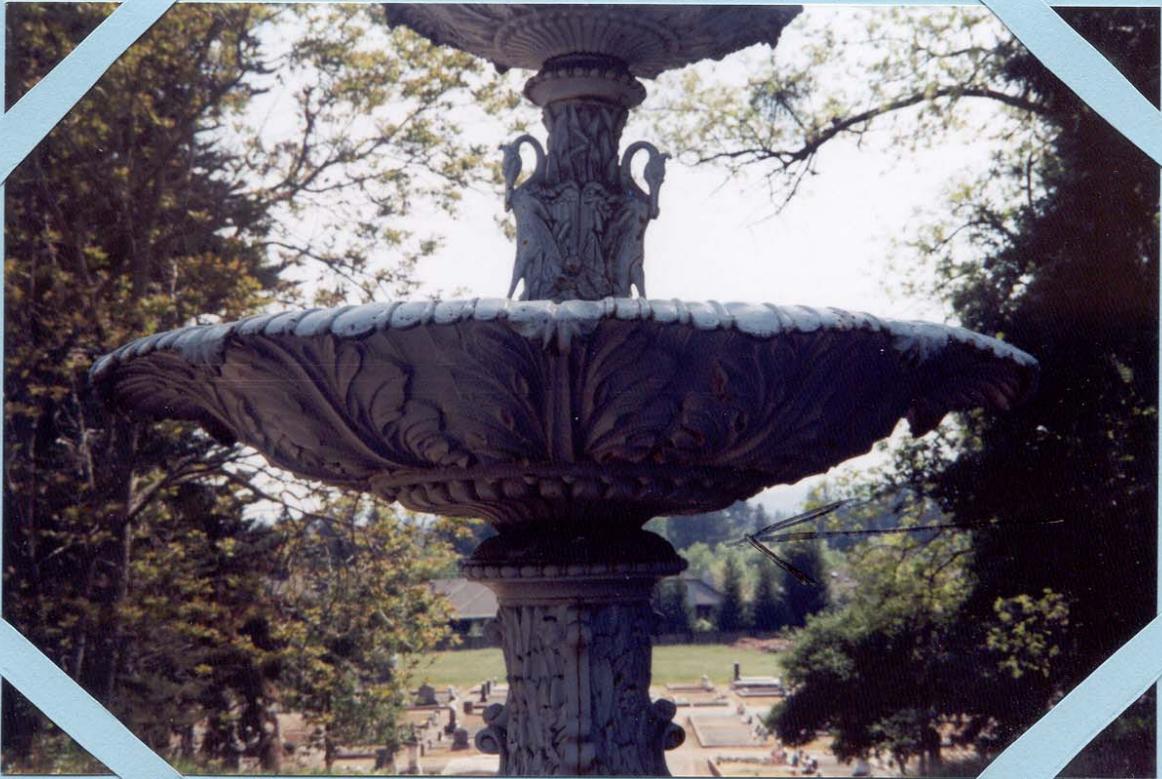
Briefly describe the Memorial (affiliation / overall condition & any concern not already touched on) .
The Veterans War Fountain is in need of repair. No one has
put any effort in to this monument per scrap of metal marker
found. The bottom bowl has large chip out of it that causes
leaning, making it unstable. See attached pictures.

1876 VETERANS MEMORIAL FOUNTAIN
OAKMOUND CEMETERY
HEALDSBURG, SONOMA COUNTY, CA
PHOTO TAKEN 8 APR 2004 BY
JAMES SPENCER, SUVCW
101 SUNRISE MOUNTAIN ROAD
CAZADERO, CA 95421
**WEST SIDE-LOWER BASIN, STEM
SEAHORSES, ARROW SHOWS BROKEN AREA**

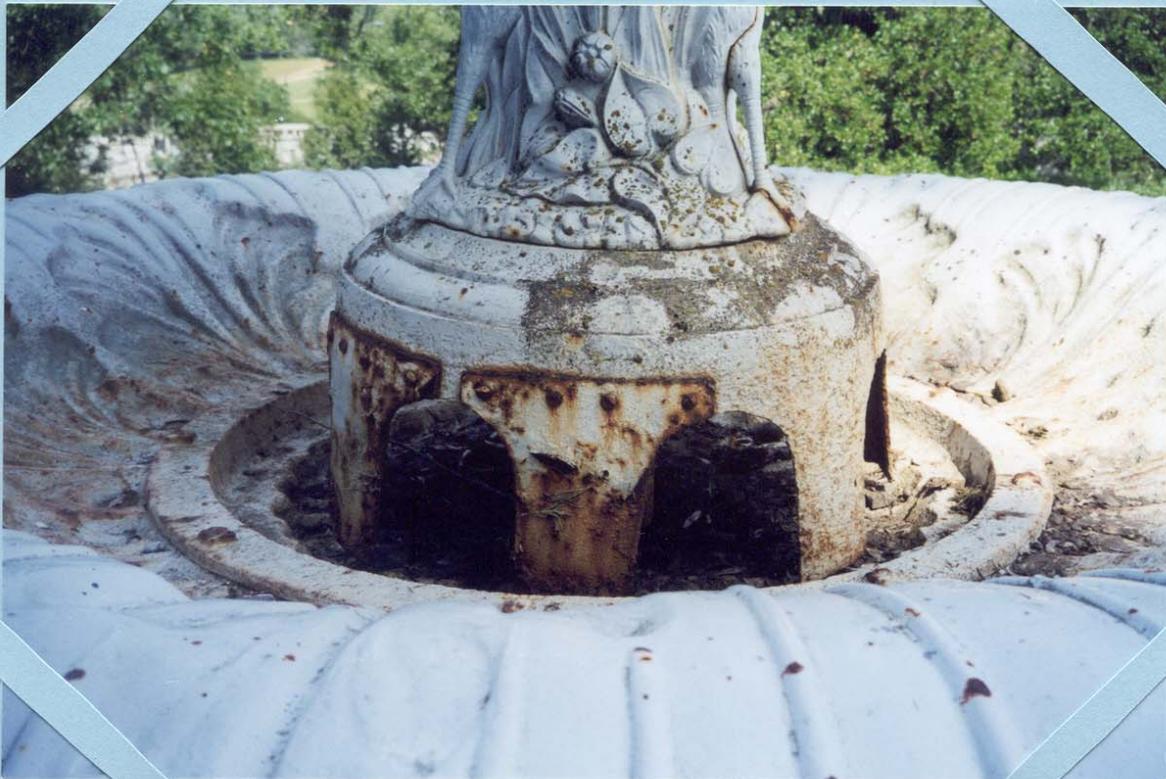
1876 VETERANS MEMORIAL FOUNTAIN
OAKMOUND CEMETERY
HEALDSBURG, SONOMA COUNTY, CA
PHOTO TAKEN 8 APR 2004 BY
JAMES SPENCER, SUVCW
101 SUNRISE MOUNTAIN ROAD
CAZADERO, CA 95421
WESTERLY SIDE SHOWING STEM BASE
REPAIR IN LOWER BOWL

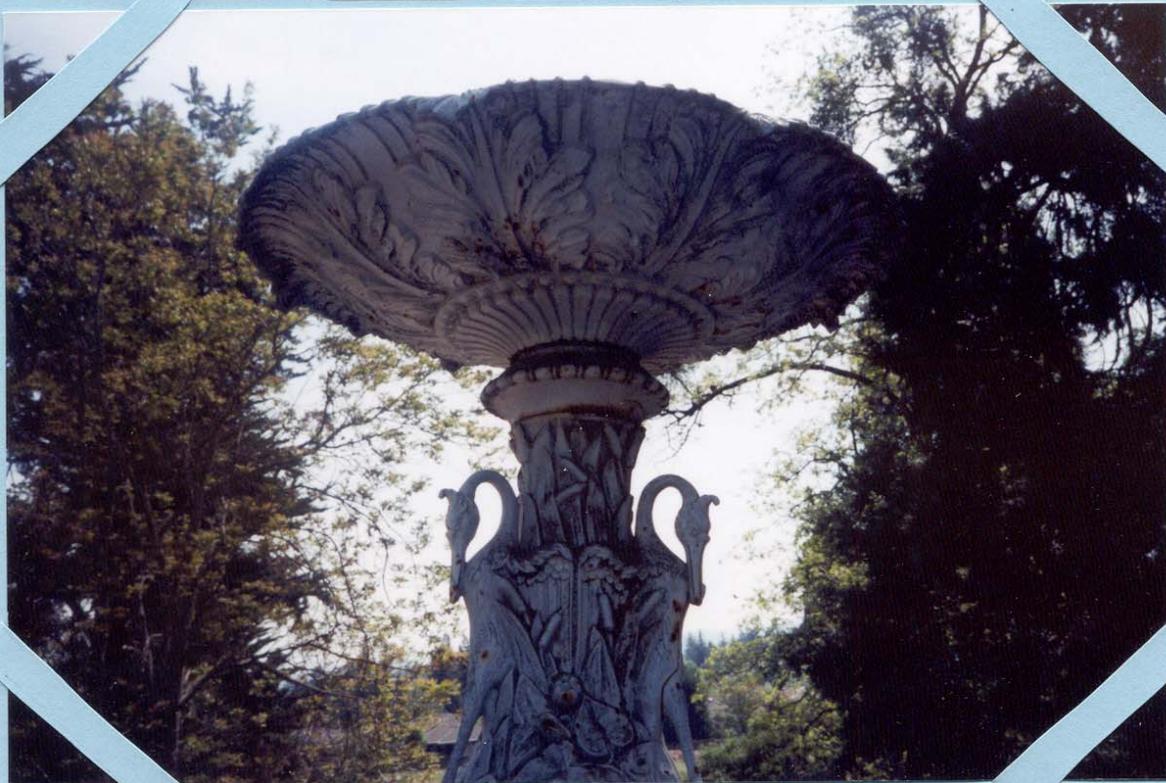
1876 VETERANS MEMORIAL FOUNTAIN
OAKMOUND CEMETERY
HEALDSBURG, SONOMA COUNTY, CA
PHOTO TAKEN 8 APR 2004 BY
JAMES SPENCER, SUVCW
101 SUNRISE MOUNTAIN ROAD
CAZADERO, CA 95421
WEST SIDE SEAHORSES AND
BOTTOM OF UPPER BASE

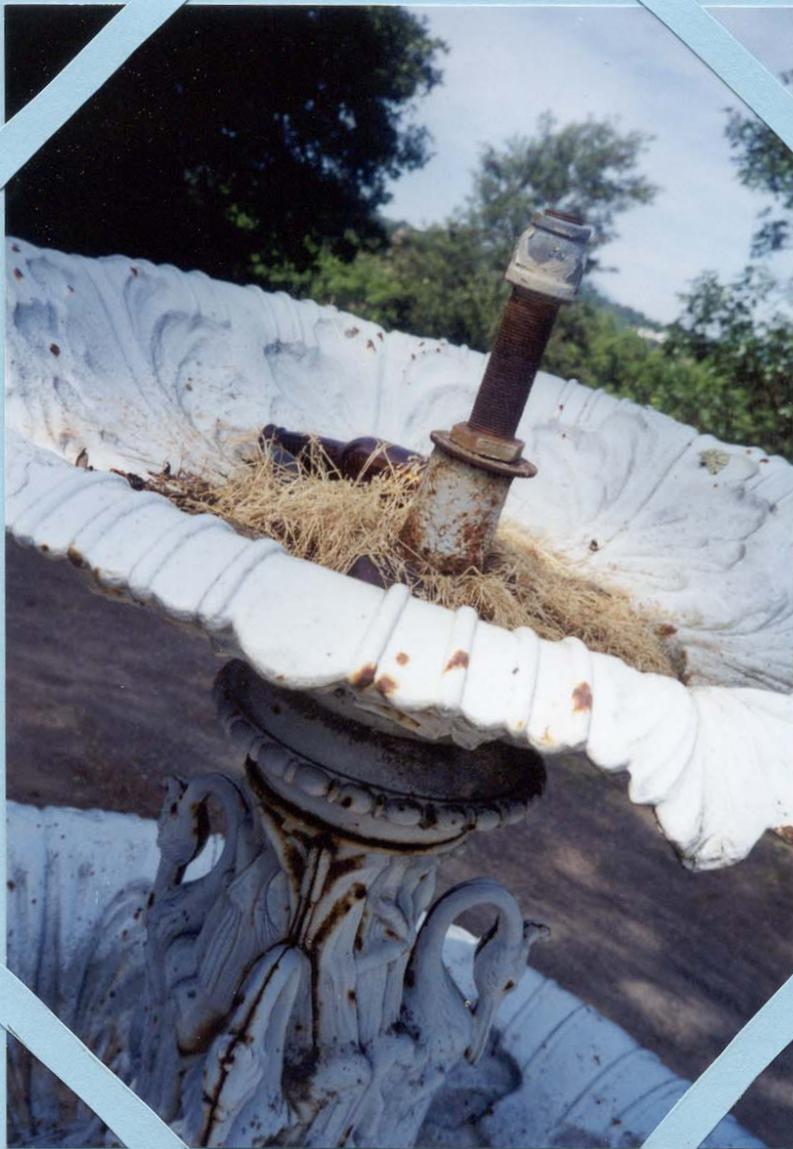
1876 VETERANS MEMORIAL FOUNTAIN
OAKMOUND CEMETERY
HEALDSBURG, SONOMA COUNTY, CA
PHOTO TAKEN 8 APR 2004 BY
JAMES SPENCER, SUVCW
101 SUNRISE MOUNTAIN ROAD
CAZADERO, CA 95421
TOP BOWL BASIN BEFORE CLEANING
