CIVIL WAR MEMORIAL ASSESSMENT FORM

The 2d Col. Vol. Cav. Memorial

Woodlawn Cemetery Independence, Missouri

By Brian V. Smarker Sons of Union Veterans of the Civil War Department of Missouri Westport Camp #64

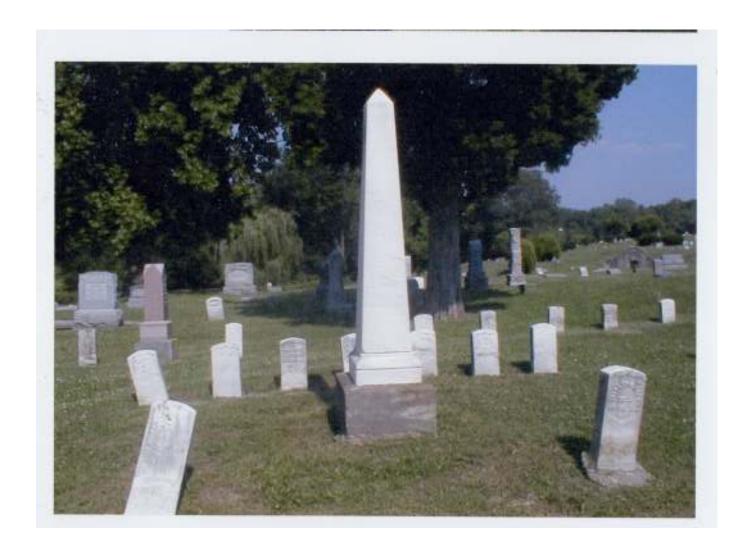
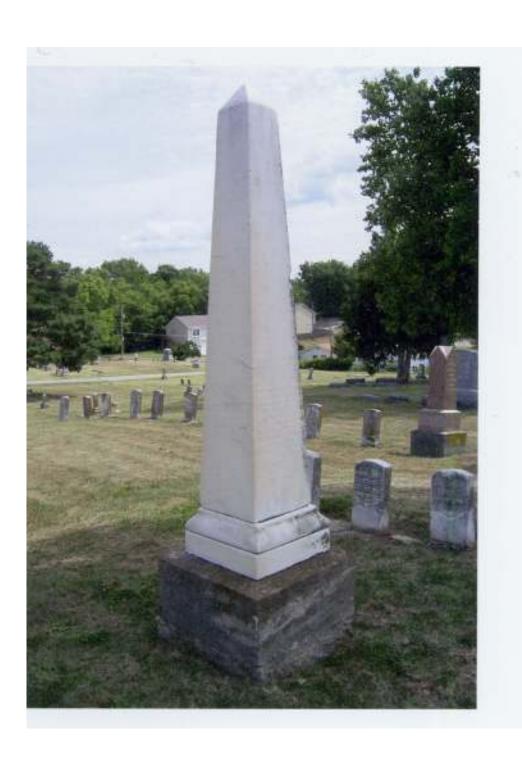
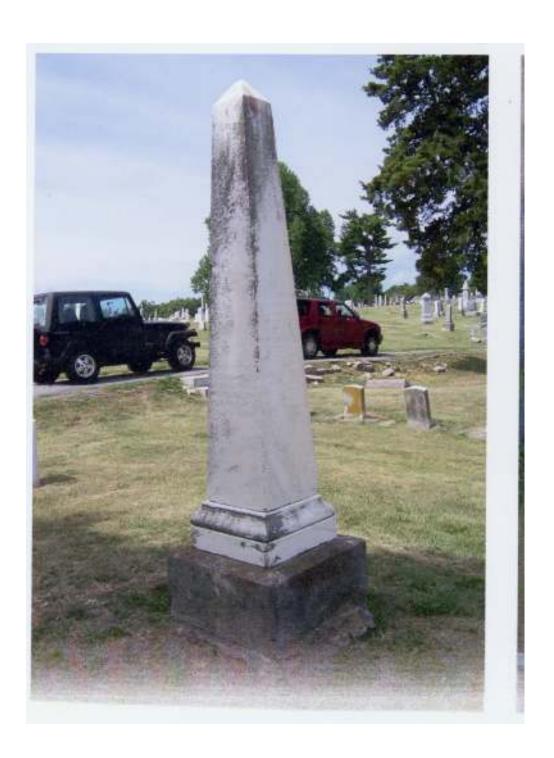
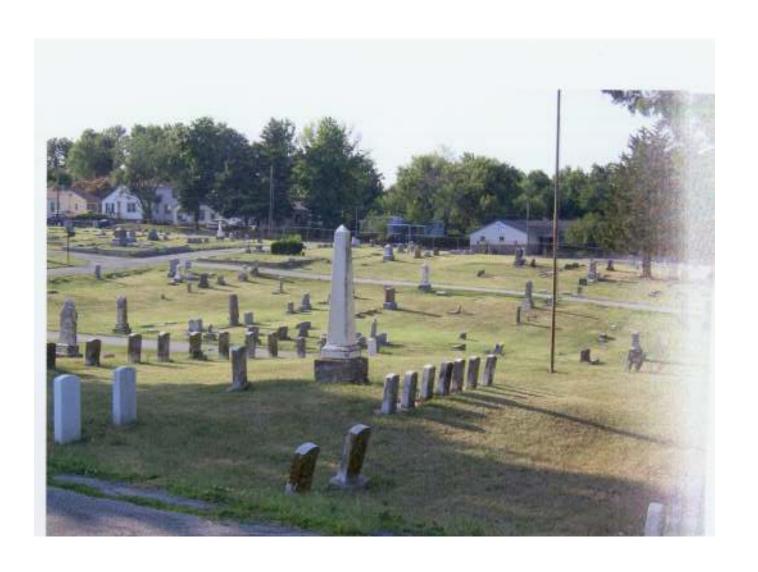
Surface Coating							
Does there appear to be a coating? Yes No Unable to determine							
If known, identify type of coating:							
○ Gilded ○ Painted ○ Varnished ○ Waxed ○ Unable to determine							
Is the coating in good condition? Yes ONO Ounable to determine							
Basic Surface Condition Assessment							
In your opinion, what is the general appearance or condition of the Memorial? (a) Would benefit from treatment (b) In urgent need of treatment (c) Unable to determine							
O Vien manned O Vien a Seriem ver a Seriem of the Seriem o							
Overall Description							
Briefly describe the Memorial (affiliation / overall condition & any concern not already touched on).							
Recorded as the oldest Civil War monument west of the Mississippi River, this monument is in surprisingly							
good shape except for the discolored white Vermont marble and illegible, weather-worn inscriptions. There

are small pieces broken from the edges, too, which sometimes also removed a letter of the inscription. The inscriptions are very difficult to read even with shadows cast across the words. In fact, without knowing what							
the south face says, it would be impossible to figure it out. (see attached document)							
Supplemental Background Information							
Supplemental Background Information In addition to your on-site survey, any additional information you can provide on the described							
Memorial will be welcomed. Please label each account with its source (author, title, publisher,							
date, pages). Topics include any reference to the points listed on this questionnaire, plus any							
previous conservation treatments - or efforts to raise money for treatment. Thank you.							
Inspector Identification							
Date of On-site Survey 17 Jun 2006 Westport 64 MO SUVCW							
Your Name Brian Smarker

All four faces of the monument bear weather-beaten inscriptions which have become difficult to read. Even after a stone rubbing the words appear incomprehensible. The least invasive method of deciphering the text is using a mirror to reflect sunlight across the engravings or, perchance the time of day is right, have the sun cast shadows across the surfaces enhancing their text.

There are those who believe the 2d Col. Vol. Cav. monument should be restored, yet in its current state, it would seem more feasible to leave it alone for history's sake and, possibly, erect a modern replica to perpetuate the memory of the Second Colorado Cavalry buried at Woodlawn Cemetery in Independence, Missouri.
