NATIONAL ORGANIZATION
SONS OF UNION VETERANS OF THE CIVIL WAR
CIVIL WAR MEMORIAL ASSESSMENT FORM

Department of Iowa - Civil War Monuments
Hardin County - Eldora

Soldier Monument and Cannon at Courthouse

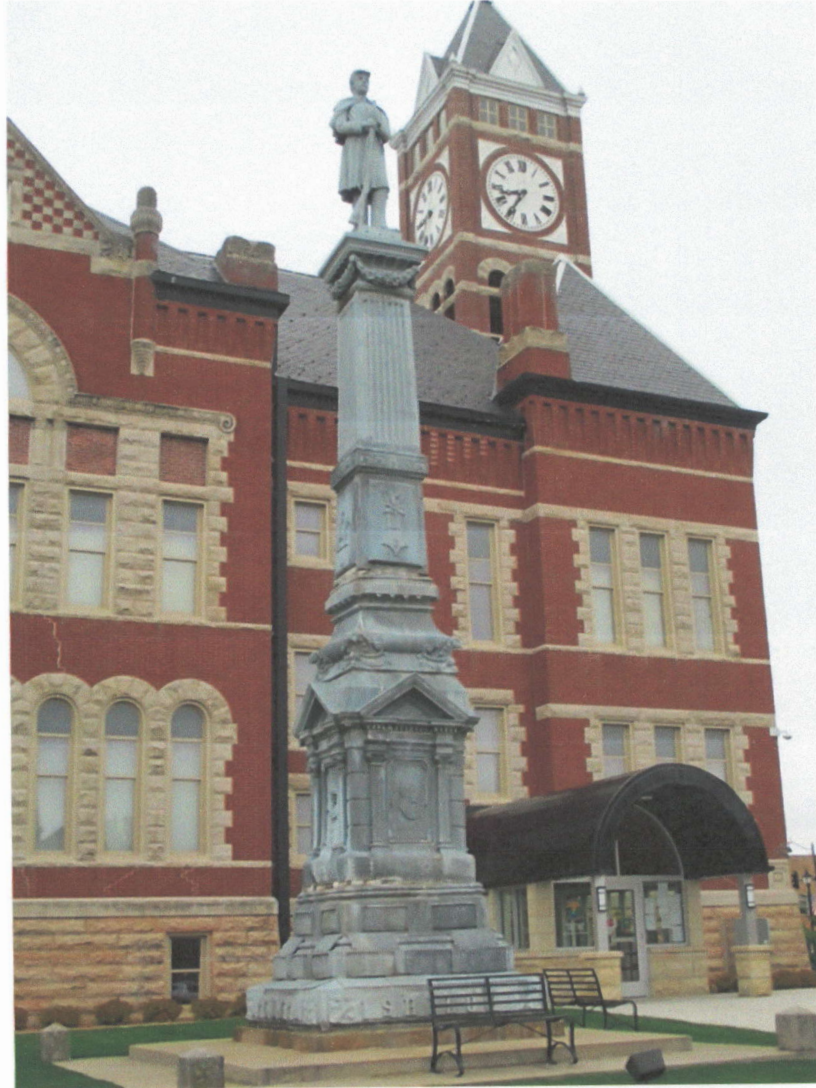
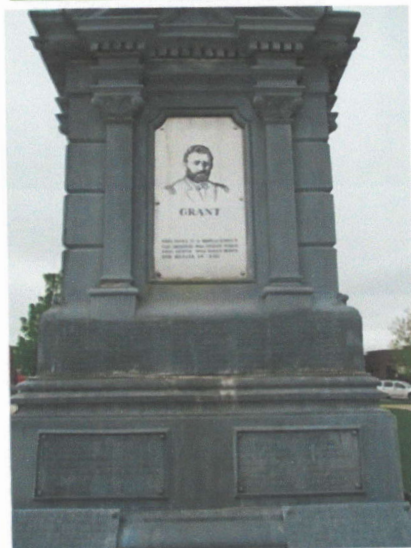
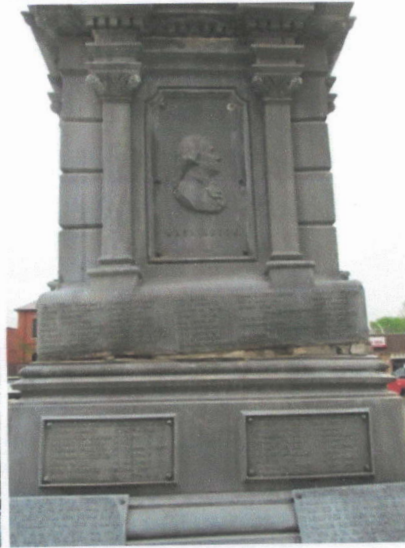
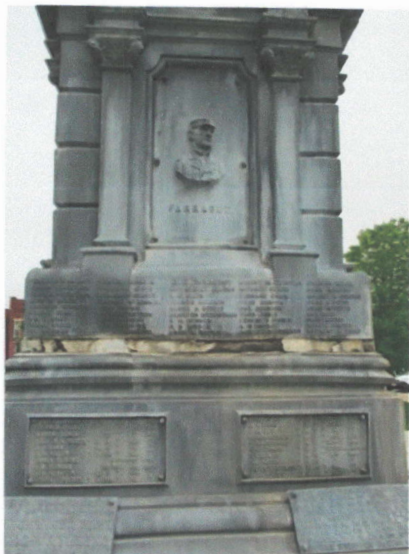
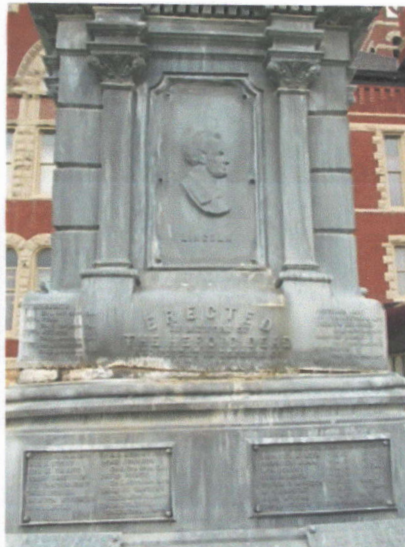
The soldier monument is "white bronze" or zinc and 35 feet high. About 510 soldiers of the region are named around the base. There are panels of Grant, Washington, Farragut and Lincoln. The Grant panel is a replacement. It was dedicated in 1886. In the 1980's the monument was sagging and there was danger of losing it. It was taken apart and concrete was used on the inside as a foundation. Today there is some separation and cracking of the white bronze.

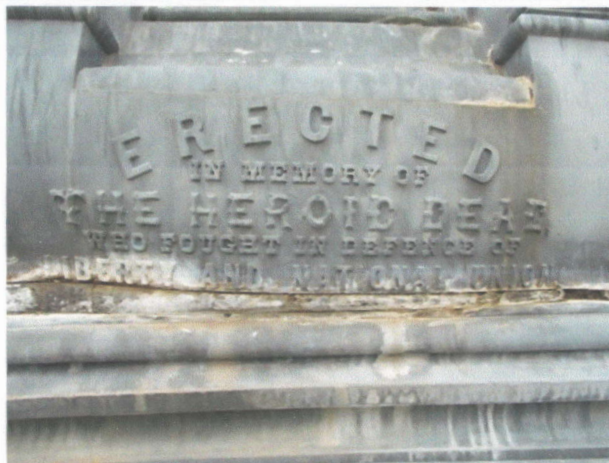
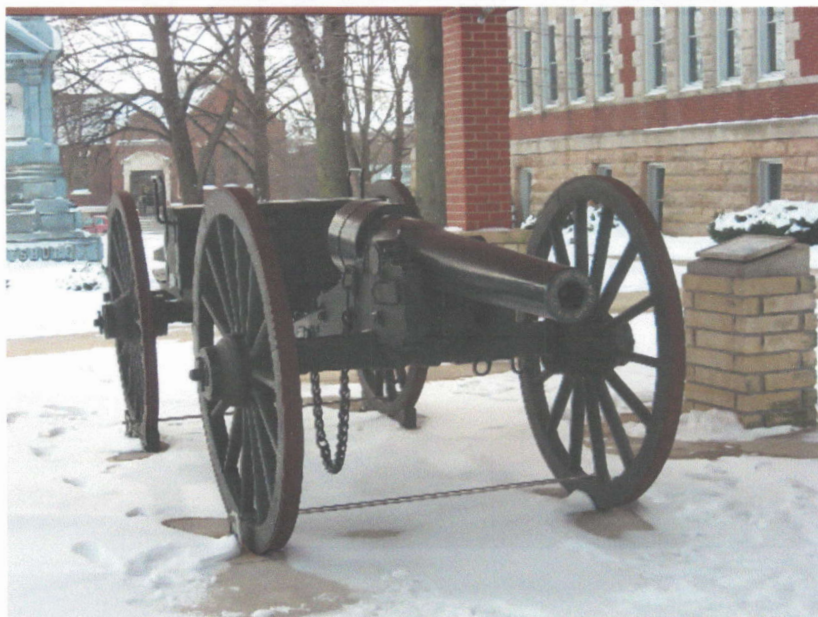
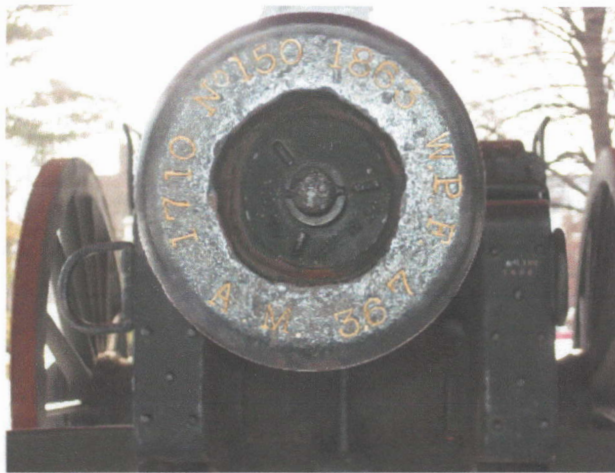
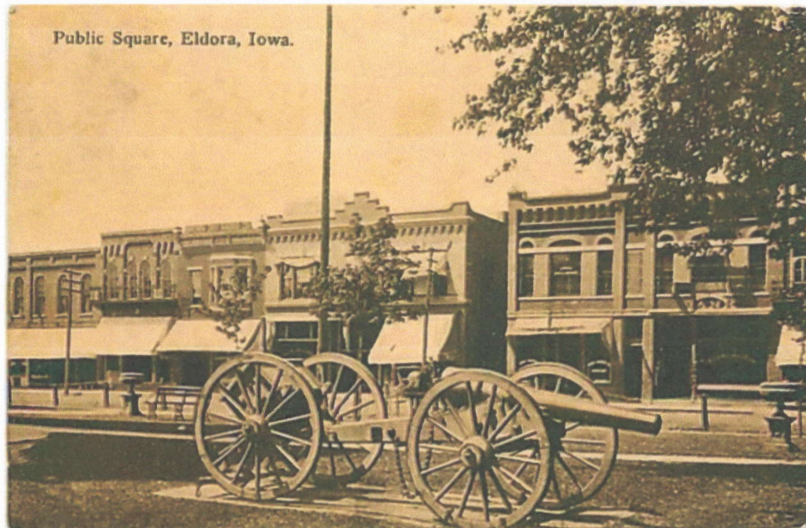
The cannon is a 3.67 inch Army Parrott rifle cast at the West Point Foundry in 1863 with a carriage and limber in great condition. The markings on the cannon are highlighted. In the early 1990's, the late Gene Farmer rebuilt the carriage and limber. The cannon sets under a shelter for protection from the elements. Mr. Farmer had led efforts to provide the shelter along with restoration of the cannon and monument. The location is on the east side of the courthouse. Photos taken 1/27/08 and 5/19/20. Also included is an old undated copy of a postcard showing the cannon in a different location and without the shelter. Thanks to Danny Krock for providing this.
